BEARING INSPECTION REPORT **FORTH ROAD BRIDGE**

Client: Atkins

Date: 21 April 2008

Client: Atkins
Structure: Forth Road Bridge
Location: South Queensferry, West Lothian
Inspector: Paul Latham
Dates: 18 & 19 February 2008

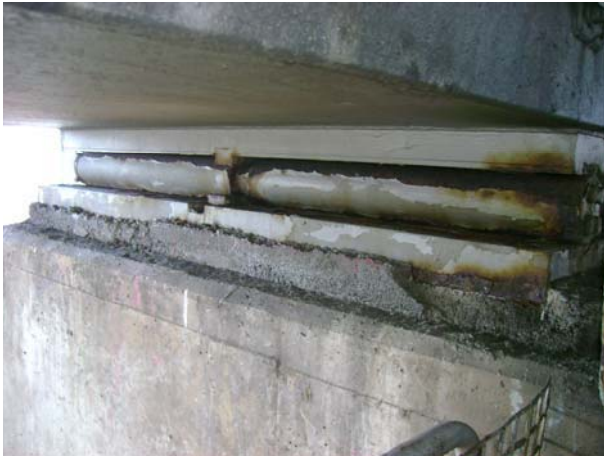
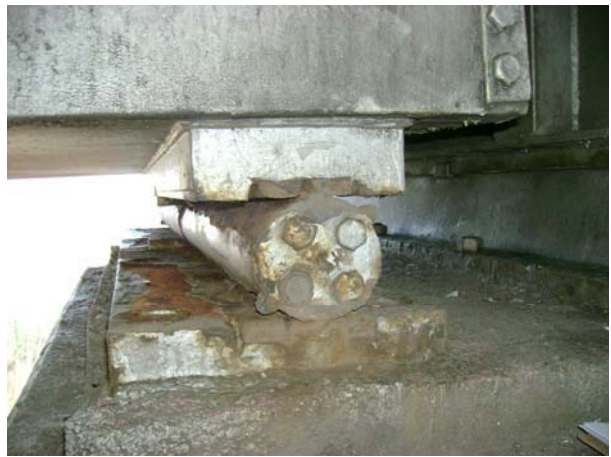
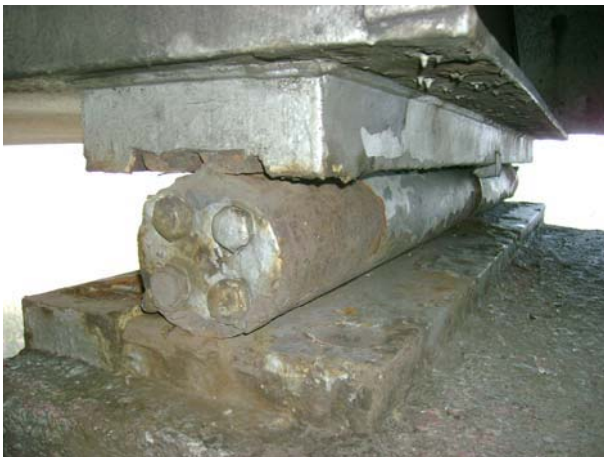
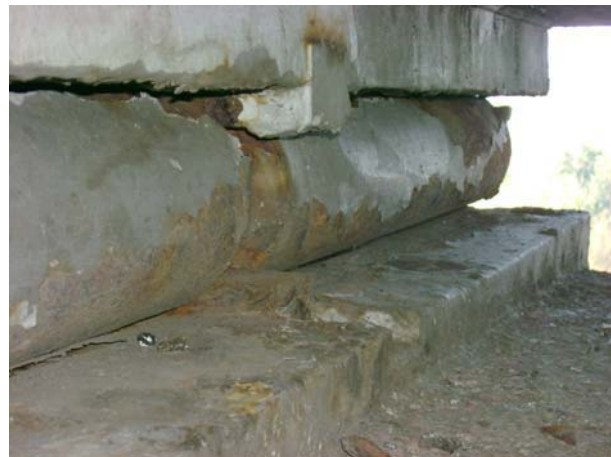
Pier S3 – Position: S3 West - Roller Bearings

Plinth condition	Poor with evidence of concrete spawling. Point loading on steel packs beneath rocker causing fracture cracks to pier.
Base grout condition	Poor. Grout showing signs of failure particularly around roller base.
Bearing fully supported	Yes
Top plate condition	Heavy corrosion at roller /top plate interface and rocker/top plate interface.
Top plate fixings condition	N/A. Roller top plate welded to steel beam above, rocker top plate welded to steel beam above.
Stainless steel bearing surface condition	N/A
Witness & extent of movement	No evidence of movement on rocker bearing. Movement of between 80 – 100mm witnessed on roller bearing.
Base plate condition	Evidence of heavy corrosion at roller/base plate interface. Roller gear cogs out of synchronization and broken.
Base plate fixings condition	Rocker bearing good condition. Roller bearing fixings showing some signs of corrosion to bolt heads.

PTFE condition & thickness	N/A
Elastomeric pad condition	N/A
Bearing Rotation	N/A
Bearing surface treatment condition	Generally unsatisfactory with evidence of heavy corrosion to rocker/top plate interface & roller/top plate/base plate interfaces.
Structural concrete condition	Spawling witnessed on north face of pier with evidence of previous repair work been carried out at an earlier date.
Water penetration evidence	Evidence of water penetration around roller base grout bed.
Inspector's Comments	<p>Roller Bearing</p> <p>Excessive corrosion to both the top & bottom bearing faces & to the corresponding roller surface causing irregular wear and changes to the profile of the roller. This has caused the roller to slide and break the teeth off the rack assembly.</p> <p>The base grout is of poor quality & has insufficient cover around the perimeter of the bearing. There is evidence of sections of the base grout separating from the base plate which has probably been caused by the sliding effect of the roller.</p> <p>The paint system is generally in poor condition. The bearing is in an unserviceable state.</p>

<p>Rocker Bearing Extensive wear to rocker top plate with evidence of severe corrosion. The painted areas on the rocker ends show no signs of any movement which seems to suggest that the bearing is not functioning as it was designed for.</p> <p>There is evidence of the base grout separating from the rocker base. This has exposed the steel shim packs beneath suggesting that possible point loading is occurring. This is further justified by the concrete spawling witnessed on the pier top, directly below the steel shims.</p>
<p>Recommendation</p>	<p>Both the rocker & roller bearing should be replaced as neither are functioning correctly.</p>

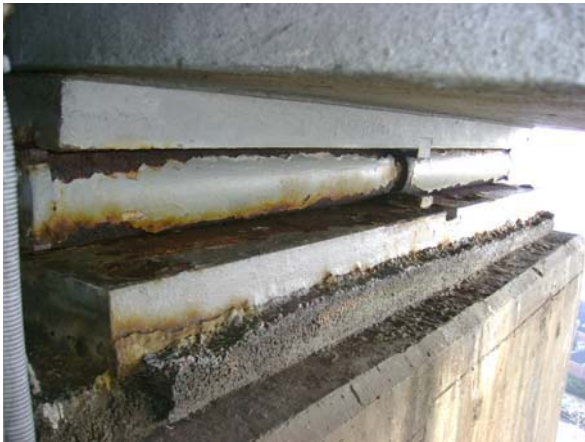
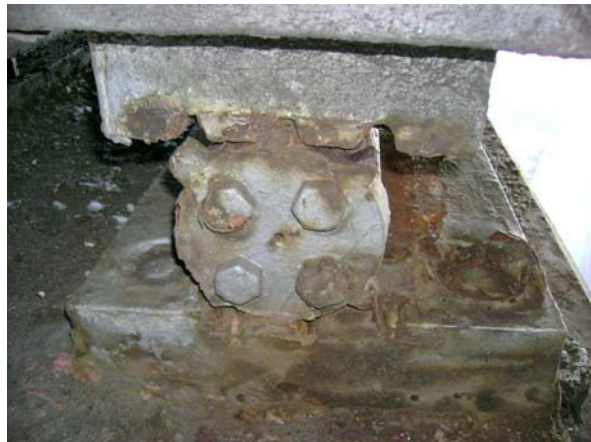
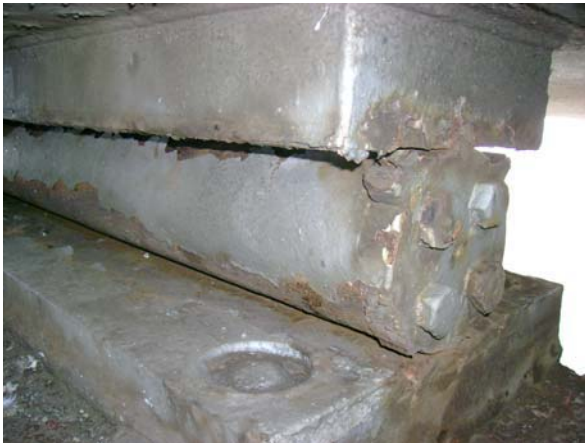
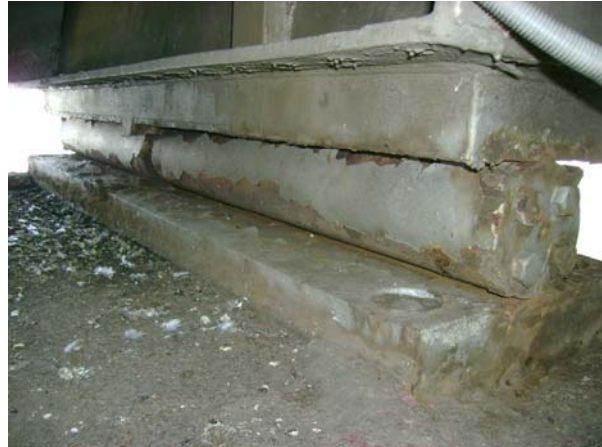
Pier S3 – Position: S3 East - Roller Bearings

Plinth condition	Poor with evidence of concrete spawling. Point loading on steel packs beneath rocker causing fracture cracks to pier.
Base grout condition	Poor. Grout showing signs of failure particularly around roller base.
Bearing fully supported	Yes
Top plate condition	Heavy corrosion at roller /top plate interface and rocker/top plate interface.
Top plate fixings condition	N/A. Roller top plate welded to steel beam above, rocker top plate welded to steel beam above.
Stainless steel bearing surface condition	N/A
Witness & extent of movement	No evidence of movement on rocker bearing. Movement of between 80 – 100mm witnessed on roller bearing.
Base plate condition	Evidence of heavy corrosion at roller/base plate interface. Roller gear cogs out of synchronization and broken.
Base plate fixings condition	Rocker bearing good condition. Roller bearing fixings showing some signs of corrosion to bolt heads.

PTFE condition & thickness	N/A
Elastomeric pad condition	N/A
Bearing Rotation	N/A
Bearing surface treatment condition	Generally unsatisfactory with evidence of heavy corrosion to rocker/top plate interface & roller/top plate/base plate interfaces.
Structural concrete condition	Spawling witnessed on north face of pier with evidence of previous repair work been carried out at an earlier date.
Water penetration evidence	Evidence of water penetration around roller base grout bed.
Inspector's Comments	<p>Roller Bearing</p> <p>Excessive corrosion to both the top & bottom bearing faces & to the corresponding roller surface causing irregular wear and changes to the profile of the roller. This has caused the roller to slide and break the teeth off the rack assembly.</p> <p>The base grout is of poor quality & has insufficient cover around the perimeter of the bearing. There is evidence of sections of the base grout separating from the base plate which has probably been caused by the sliding effect of the roller.</p> <p>The paint system is generally in poor condition. The bearing is in an unserviceable state.</p> <p>Rocker Bearing</p> <p>Extensive wear to rocker top plate with evidence of severe corrosion.</p>

<p>The painted areas on the rocker ends show no signs of any movement which seems to suggest that the bearing is not functioning as it was designed for.</p> <p>The base grout is of poor quality & shows signs of insufficient cover around the base.</p>
Recommendation	Both the rocker & roller bearing should be replaced as neither are functioning correctly.

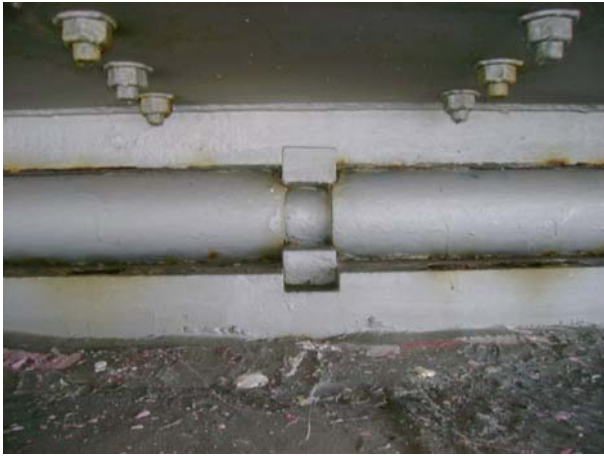
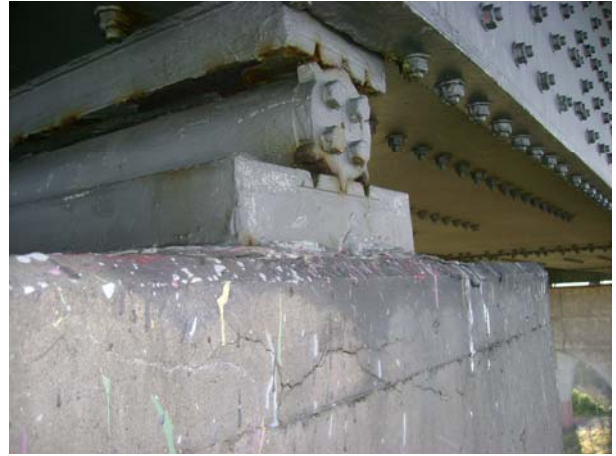
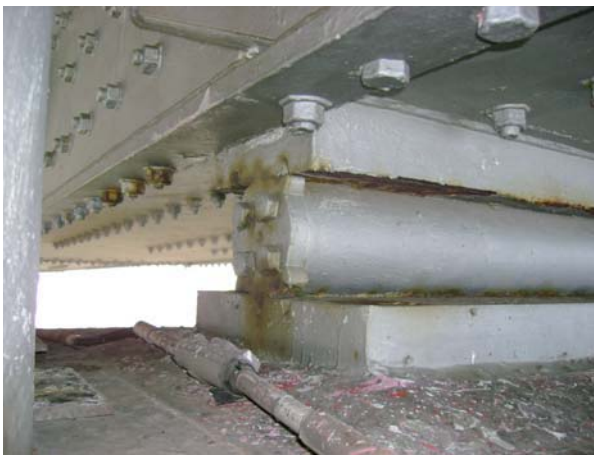
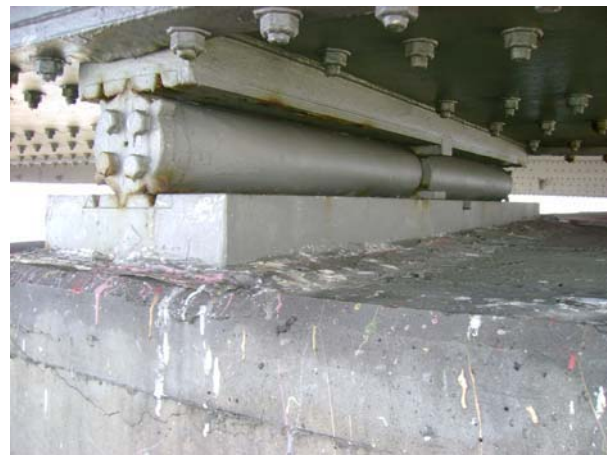
Pier S4 – Position: S4 West

Plinth condition	Satisfactory
Base grout condition	No evidence of structural failure, excessive paint applied to base grout.
Bearing fully supported	Yes
Top plate condition	Generally satisfactory although evidence of corrosion at roller /top plate interface witnessed.
Top plate fixings condition	N/A. Roller top plate welded to steel beam above. Connection appears structurally sound.
Stainless steel bearing surface condition	N/A
Witness & extent of movement	Minimal evidence of movement witnessed.
Base plate condition	Generally satisfactory. Evidence of corrosion at base plate/roller interface.
Base plate fixings condition	Counter-bored fixing holes. Unable to ascertain condition of fixings.
PTFE condition & thickness	N/A
Elastomeric pad condition	N/A
Bearing Rotation	N/A
Bearing surface treatment condition	Generally satisfactory except at roller/top plate/base plate interfaces.
Structural concrete condition	Spawling witnessed on west face of pier.

Water penetration evidence	None witnessed.
Inspector's Comments	Heavy corrosion to both top & bottom bearing faces & to the corresponding roller surface causing an irregular bearing surface. A consequence of this may cause an increase in stresses being transferred to the sub-structure. Large areas of stress cracking to the west pier sub-structure were witnessed. Evidence of any movement is very minimal. The paint system is generally in poor condition.
Recommendation	It is unlikely that this bearing is functioning correctly & ideally the bearing should be replaced.

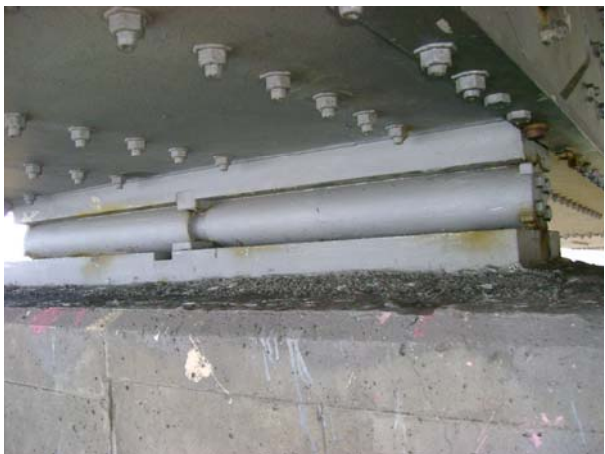
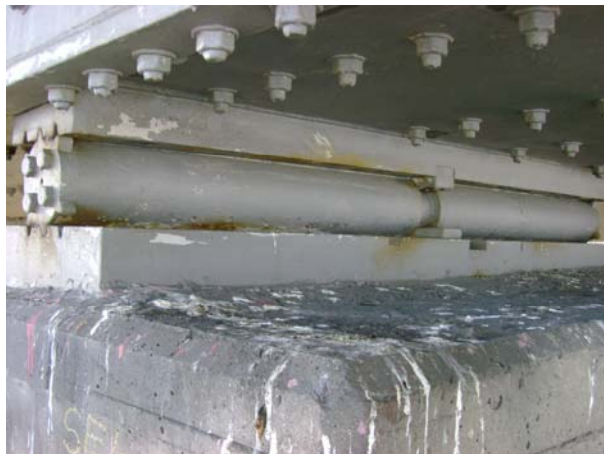
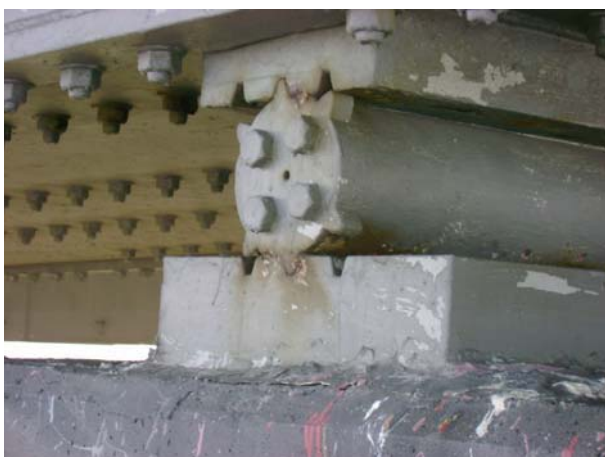
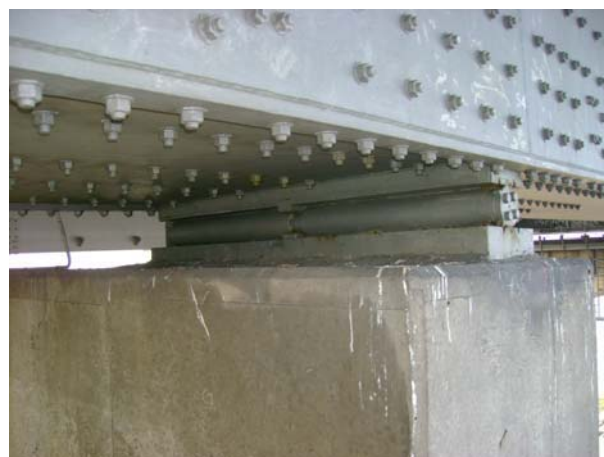
Pier S4 – Position: S4 East

Plinth condition	Generally satisfactory
Base grout condition	Poor quality and porous in appearance.
Bearing fully supported	Yes
Top plate condition	Generally satisfactory although evidence of corrosion at roller /top plate interface witnessed.
Top plate fixings condition	N/A. Roller top plate welded to steel beam above.
Stainless steel bearing surface condition	N/A
Witness & extent of movement	No visible evidence of movement witnessed.
Base plate condition	Generally satisfactory. Evidence of corrosion at base plate/roller interface.
Base plate fixings condition	Counter-bored fixing holes. Unable to ascertain condition of fixings.
PTFE condition & thickness	N/A
Elastomeric pad condition	N/A
Bearing Rotation	N/A
Bearing surface treatment condition	Generally satisfactory except at roller/top plate/base plate interfaces.
Structural concrete condition	Evidence of cracking witnessed on north face of pier. Spawling witnessed on east face of pier.

Water penetration evidence	None
Inspector's Comments	Heavy corrosion to both top & bottom bearing faces & to the corresponding roller surface causing an irregular bearing surface. A consequence of this may cause an increase in stresses being transferred to the sub-structure. Areas of stress cracking to the north pier sub-structure were witnessed & concrete spawling witnessed on east face of pier. No evidence of any movement was witnessed. The paint system is generally in poor condition.
Recommendation	It is unlikely that this bearing is functioning correctly & ideally the bearing should be replaced.

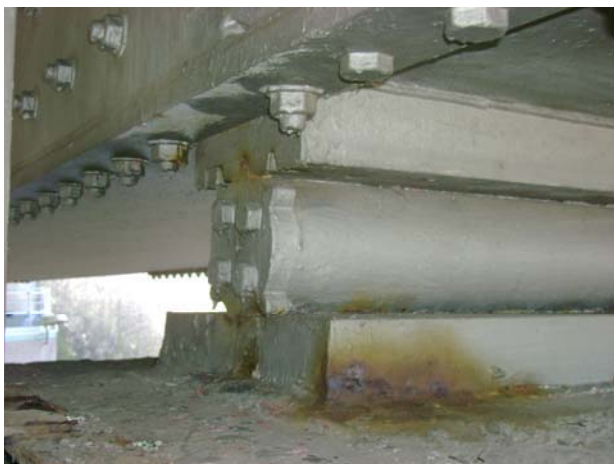
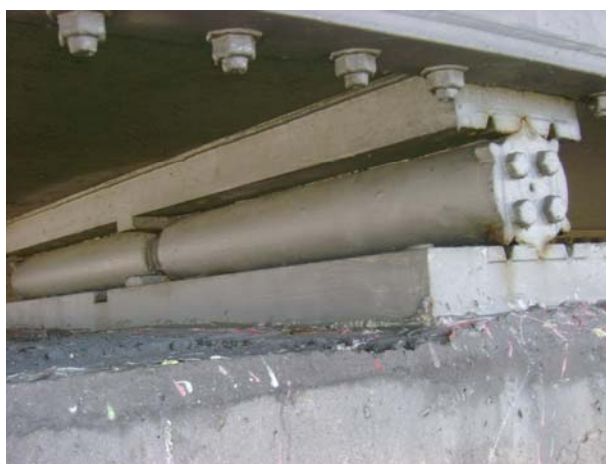
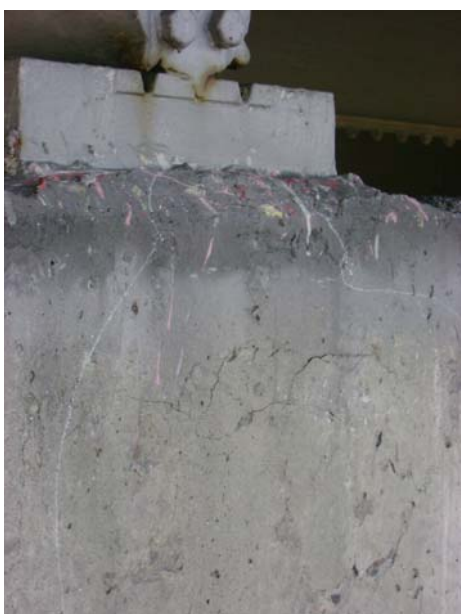
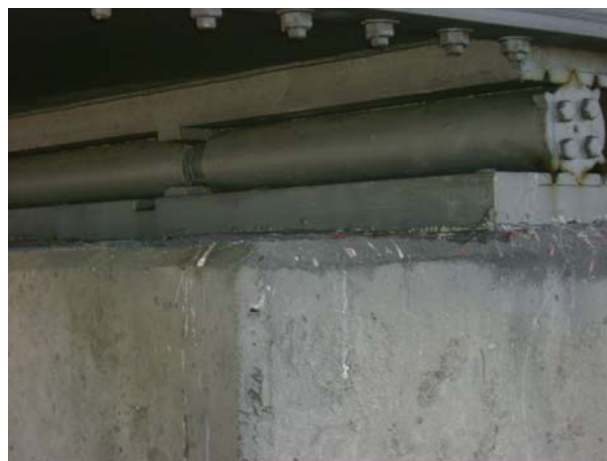
Pier S10 – Position: S10 West

Plinth condition	Satisfactory
Base grout condition	No evidence of structural failure, excessive paint applied to base grout.
Bearing fully supported	Yes
Top plate condition	Generally satisfactory.
Top plate fixings condition	N/A. Roller top plate welded to steel beam above. Connection appears structurally sound.
Stainless steel bearing surface condition	N/A
Witness & extent of movement	Evidence of minimal movement witnessed.
Base plate condition	Generally satisfactory.
Base plate fixings condition	Counter-bored fixing holes. Unable to ascertain condition of fixings.
PTFE condition & thickness	N/A
Elastomeric pad condition	N/A
Bearing Rotation	N/A
Bearing surface treatment condition	Generally satisfactory. Evidence of corrosion at north west corner base.
Structural concrete condition	Spawling witnessed on west face of pier.
Water penetration evidence	None witnessed.
Inspector's Comments	The bearing is coated in excessive paint and any movement would normally be clearly visible between mating moving components. The bearing shows little or no movement at all. There is evidence of concrete spawling to the west face of the pier.

Recommendation	It is unlikely that this bearing is functioning correctly & ideally the bearing should be replaced or fully refurbished.

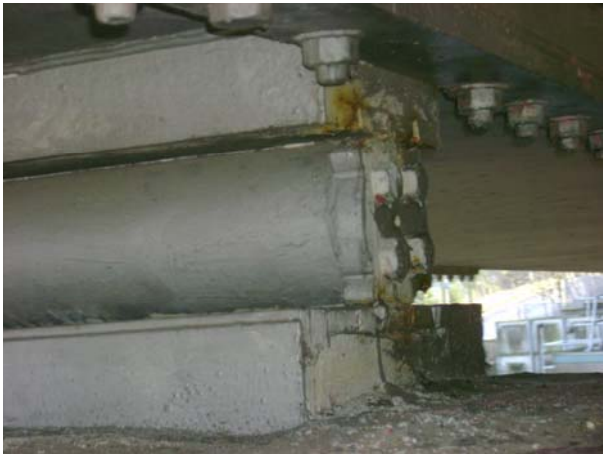
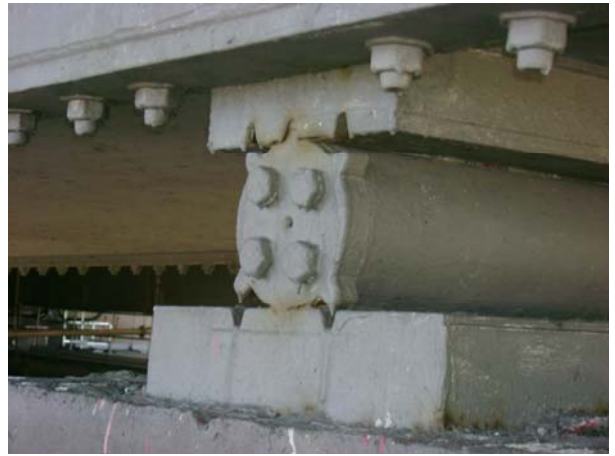
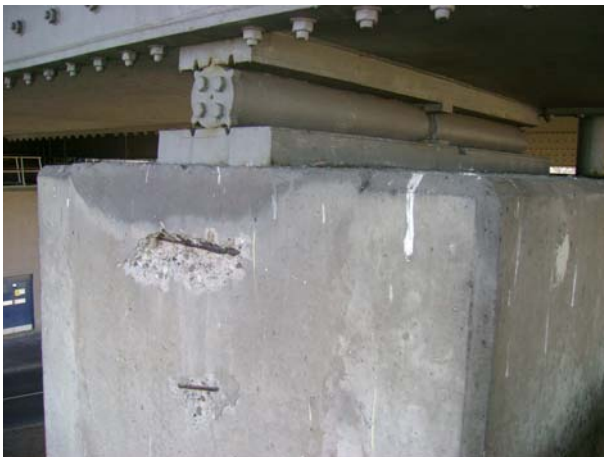
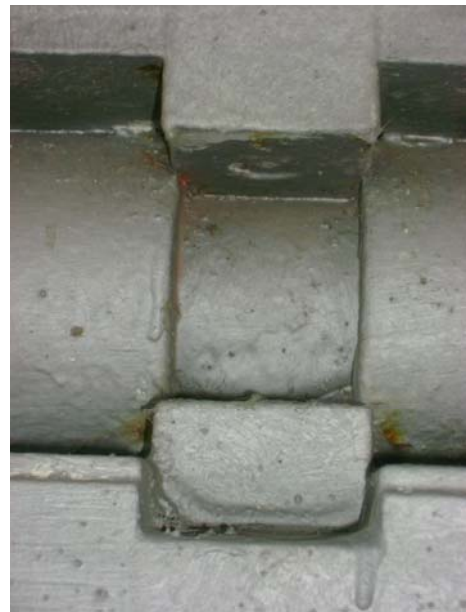
Pier S10 – Position: S10 East

Plinth condition	N/A
Base grout condition	Generally poor quality, showing signs of laminating and porous in appearance.
Bearing fully supported	Yes
Top plate condition	Generally satisfactory.
Top plate fixings condition	N/A. Roller top plate welded to steel beam above. Connection appears structurally sound.
Stainless steel bearing surface condition	N/A
Witness & extent of movement	No evidence of movement witnessed.
Base plate condition	Generally satisfactory.
Base plate fixings condition	Counter-bored fixing holes. Unable to ascertain condition of fixings.
PTFE condition & thickness	N/A
Elastomeric pad condition	N/A
Bearing Rotation	N/A
Bearing surface treatment condition	Generally satisfactory.
Structural concrete condition	Spawling witnessed on east face of pier. Re-bar exposed in two separate locations.
Water penetration evidence	None witnessed.
Inspector's Comments	The bearing is coated in excessive paint and any movement would normally be clearly visible between mating moving components. The bearing shows no movement at all. There is evidence of concrete spawling to the east face of the pier with re-bar exposed at two positions.

Recommendation	It is unlikely that this bearing is functioning correctly & ideally the bearing should be replaced or fully refurbished.

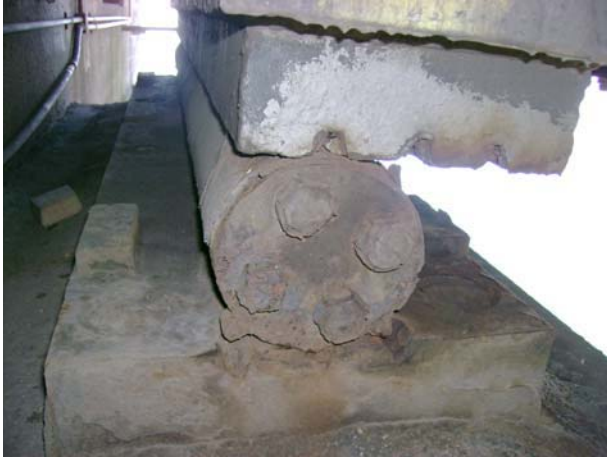
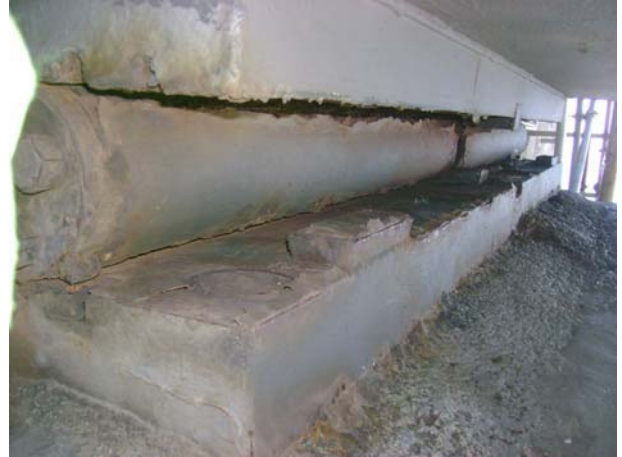
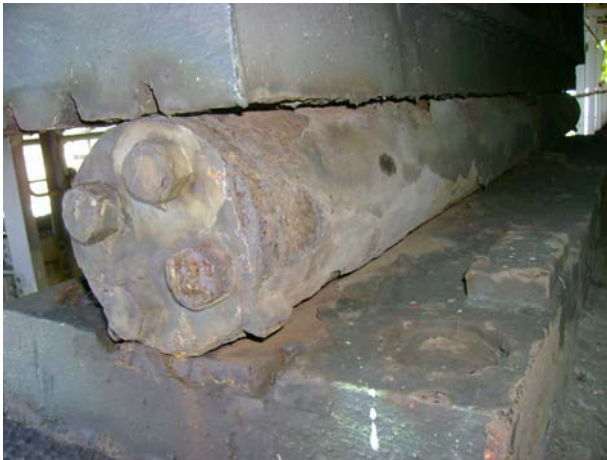
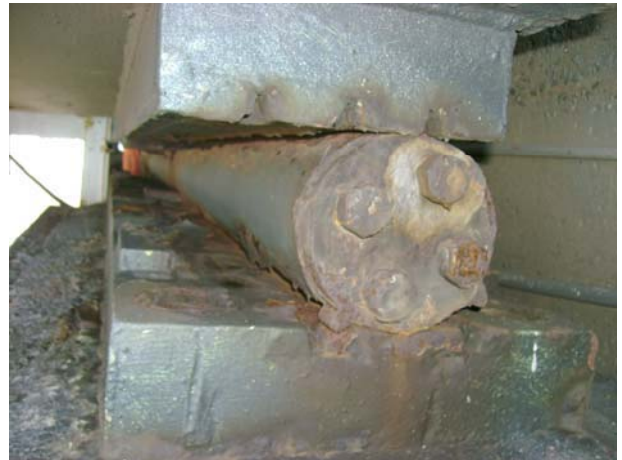
North Side Tower West – Position: West

Plinth condition	Evidence of cracking on north face.
Base grout condition	Generally poor quality and porous in appearance.
Bearing fully supported	Yes
Top plate condition	Heavy corrosion evident between top bearing surface and roller.
Top plate fixings condition	N/A. Roller top plate welded to steel beam above. Connection appears structurally sound.
Stainless steel bearing surface condition	N/A
Witness & extent of movement	Evidence of minimal movement witnessed. Roller is offset from original centre.
Base plate condition	Heavy corrosion all round. Roller gear cogs out of synchronization and broken.
Base plate fixings condition	Counter-bored fixing holes. Unable to ascertain condition of fixings. Bolt heads showing signs of corrosion.
PTFE condition & thickness	N/A
Elastomeric pad condition	N/A
Bearing Rotation	N/A
Bearing surface treatment condition	Generally unsatisfactory with evidence of heavy corrosion between roller/top plate/base plate interfaces.

Structural concrete condition	Generally satisfactory.
Water penetration evidence	None witnessed.
Inspector's Comments	<p>Excessive corrosion to both the top & bottom bearing faces & to the corresponding roller surface causing irregular wear and changes to the profile of the roller. This has caused the roller to slide and break the teeth off the rack assembly. The roller has slid approximately 50mm from its original centre position.</p> <p>The base grout is of poor quality & has insufficient cover around the perimeter of the bearing. There is evidence of sections of the base grout separating from the base plate which has probably been caused by the sliding effect of the roller.</p> <p>The paint system is generally in poor condition. The bearing is in an unserviceable state.</p>
Recommendation	It is unlikely that this bearing is functioning correctly & ideally the bearing should be replaced or fully refurbished.

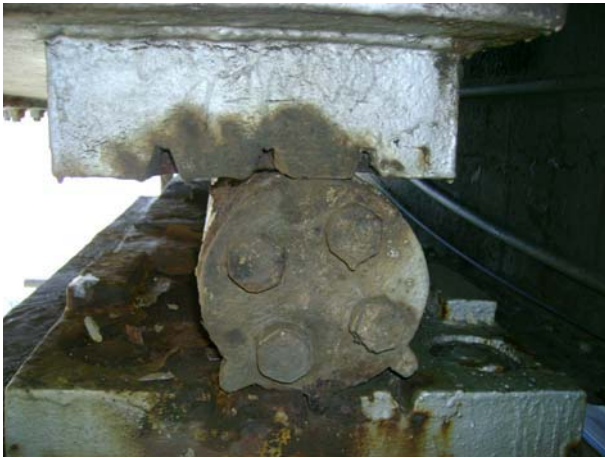
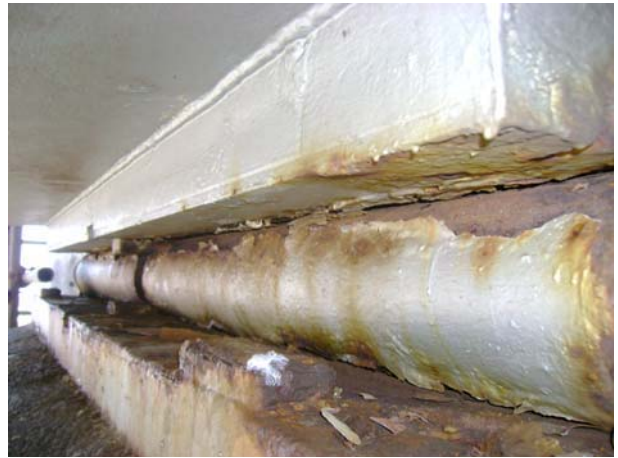
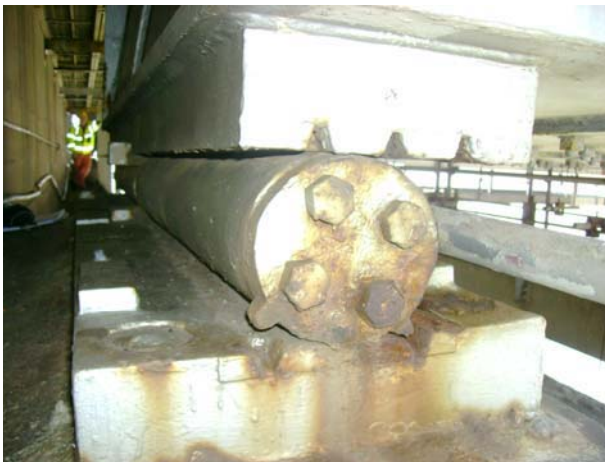
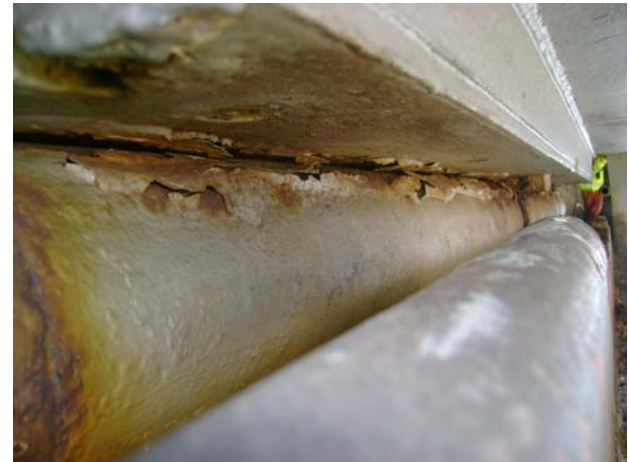
North Side Tower East – Position: East

Plinth condition	Generally satisfactory.
Base grout condition	Generally poor quality with evidence of surface lamination and porous in appearance.
Bearing fully supported	Yes
Top plate condition	Heavy corrosion evident between top bearing surface and roller.
Top plate fixings condition	N/A. Roller top plate welded to steel beam above. Connection appears structurally sound.
Stainless steel bearing surface condition	N/A
Witness & extent of movement	Evidence of minimal movement witnessed. Roller is offset from original centre.
Base plate condition	Heavy corrosion witnessed to north side in particular. Heavy corrosion evident at roller/base plate interface. Roller gear cogs out of synchronization and broken.
Base plate fixings condition	Counter-bored fixing holes. Unable to ascertain condition of fixings. Bolt heads showing signs of corrosion.
PTFE condition & thickness	N/A
Elastomeric pad condition	N/A

Bearing Rotation	N/A
Bearing surface treatment condition	Generally unsatisfactory with evidence of heavy corrosion between roller/top plate/base plate interfaces.
Structural concrete condition	Generally satisfactory.
Water penetration evidence	None witnessed.
Inspector's Comments	<p>Excessive corrosion to both the top & bottom bearing faces & to the corresponding roller surface causing irregular wear and changes to the profile of the roller. This has caused the roller to slide and break the teeth off the rack assembly. The roller has slid approximately 30mm from its original centre position.</p> <p>The base grout is of poor quality & has insufficient cover around the perimeter of the bearing. There is evidence of sections of the base grout separating from the base plate which has probably been caused by the sliding effect of the roller.</p> <p>The paint system is generally in poor condition. The bearing is in an unserviceable state.</p>

Recommendation	It is unlikely that this bearing is functioning correctly & ideally the bearing should be replaced or fully refurbished.

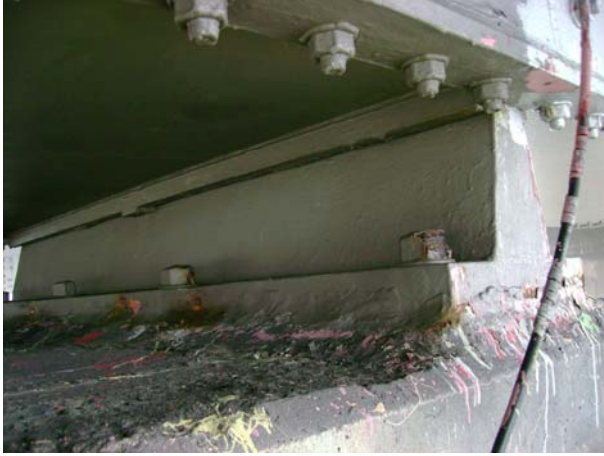
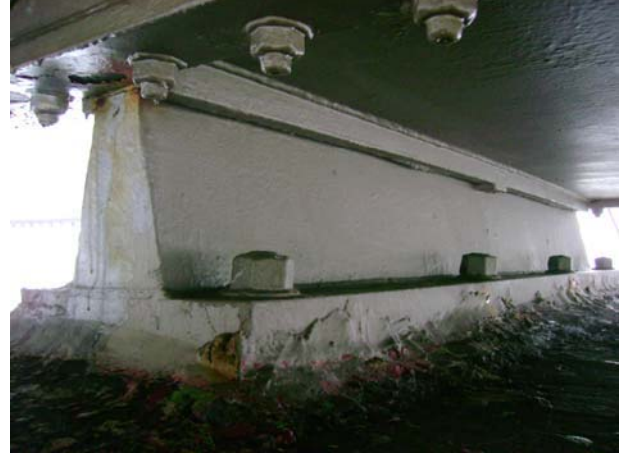
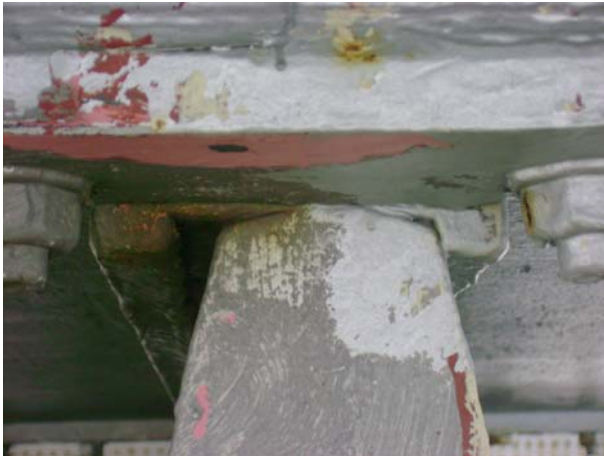
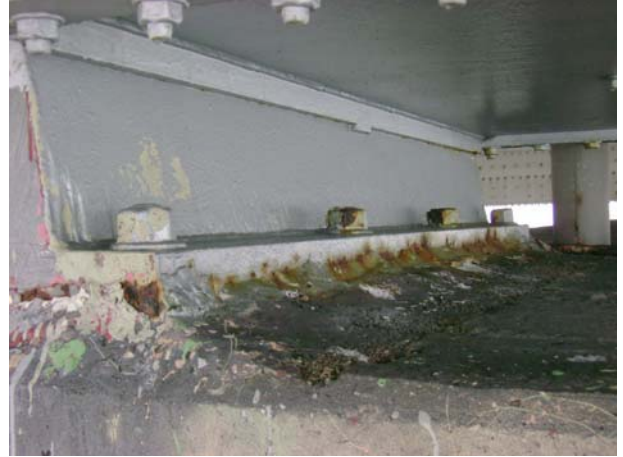
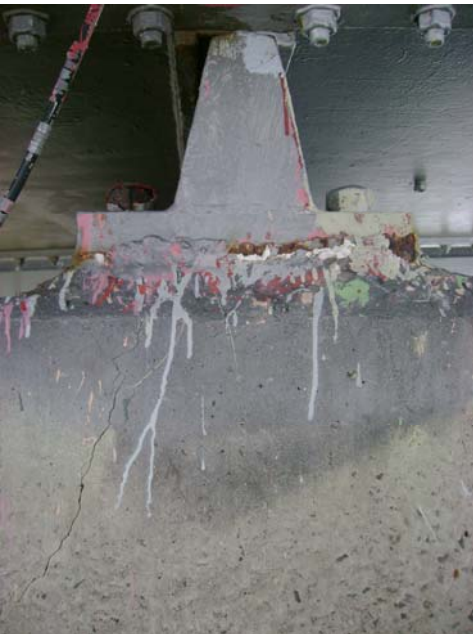
Pier N1 – Position: N1 West

Plinth condition	N/A
Base grout condition	Generally poor quality with evidence of surface lamination from pier water penetration around base.
Bearing fully supported	Yes
Top plate condition	Generally satisfactory but with evidence of heavy corrosion between rocker & top plate interface.
Top plate fixings condition	N/A. Rocker top plate welded to steel beam above.
Stainless steel bearing surface condition	N/A
Witness & extent of movement	No evidence of movement on bearing.
Base plate condition	Generally satisfactory but some areas of minor corrosion evident between base and grout bed.
Base plate fixings condition	Generally satisfactory condition but some areas of corrosion present on bolt heads.
PTFE condition & thickness	N/A
Elastomeric pad condition	N/A
Bearing Rotation	N/A
Bearing surface treatment condition	Generally satisfactory with evidence of heavy corrosion to rocker/top plate interface.
Structural concrete condition	Cracks witnessed on west face of pier. Crack propagation from central load point of bearing.

Water penetration evidence	Evidence of water penetration around rocker base grout bed.
Inspector's Comments	The bearing shows signs of heavy wear on the top plate mating surface, although there is no evidence to suggest that there has been any movement recently. Extensive wear to rocker top plate with evidence of severe corrosion. The crack on the west face of the pier is propagating from the bolt line on the north side and is approximately 600mm in length. This is a possible sign of over-loading.
Recommendation	It is unlikely that this bearing is functioning correctly & ideally the bearing should be replaced or fully refurbished.

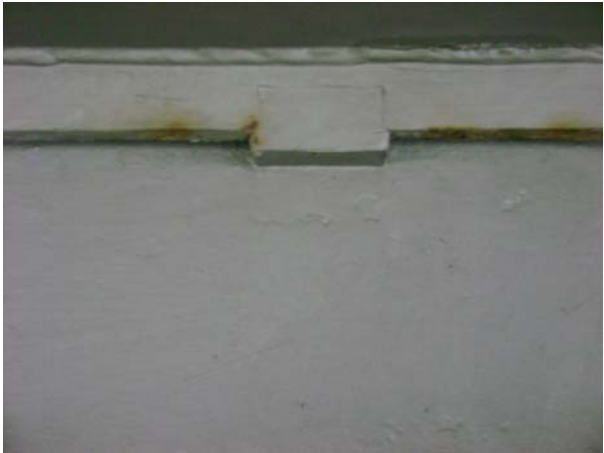
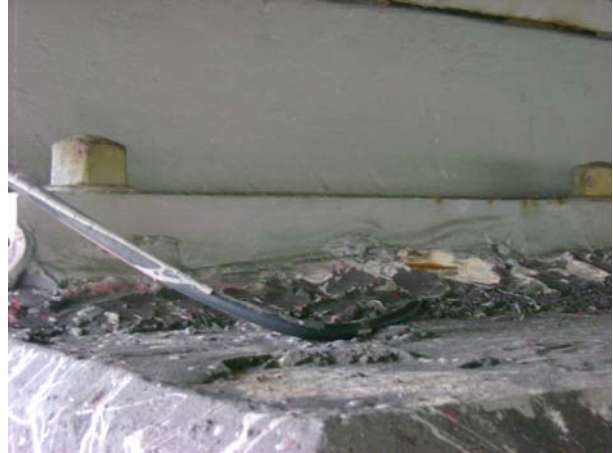
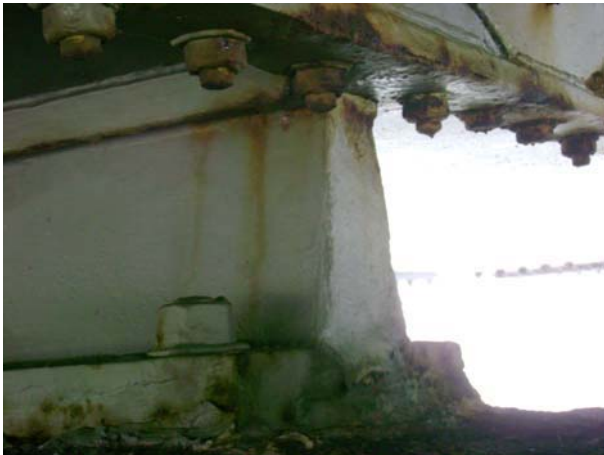
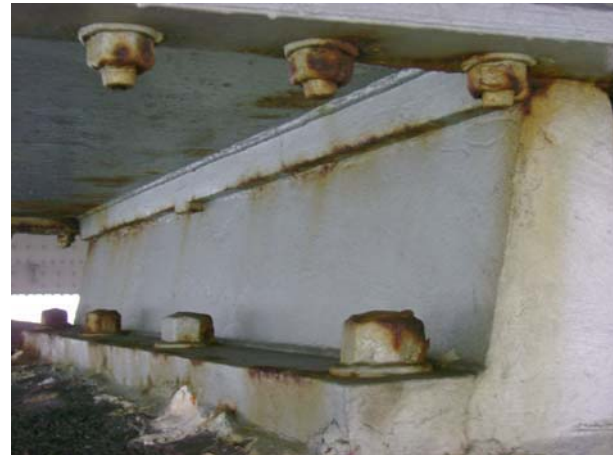
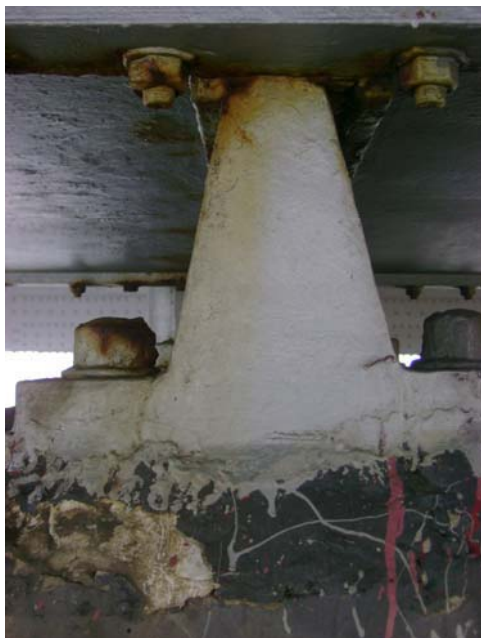
Pier N1 – Position: N1 East

Plinth condition	N/A
Base grout condition	Generally poor quality and porous in appearance. Steel packs are exposed at a couple of locations within the grout bed.
Bearing fully supported	Yes
Top plate condition	Generally satisfactory but with evidence of heavy corrosion between rocker & top plate interface.
Top plate fixings condition	N/A. Rocker top plate welded to steel beam above.
Stainless steel bearing surface condition	N/A
Witness & extent of movement	No evidence of movement on bearing.
Base plate condition	Generally satisfactory but some areas of minor corrosion evident between base and grout bed.
Base plate fixings condition	Generally satisfactory condition but some areas of corrosion present on bolt heads.
PTFE condition & thickness	N/A
Elastomeric pad condition	N/A
Bearing Rotation	N/A
Bearing surface treatment condition	Generally satisfactory with evidence of heavy corrosion to rocker/top plate interface.

Structural concrete condition	Some evidence of light cracking to east face of the east bearing.
Water penetration evidence	Evidence of water penetration around rocker base grout bed.
Inspector's Comments	The bearing shows signs of heavy wear on the top plate mating surface, although there is no evidence to suggest that there has been any movement recently. Extensive wear to rocker top plate with evidence of severe corrosion.
Recommendation	It is unlikely that this bearing is functioning correctly & ideally the bearing should be replaced or fully refurbished.
