Evaluation of the Low-Energy Design and Energy Performance of the Zion National Park Visitors Center

P. Torcellini, N. Long, S. Pless, and R. Judkoff

NREL

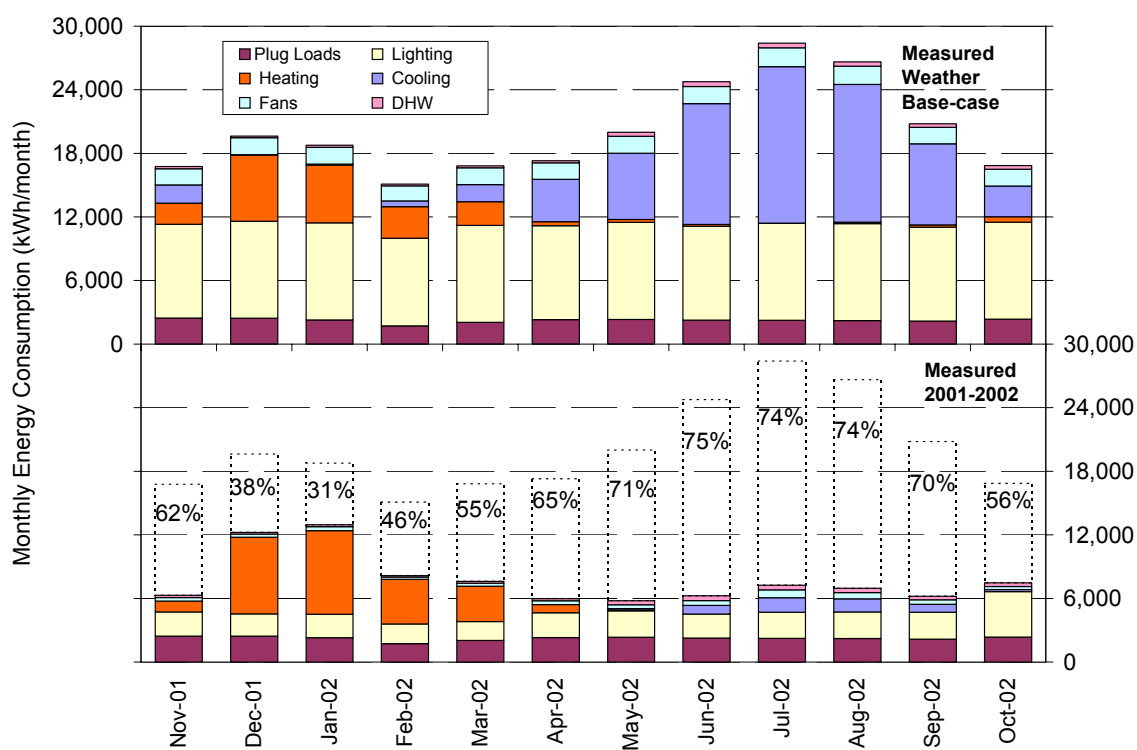
Figure ES-1 Comparison of base-case model using recorded weather data to measured energy consumption

NREL compared monitored energy performance results to base-case building energy models using the same weather files. Our criterion for quantifying performance throughout the project was energy cost. From November 2001 through October 2002, the annual energy costs for the Visitor Center Complex were \$5,094/yr or \$0.43/ft²·yr (\$4.63/m²·yr), net site energy use was 85,000 kWh/yr or 24.7 kBtu/ft²·yr (280.5 MJ/m²·yr) and source energy intensity was 80 kBtu/ft²·yr (908.5 MJ/m²·yr). Photovoltaic panels produced 7,900 kWh/yr or 8.5% of the total site energy use. The base-case energy model, based on ASHRAE Standard 90.1, yielded energy costs of \$15,250/yr or \$1.30/ft²·yr (\$13.99/m²·yr); site energy use was 241,800 kWh/yr or 70.3 kBtu/ft²·yr (798 MJ/m²·yr), translating to a source energy intensity of 227 kBtu/ft²·yr (2,580 MJ/m²·yr). This data represents savings (including receptacle loads) of 67% for energy cost, 62% for site energy, and 65% for source energy (see Figure ES-1 and Table ES-1). When we implemented controls to reduce demand charges, average daily peak demand in winter declined by almost 50%.

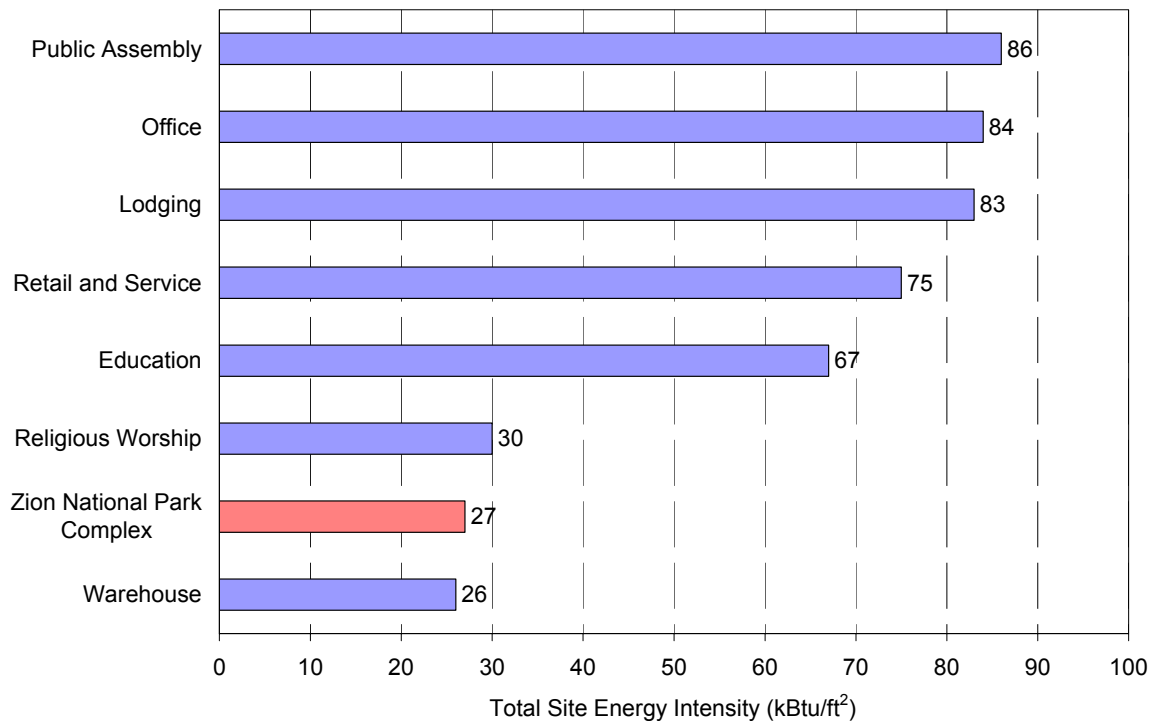
Figure ES-2 1999 Western U.S. site energy intensity by building type, with ZNP Complex average

The Visitor Center Complex is a combination of office, retail, and service areas. Figure ES-2 compares measured energy use of the Visitor Center Complex with other types of commercial buildings in the western United States (EIA 2002), with the Visitor Center Complex energy use equivalent to a warehouse.

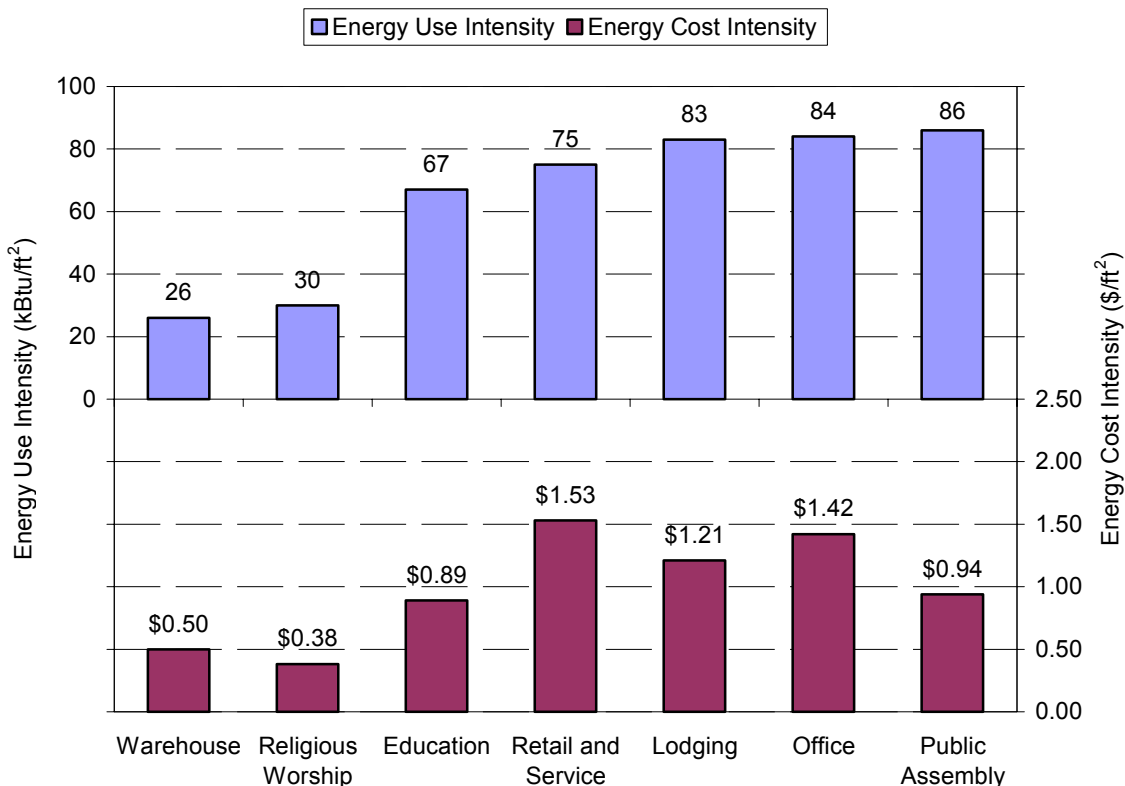
Figure 2-1 1999 Energy Use and Costs by Building Type for Western U.S. (EIA 2002)

In 2002, the Energy Information Administration (EIA) conducted the Commercial Buildings Energy Consumption Survey (CBECS), a national survey that collected information about thousands of commercial buildings in the United States including energy consumption during 1999. Data surveyed includes building physical and operating characteristics, energy consumption, and energy expenditures for all types of commercial buildings across U.S. climatic regions. The EIA defines energy intensity as site energy consumption per square foot of total floor space (EIA 2002). The Visitor Center Complex is a combination of office, retail, and service and does not directly fit into any specific category of the CBECS database. See Figure 2-1 for a comparison of energy use and energy costs for a variety of building types in the Western United States.

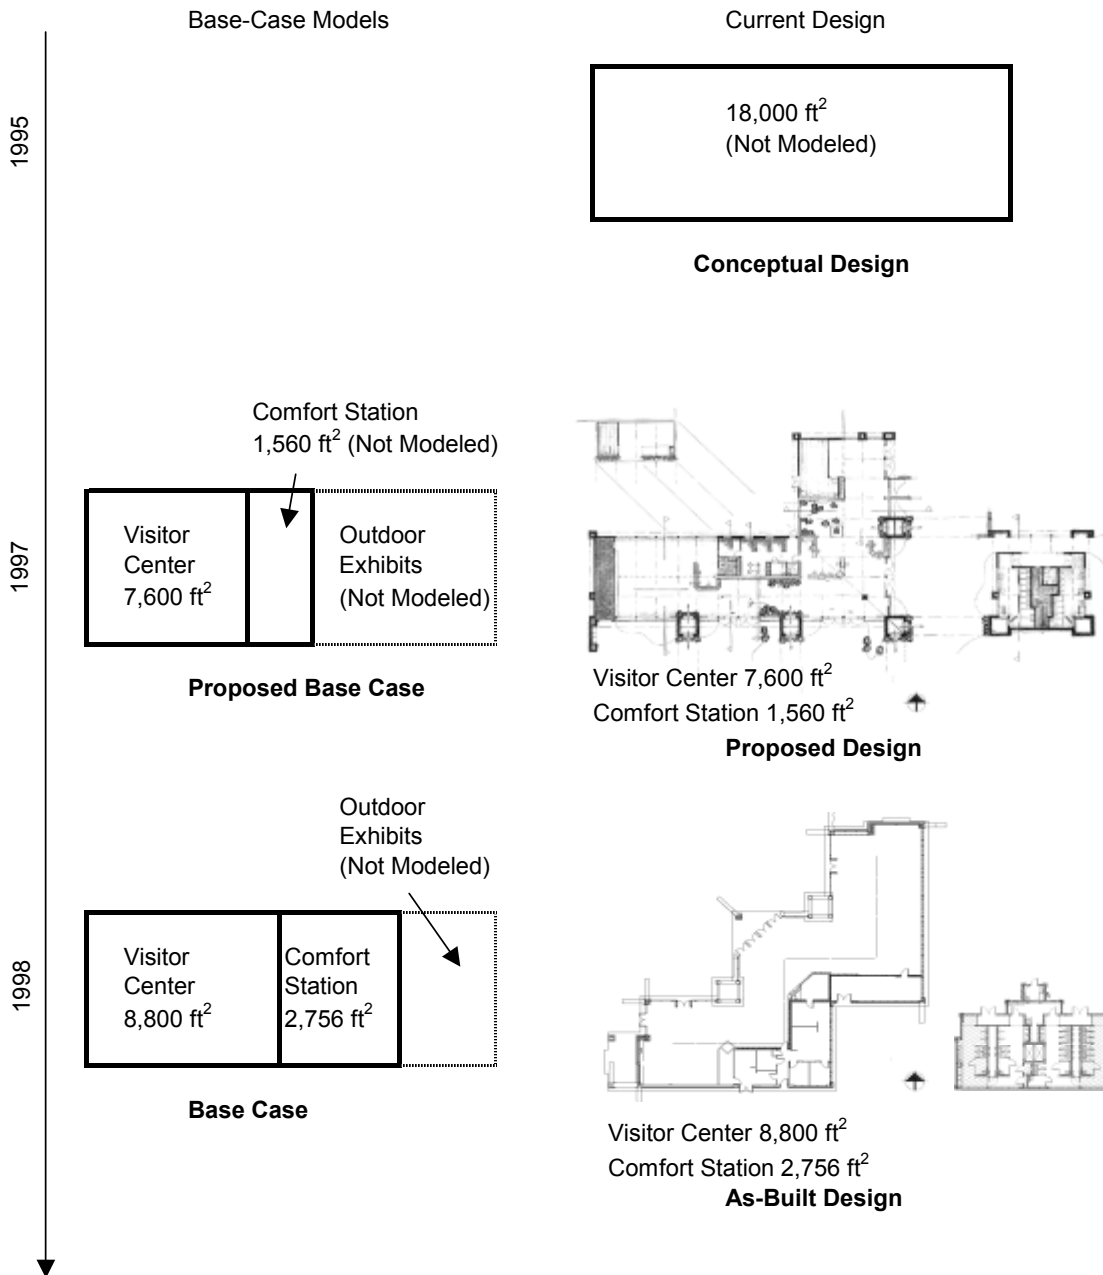
Figure 3-2 Flowchart of building designs

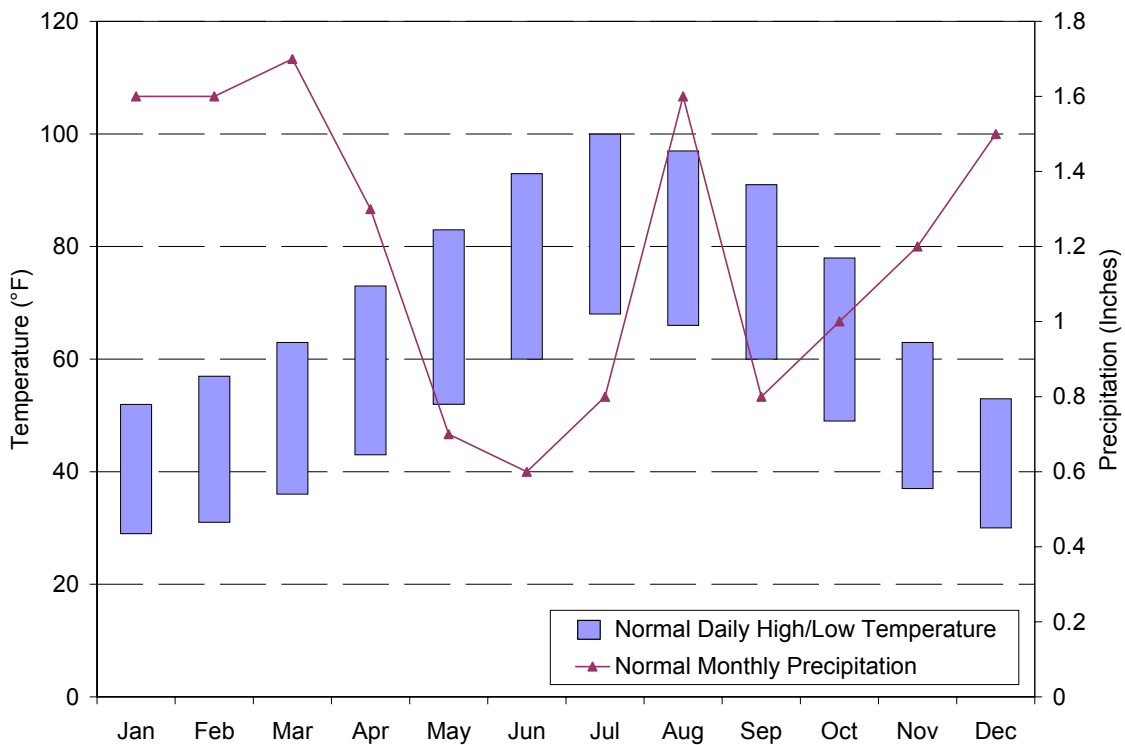
Figure 3-3 Typical monthly average daily weather for ZNP

Another important part of predesign is to evaluate the climate in which the building is located. To help the NPS determine the best design for their new building, a series of design charrettes were held at ZNP. Participating were ZNP staff, NREL building researchers, and NPS engineers and architects. The attendees of the charrette spent several days camping in ZNP to gain a better understanding of the environmental conditions of the canyon, which heavily influenced the design process. During the first part of the design charrette, NREL and NPS staff observed natural cooling within the canyon that could easily be adapted to the built environment. A temporary weather station recorded hourly integrated values of shielded air temperature, relative humidity, global horizontal solar radiation, wind speed, and wind direction. This data was used to quantify the observations of the design team. These were important observations for a region where daily high summer temperatures regularly exceed 100°F (38°C), as shown in Figure 3-3.

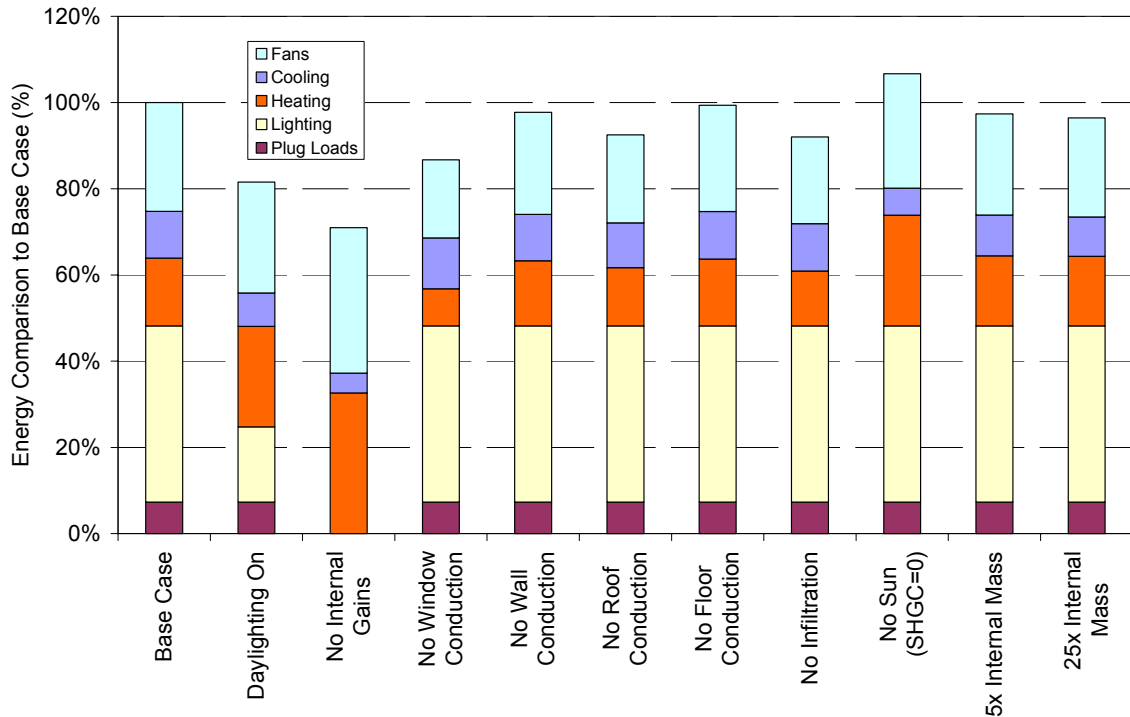
Figure 3-5 Parametric analysis results

Parametric Alternative	Description
Base Case	Code minimum as defined in Step 2 above
Daylighting On	Daylighting enabled in simulation
No Internal Gains	Remove all receptacles, lighting, and occupants
No Window Conduction	No conduction across windows (R-99)
No Wall Conduction	No conduction through walls (R-99)
No Roof Conduction	No conduction through roof (R-99)
No Floor Conduction	No conduction through floor slabs (R-99)
No Infiltration	No uncontrolled outside air
No Sun (SHGC = 0)	No solar heat gain through windows
5x Internal Mass	Five times more thermal capacitance
25x Internal Mass	Twenty five times more thermal capacitance

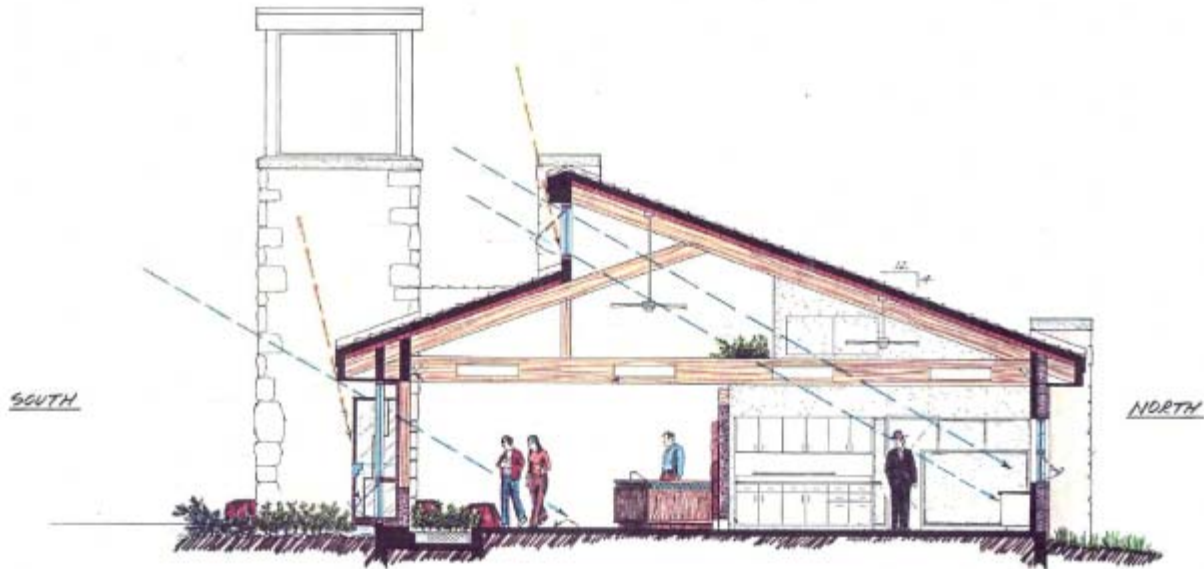
Figure 3-6 Diagram of energy design solutions for the Visitor Center Complex

The building envelope design minimizes summer solar gains with window overhangs and reduces electric lighting loads with large south-facing windows that allow more natural light to enter the building (see Figure 3-6). However, the building envelope design did not offset the entire cooling load. Next, natural ventilation cooling was integrated with the daylighting design—automatic window actuators were added to the clerestory windows. For more information on the natural ventilation system, see Section 4.4. The remaining cooling loads were met by the evaporative cooltower system discussed below.

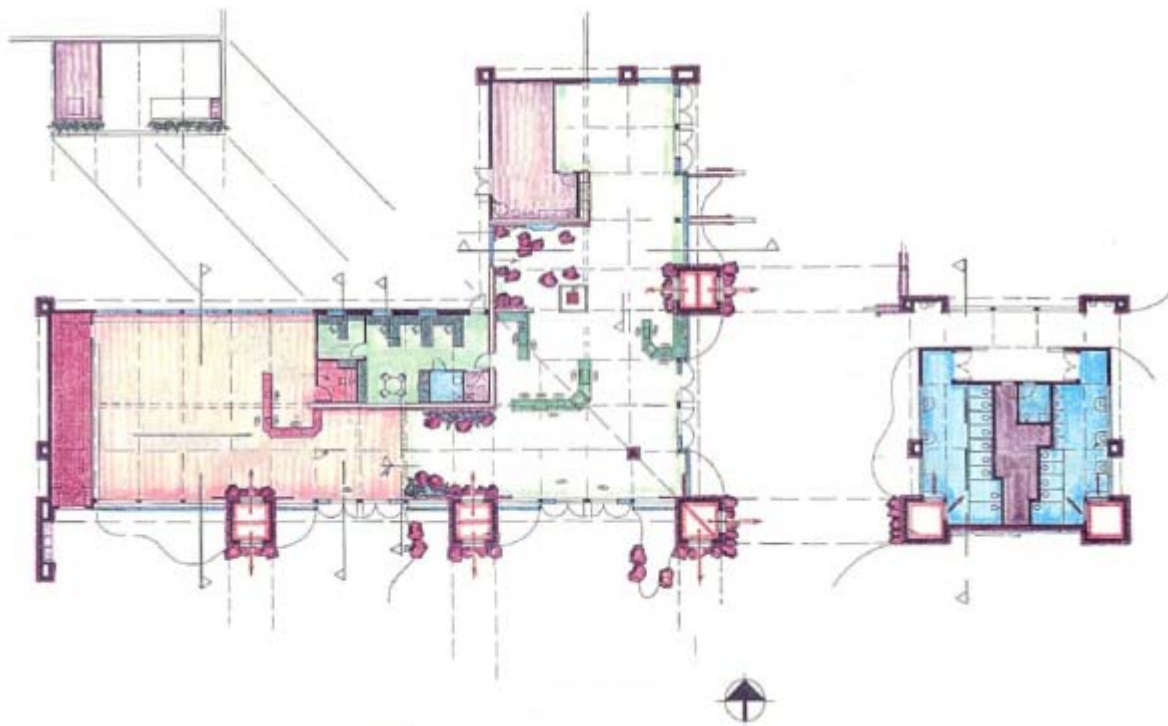
Figure 3-8 Conceptual design floor plan for Visitor Center and Comfort Station (Step 6)

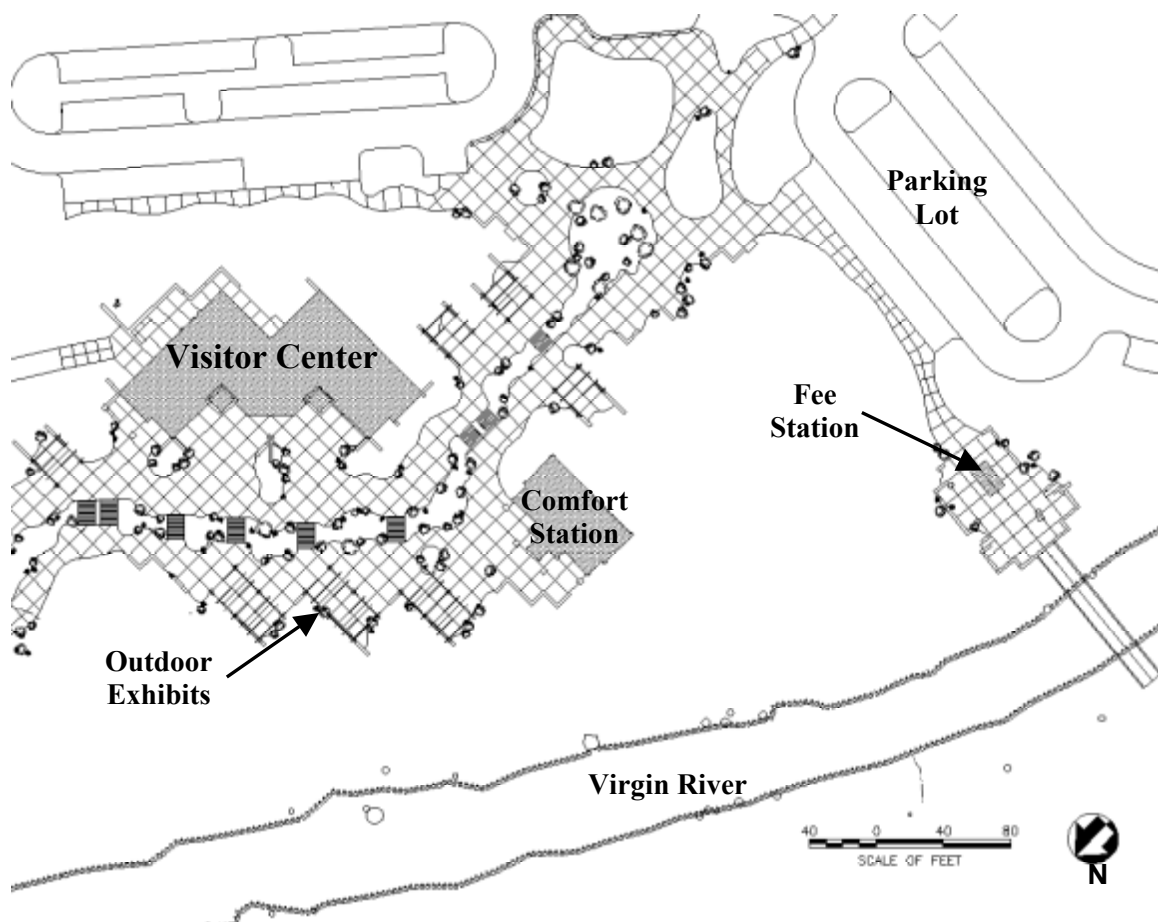
Figure 4-1 Visitor Center Complex site layout

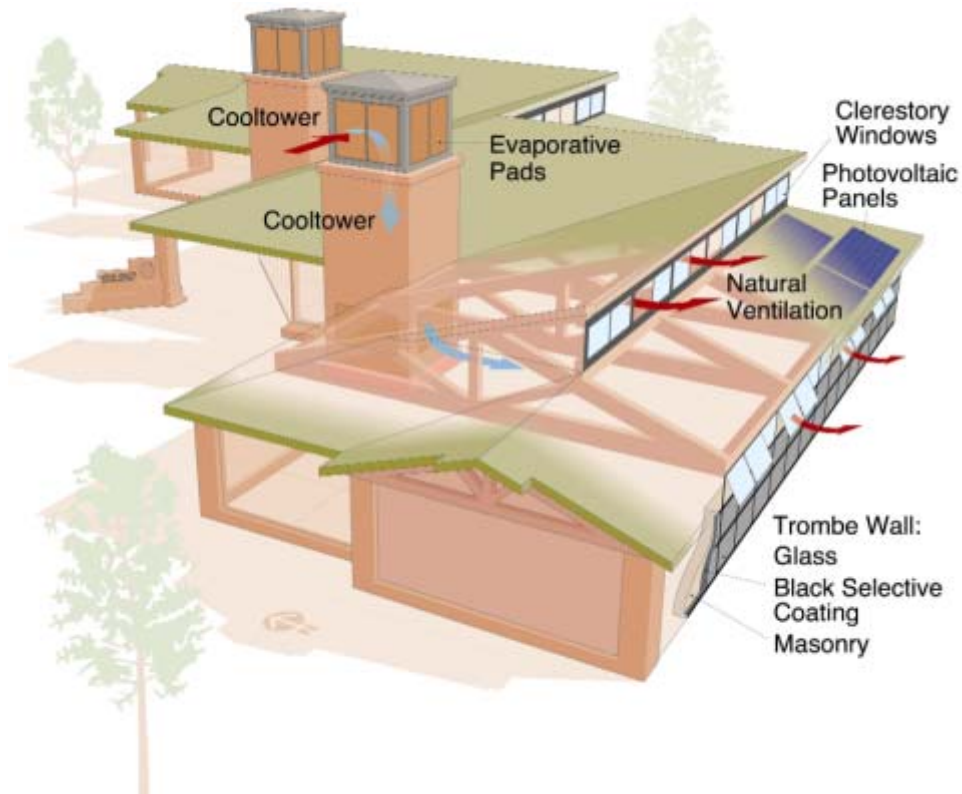
Figure 4-2 As-built Zion layout and energy-efficient features

The new building site required that the design team alter the layout of the Visitor Center building from the original “L” shaped building to the new layout seen in Figure 4-2 and Figure 4-3. The bookstore size was increased, along with the restroom facilities. As discussed earlier, studies showed resistive heating to be cost competitive as long as demand charges were not incurred. The elimination of propane heat allowed designers to avoid allocating space for fuel storage at the facility. Finally, the number of cooltowers was reduced based on cost and expected performance of the cooltowers.

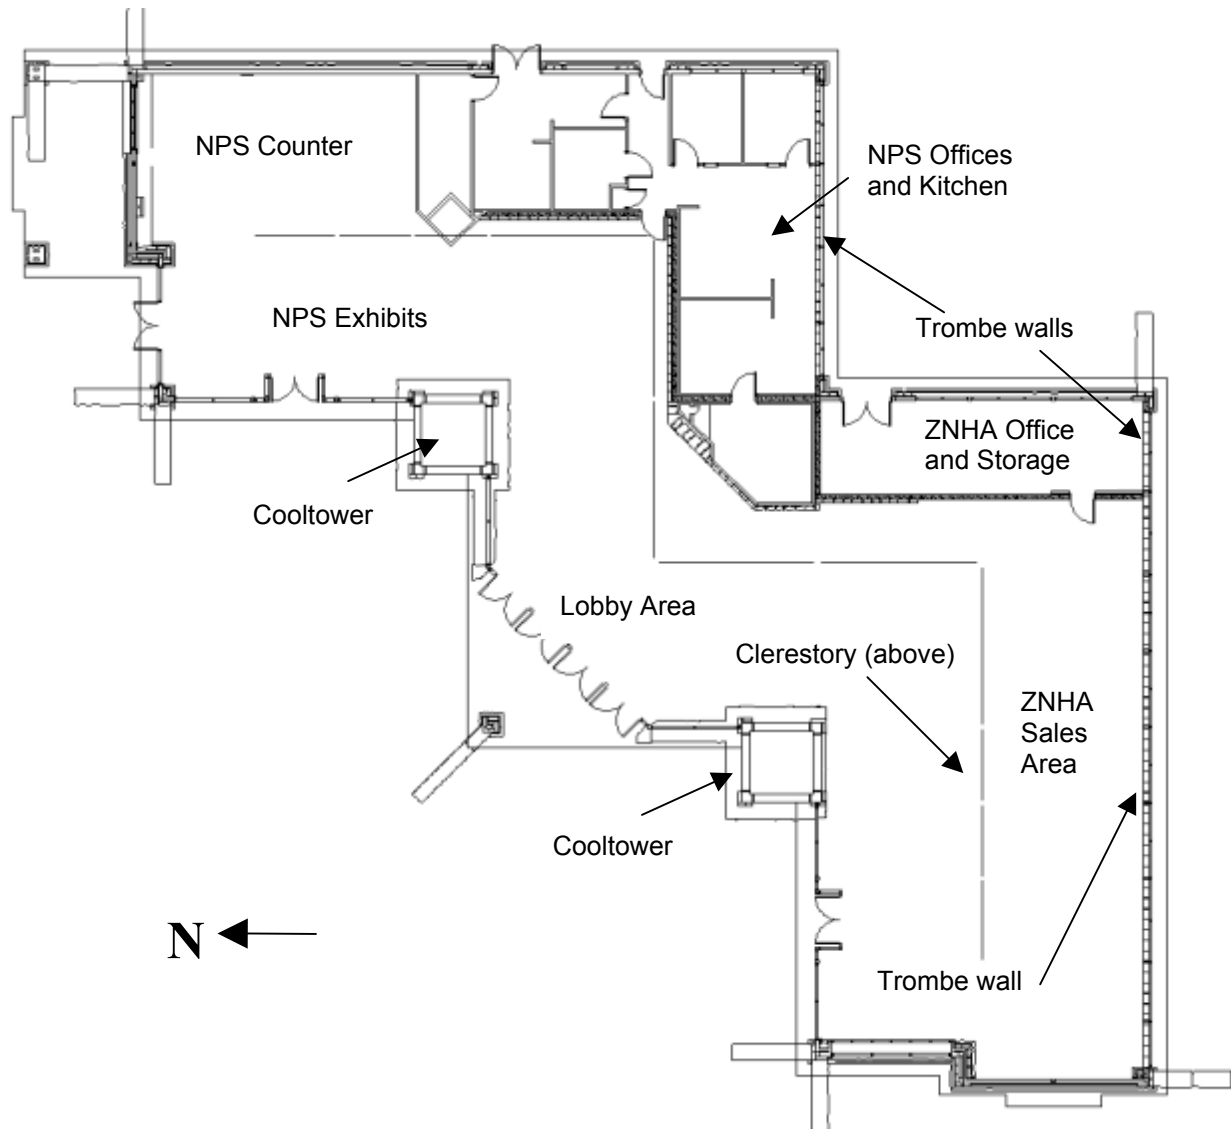
Figure 4-3 As-built Zion Visitor Center floor plan

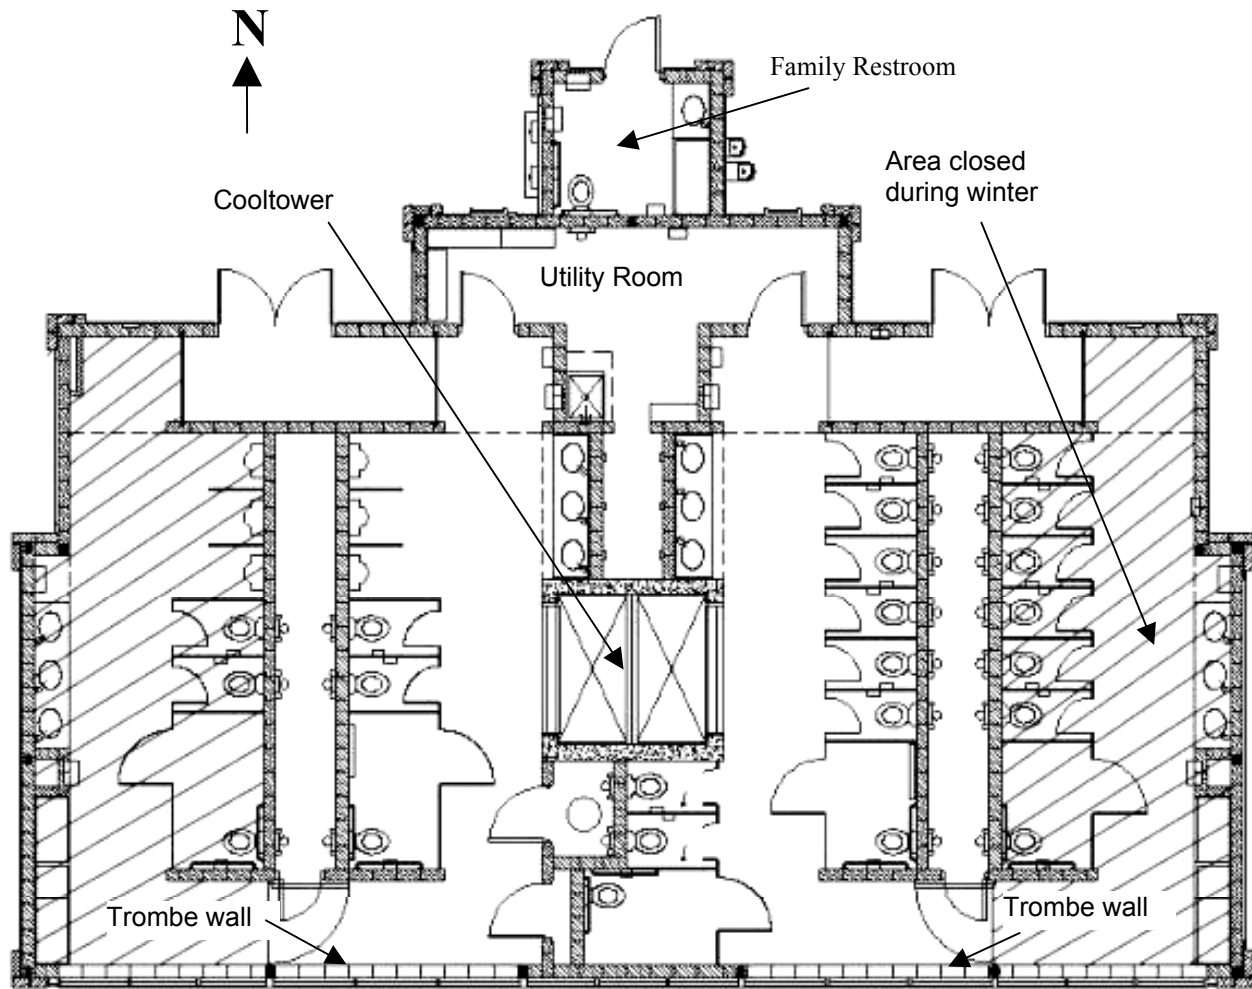
Figure 4-4 As-built Zion Comfort Station floor plan

Adjacent to the Visitor Center is a separate 2,756-ft² (256.0-m²) building for restrooms called the Comfort Station. The Comfort Station includes many features found in the Visitor Center, including a cooltower, a separate BAS, and daylighting (Figure 4-4.) Also included in the Visitor Center Complex is a fee station. This small 170-ft² (15.8-m²) structure is located at the entrance to the park. It is included in the building description section because the electric supply for this station is metered along with the rest of the facility. It was not part of the design analysis and was not evaluated as part of this study.

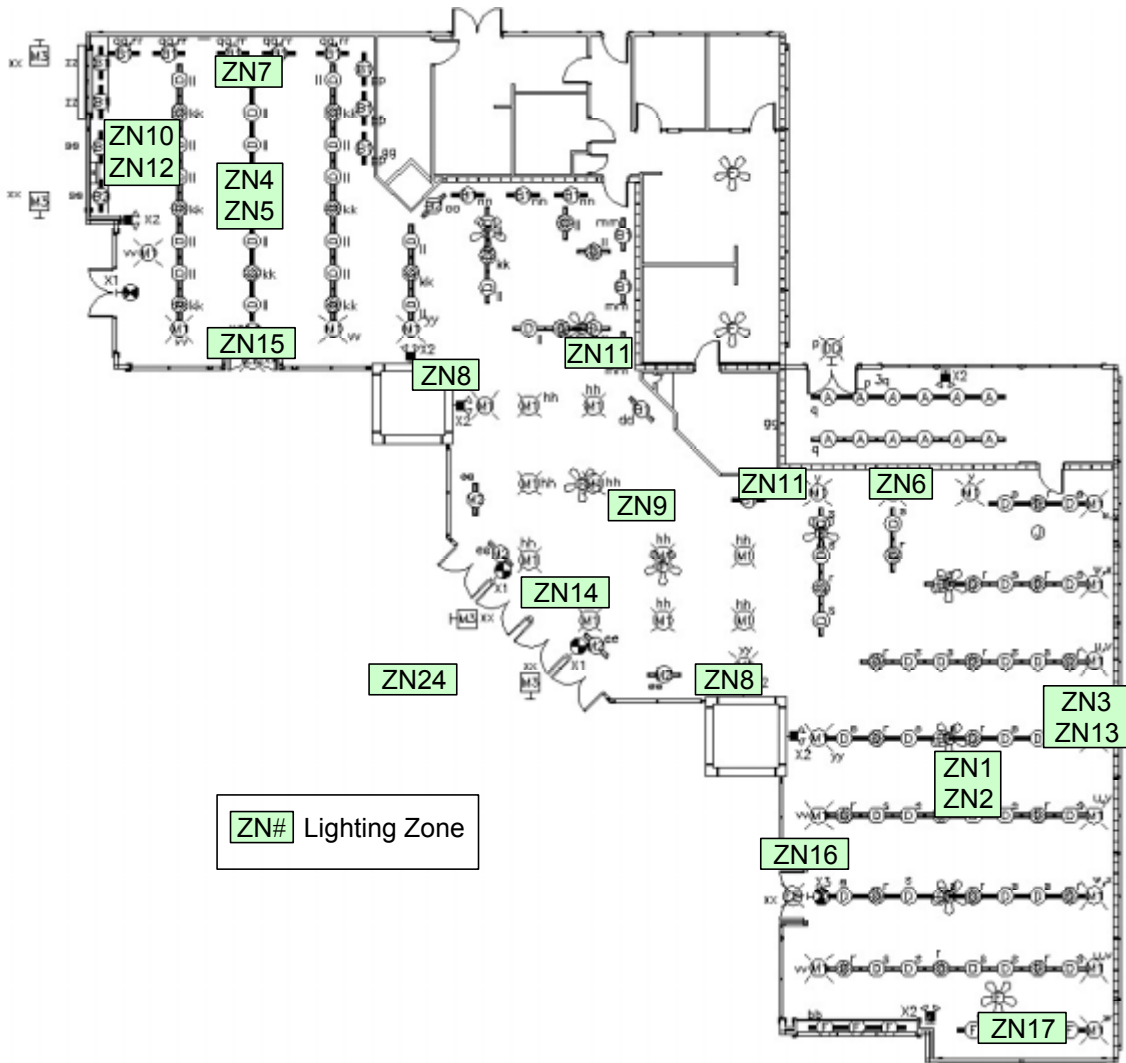
Figure 4-9 Visitor Center lighting plan showing lighting zones

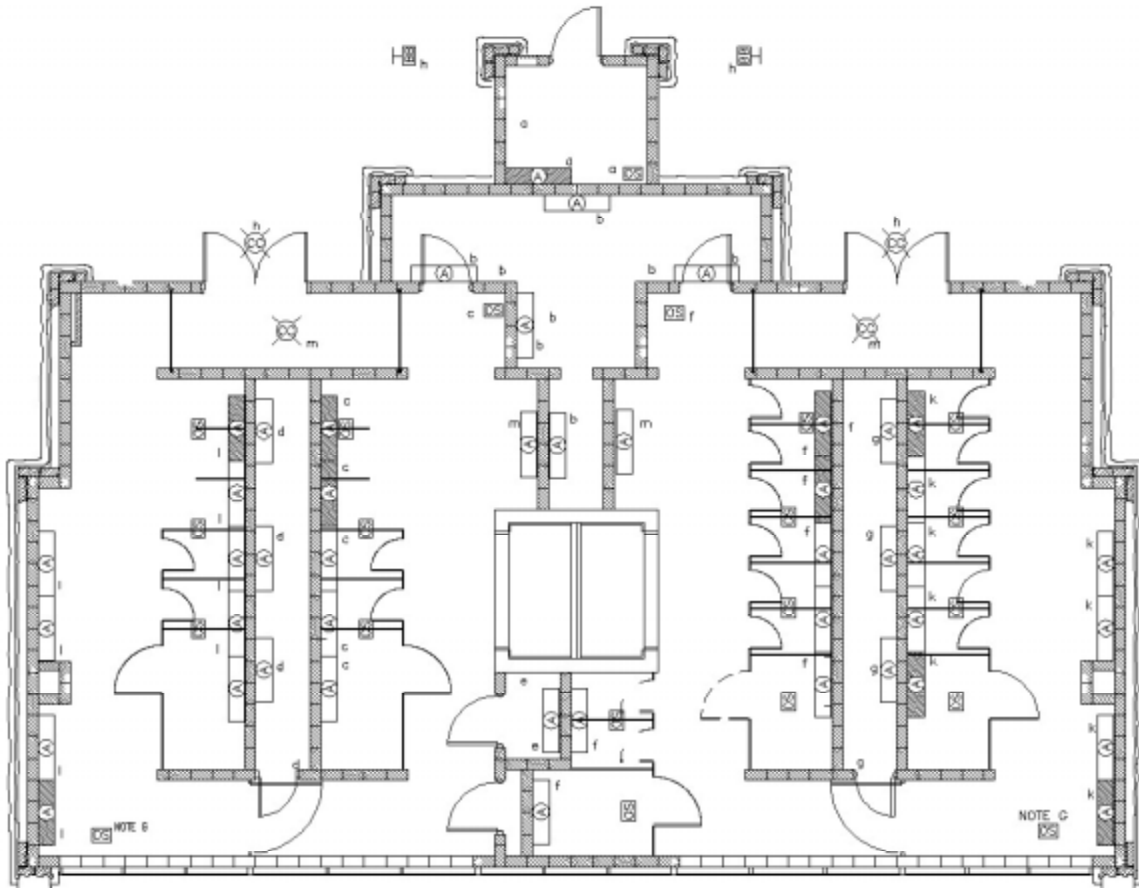
Figure 4-10 Comfort Station lighting plan

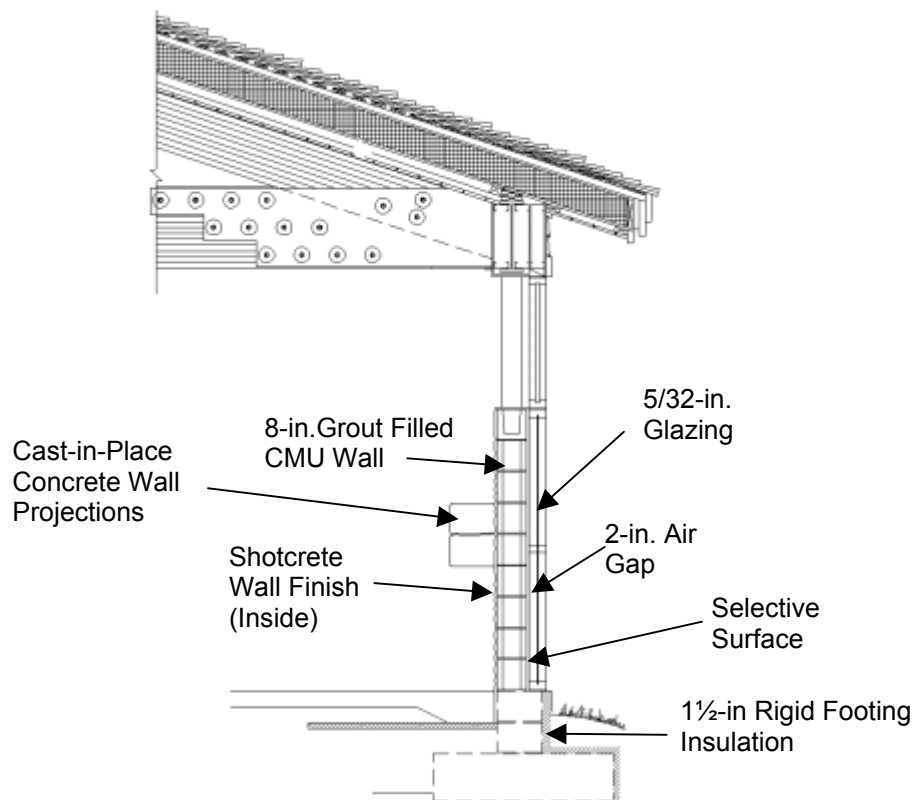
Figure 4-13 Cross-section of Trombe Wall

The Trombe wall provides a significant portion of space heating. Radiation from the sun is absorbed and stored in the masonry wall. The collected heat is then released back into the building when the temperature drops later in the day. The exterior sheet of glass and a black selective coating help to reduce heat loss from the exterior of the Trombe wall to the environment, see Figure 4-13 and Figure 4-14. The temperature of the inside surface of the Trombe wall can reach over 100°F (37.8°C) in the winter. This warm surface provides radiant comfort to the visitors. Electrical radiant ceiling panels provide supplemental heat during periods of low solar resources when the Trombe wall does not meet the heating load. The performance of the Trombe wall can be seen in Section 6.1.2.

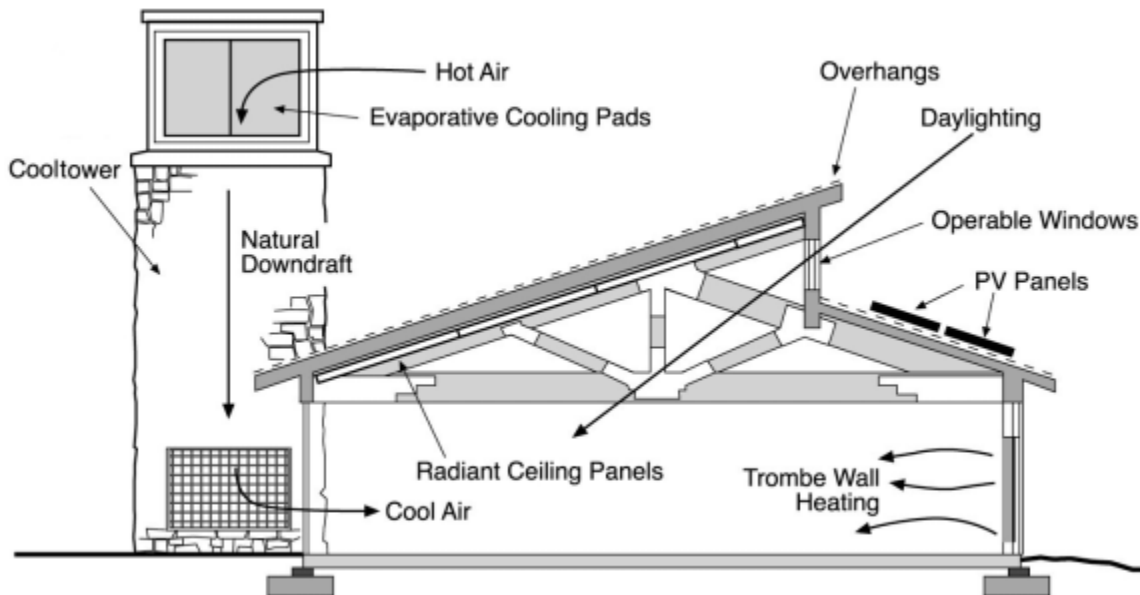
Figure 4-15 Illustration of how the cooltowers work at the Visitor Center

The cooling system functions in two stages. The first stage occurs when the clerestory windows open and natural ventilation cools the space. When natural ventilation is inadequate, the first stage is augmented by using the cooltowers to further reduce indoor temperature (second stage). We designed the cooltowers to operate on natural convection driven by buoyancy forces and prevailing winds. The cooltowers have evaporative cooling pads on all four sides at the top and large operable shutters on all four sides at the bottom. Air is cooled by pumping water over the evaporative cooling pads. This cool, dense air “falls” through the tower and exits through the large openings at the bottom of the towers, as shown in Figure 4-15. The cool air drawn into the building by the cooltowers causes the hot air already inside the space to rise and exit the building through the open clerestory windows.

There are no fans in either of the towers. The only energy required for each tower is a 1/3-hp (249-W) pump for water. The building’s energy management computer controls the operable clerestory windows, shutter doors, and pumps. The shutter doors on the exterior of the building were intended for cooling the patio area, but they are rarely used because the air entering the patio area dissipated quickly and was not effective. In addition, using the exterior doors degraded the interior performance. Figure 4-16 and Figure 4-17 show the installed towers from the outside and inside the building. Measured airflows from

each tower are approximately 8,000 ft³/min (226.5 m³/min) during typical operation. This number is only an approximation due to measurement difficulties for very low-pressure systems. To approximate the supply air flow from the cooltowers, we used a velocity probe to test air velocity at several different locations on the exhaust air grill.

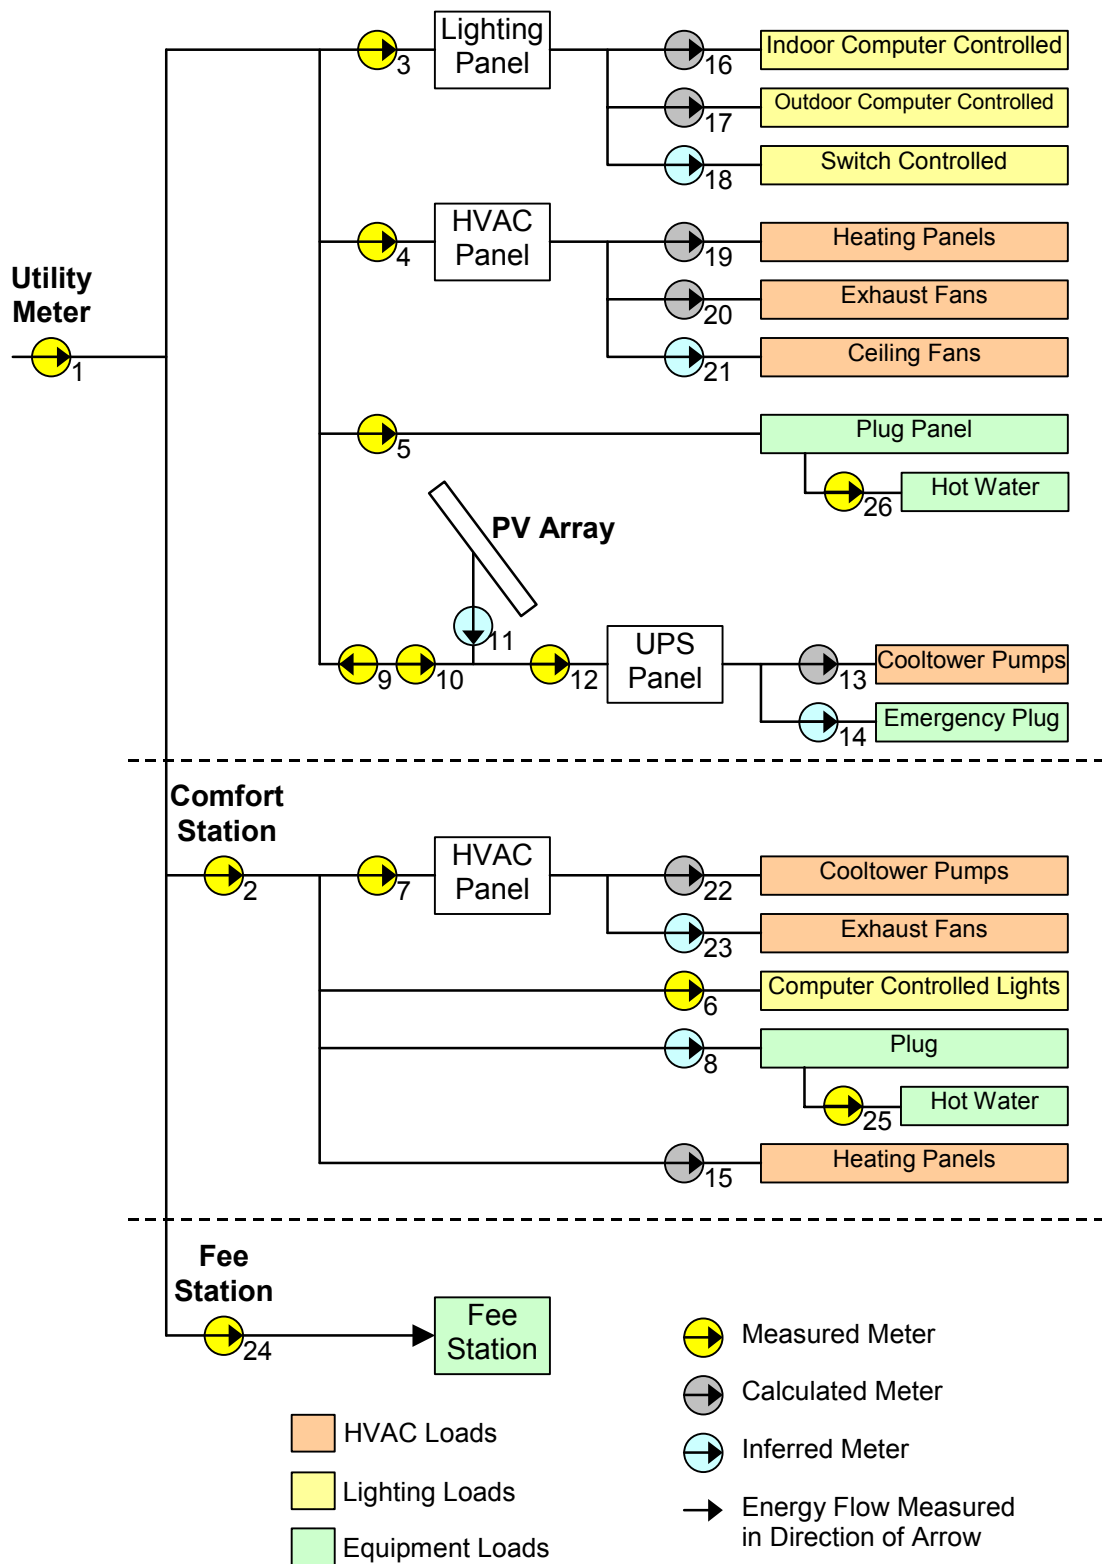
Figure 5-2 One-line electrical system plan and data acquisition meter locations

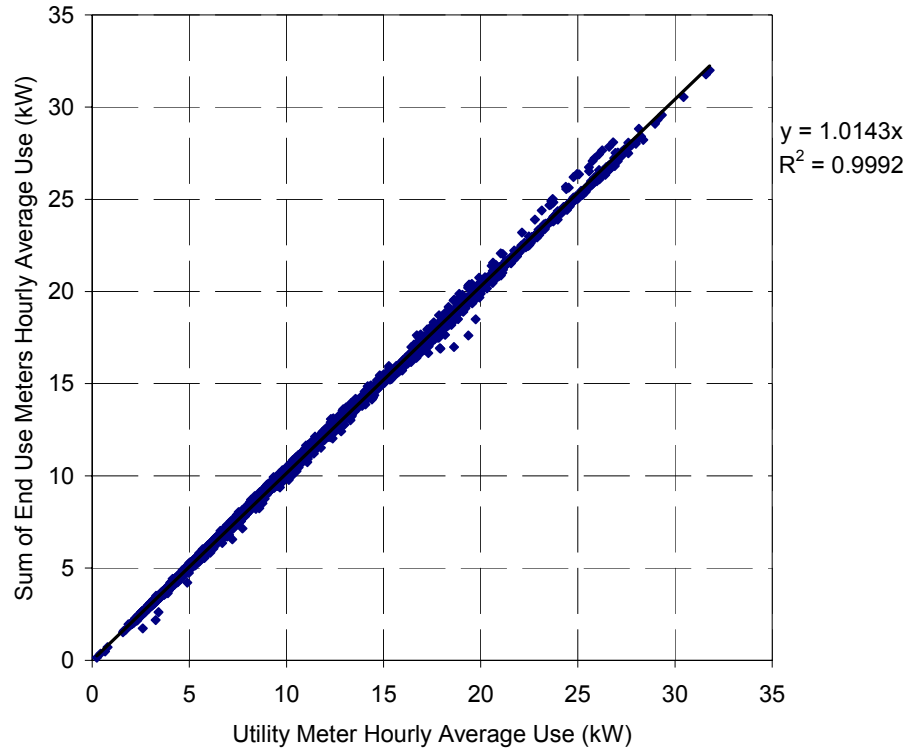
Figure 5-3 Verification of utility and measured data, November 2001 to February 2003

scale, then the total error possible of the data is 1.51%. We considered this error reasonable and the data was considered reliable.

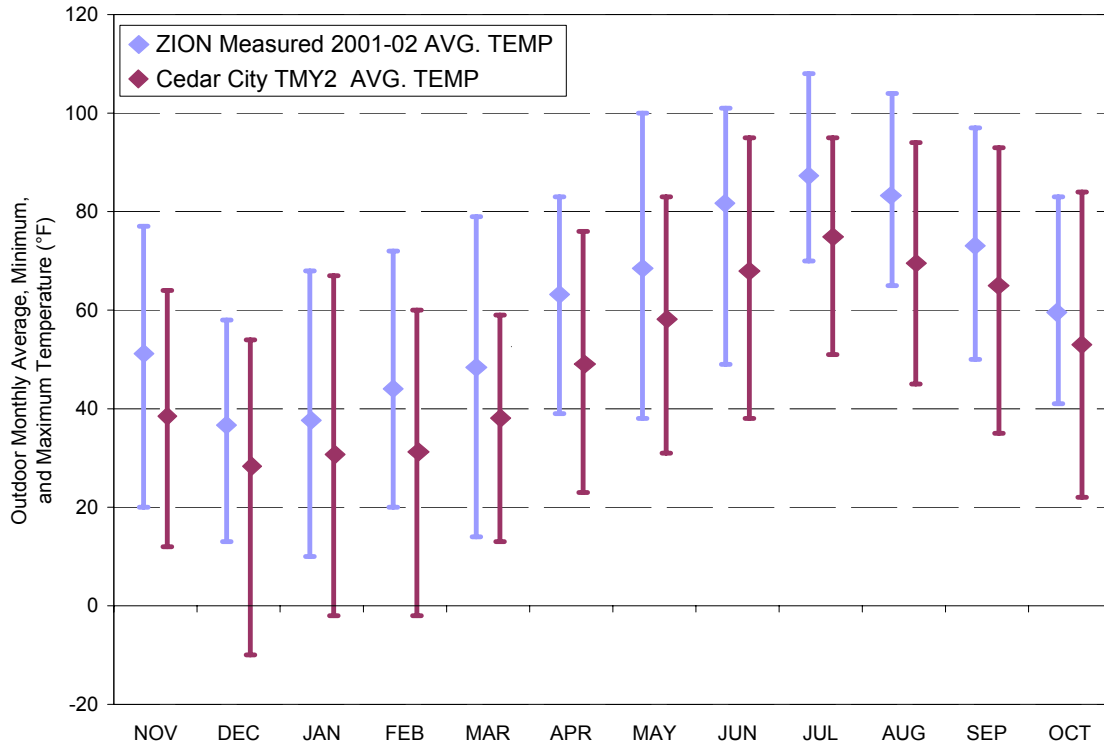
Figure 5-4 Comparison of average monthly outdoor temperatures for ZNP Complex and Cedar City

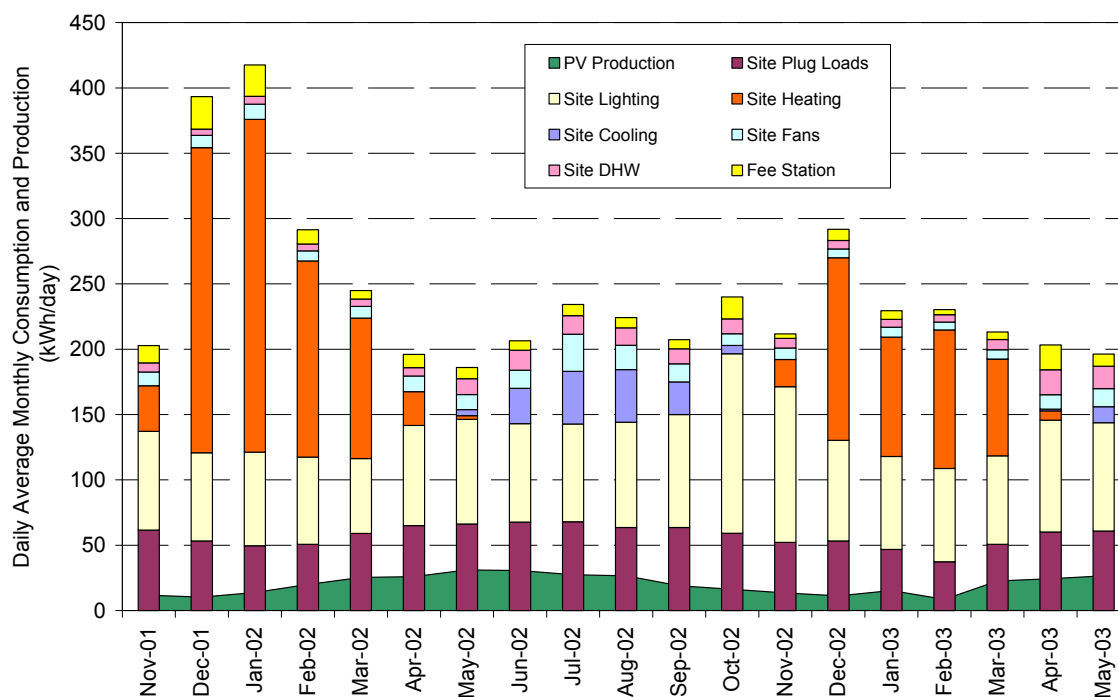
Figure 5-5 End use daily average monthly consumption, November 2001 through May 2003

The energy consumption intensity during the evaluation period decreased during the evaluation period from 27.0 kBtu/ft²·yr (306 MJ/m²·yr) to 23.8 kBtu/ft²·yr (270 MJ/m²·yr). A primary reason for the reduced site energy use was a reduction in heating energy from the winter of 2001–2002 to 2002–2003. As discussed in Section 6.1.2, the occupants reduced the heating set point of the Visitor Center by 2–4°F (1.1–2.2°C) during the winter of 2002–2003. This set-point reduction, combined with a warmer 2002–2003 winter, helped to reduce the overall heating system consumption and improve the whole-building site energy performance, as Figure 5-5 shows.

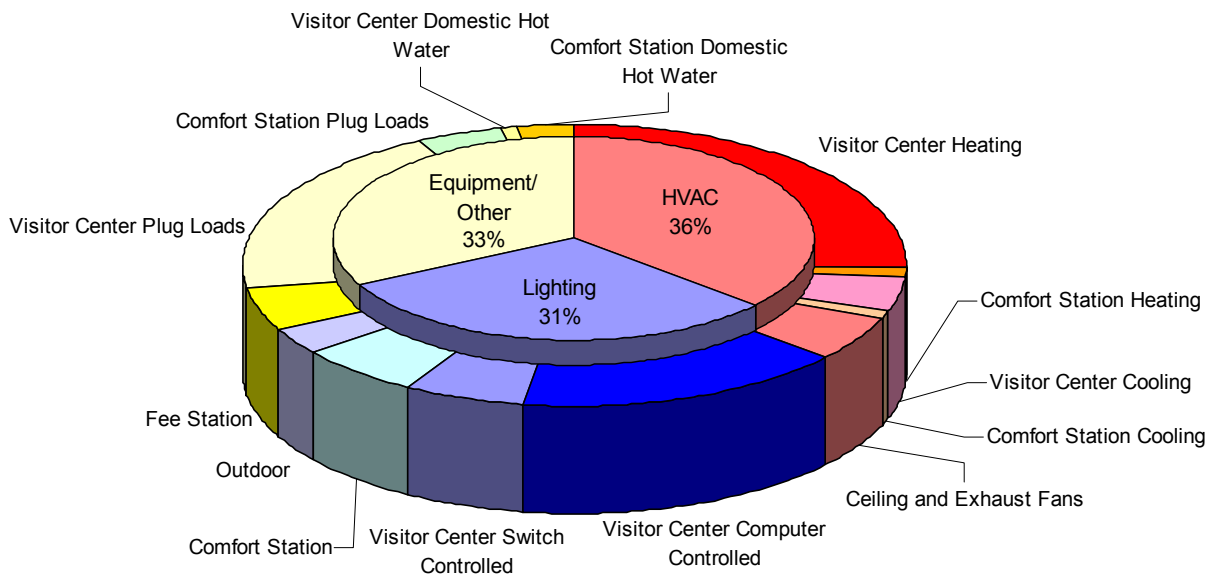
Figure 5-6 Energy consumption by end use, November 2001 through October 2002

Figure 5-6 shows the energy consumption distribution by end use from November 2001 through October 2002. The monthly and annual end-use distribution data is shown in Appendix C. The minimal energy consumption of the Comfort Station results in only 15% of the total site energy consumption, at an energy intensity of 17.4 kBtu/ft²·yr (198 MJ/m²·yr). The Visitor Center heating is the largest single energy end use, with Visitor Center plug loads and BAS controlled lighting the next most energy intensive loads.
