Evaluation of the Low-Energy Design and Energy Performance of the Zion National Park Visitors Center

P. Torcellini, N. Long, S. Pless, and R. Judkoff

NREL

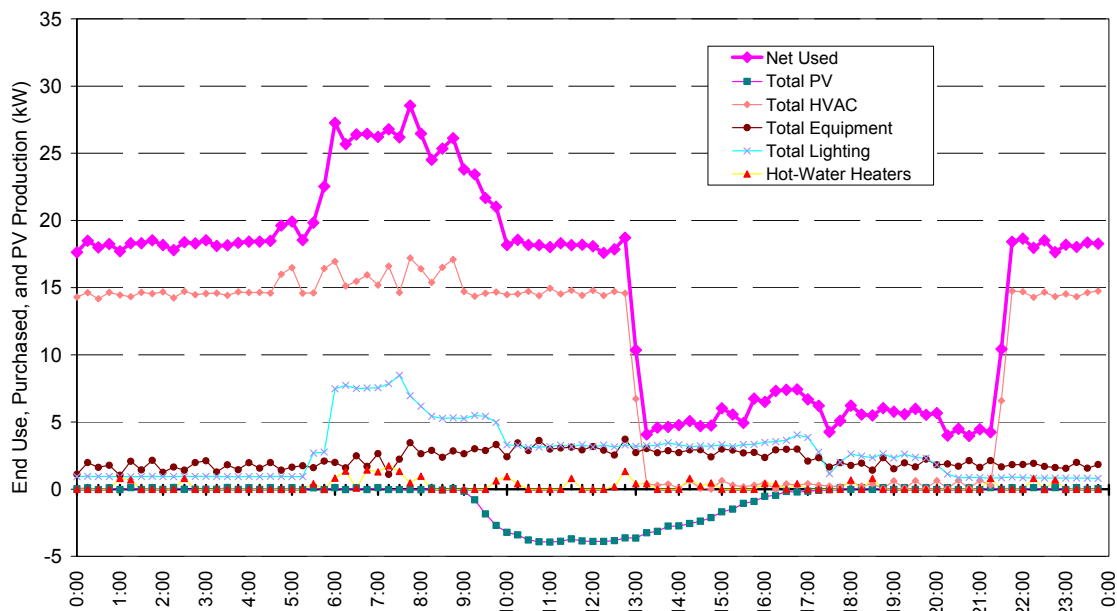
Figure 5-7 Peak demand day without demand limiting controls, February 2, 2002

The need for demand limiting controls can be seen in Figure 5-7. The cost associated with demand can be found by taking the maximum power draw over a 15-minute window multiplied by the \$8.10/kW demand charge. The peak demand for the winter of 2001–2002 was between 28 and 36 kW, with a typical peak demand day shown in Figure 5-7. The reason the winter peak demand occurred was that all end uses were on at the same time, including the hot water, lighting, and some heating. Although the key contributor to the increase in peak demand was the turning on of lights in the morning, the heat was also on, partially because of the recovery from night set back. In Figure 5-7, the hot water, lighting, and heating were at a maximum for the day during the demand peak. These types of loads offer the most potential for limiting the peak demand because they are not considered essential for short-term operation of the building. Hot water and heating systems can be temporarily turned off during potential periods of peak demand. These loads are not considered essential for short-term operation because these systems use the thermal capacitance of the tank water or the building mass, respectively. The capacitance enables these end uses to be turned off near peak demand periods without significant disruption to the operation of the building. The building thermal capacitance, in the form of massive concrete, is integral to the energy cost savings of the building. During periods of low demand, the hot water and heating systems are turned on. The nighttime heating is only used if the building can be brought back up to a comfortable temperature without incurring a demand charge. This type of control strategy can also take advantage of on-site generation for potential demand reduction by offsetting the utility power draw with on-site generation.

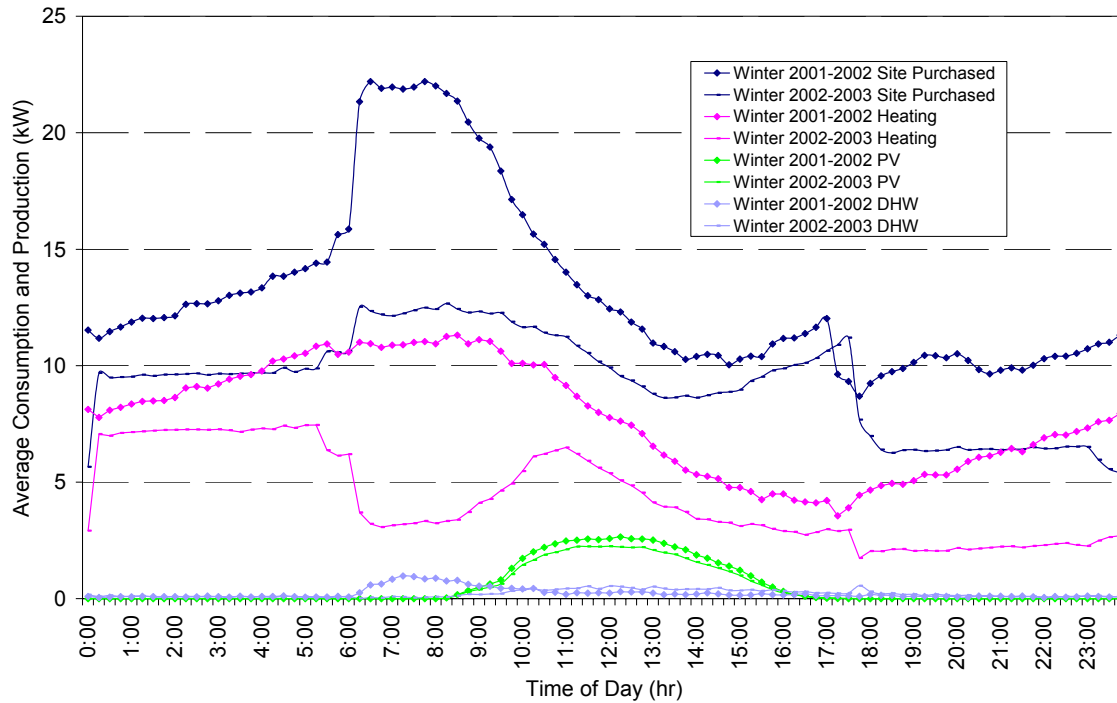
Figure 5-9 Average daily site energy purchased for heating, cooling, and hot water and PV production, Winter 2001–2002 compared to Winter 2002–2003

Figure 5-9 shows the differences of the average monthly winter site purchased electricity use over the winter of 2001–2002 (December 2001–March 2002) and the winter of 2002–2003 (December 2002–March 2003). The graph shows that during the winter of 2001–2002, the building used much more energy with a higher average peak, whereas during the winter of 2002–2003, it used much less energy with a lower average peak. The average heating profile shows the strategy of demand limiting controls. On average, the BAS limits the consumption of the electric heating and the DHW systems in the morning (during typical peak lighting consumption) and shifts the heating load to the afternoon (when PV production and daylighting are available) and nights (during typical minimum site consumption). The average daily heating profile was higher in the winter of 2001–2002 because the occupant controlled set point was 2–4°F (1.1–2.2°C) higher than the winter of 2002–2003. The domestic hot-water load without controls is lumped in the morning. With the controls, the recovery is spread throughout the day.

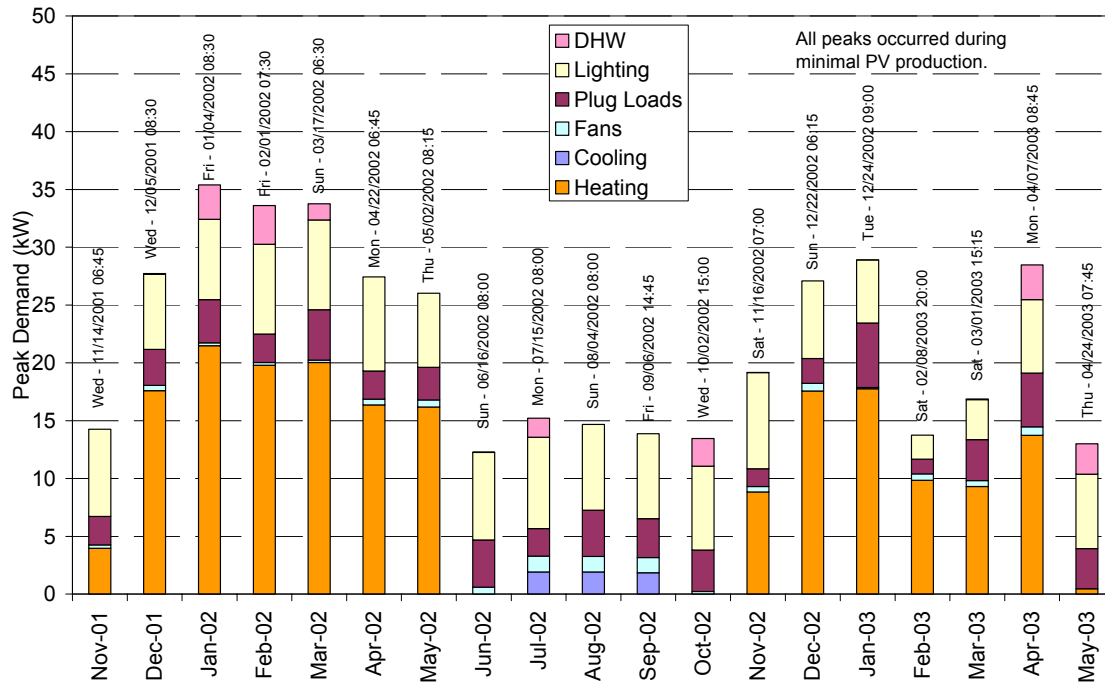
Figure 5-10 Visitor Center and Comfort Station peak demand analysis and time of occurrence for each month

The demands typically occurred during the morning when the building was first occupied. In all the cases, the PV production during the time of peak demand was minimal (see Table 5-6); therefore, the PV could not help reduce the overall demand and related costs.

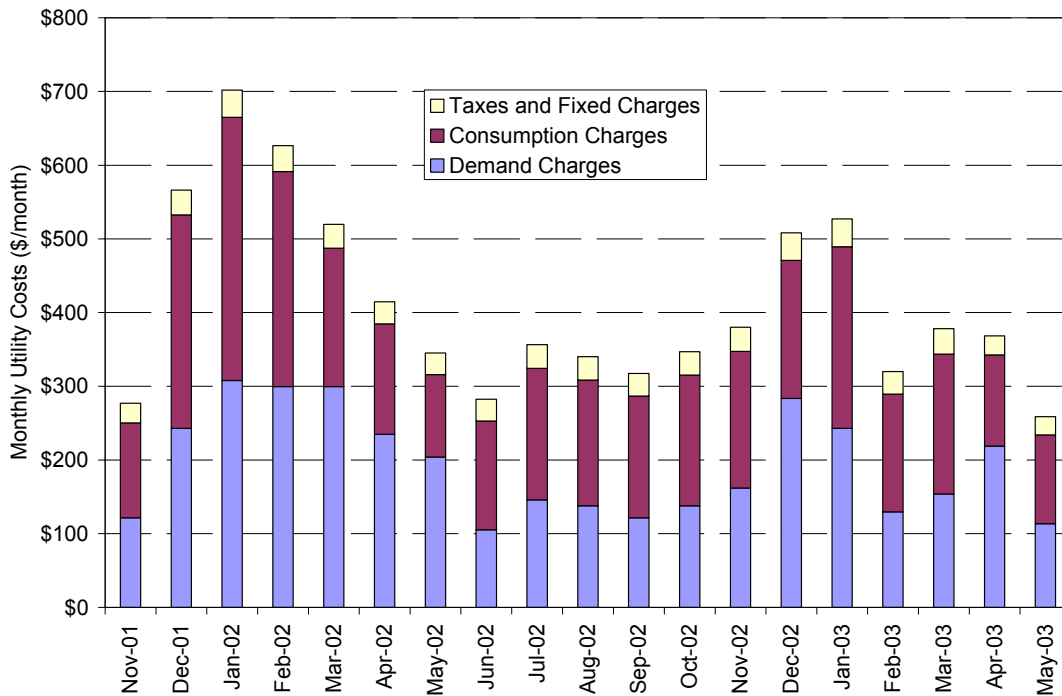
Figure 5-12 Visitor Center Complex energy costs, Nov. 2001 through May 2003

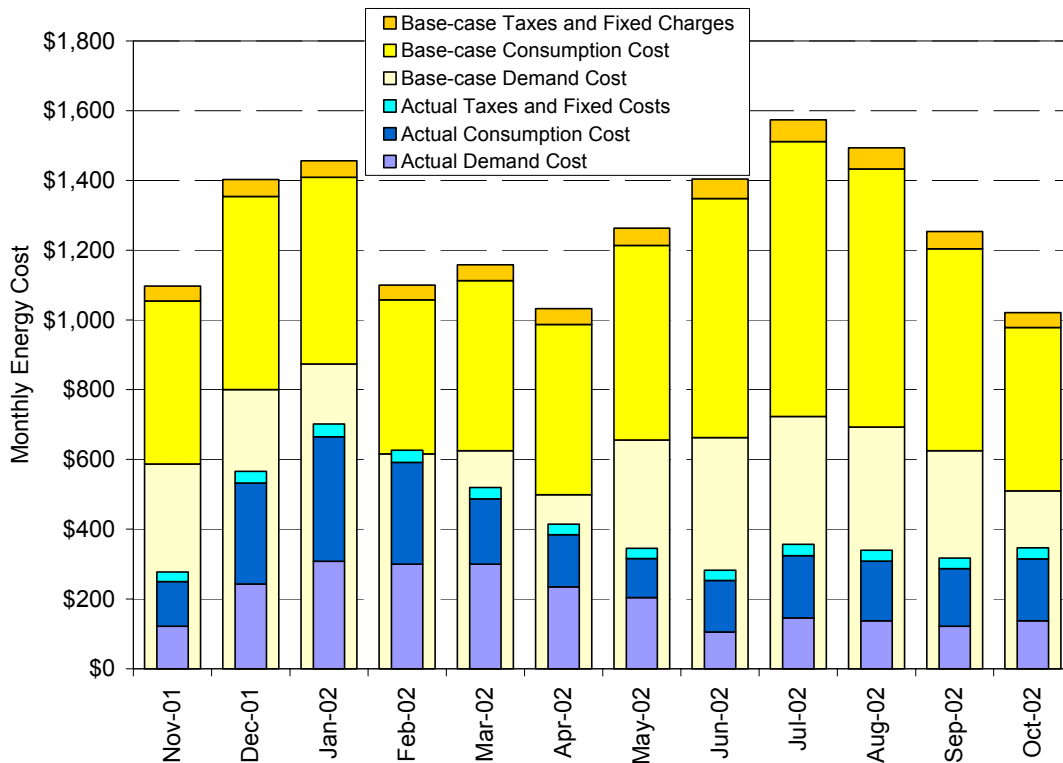
Figure 5-13 Base-case and energy costs, November 2001 through October 2002

The base case was an all-electric building that used air-source heat pumps, as specified in ASHRAE 90.1. Comparing energy consumption of an electric resistive heating system to a more efficient heat pump system resulted in a lower energy cost saving as well. Although the energy cost saving was less than expected at 67%, the realized cost saving is still significant. Again, if the redesign had been resimulated during the design process, the expected energy cost saving would have been recalculated. These energy cost savings would have been closer to the realized savings.

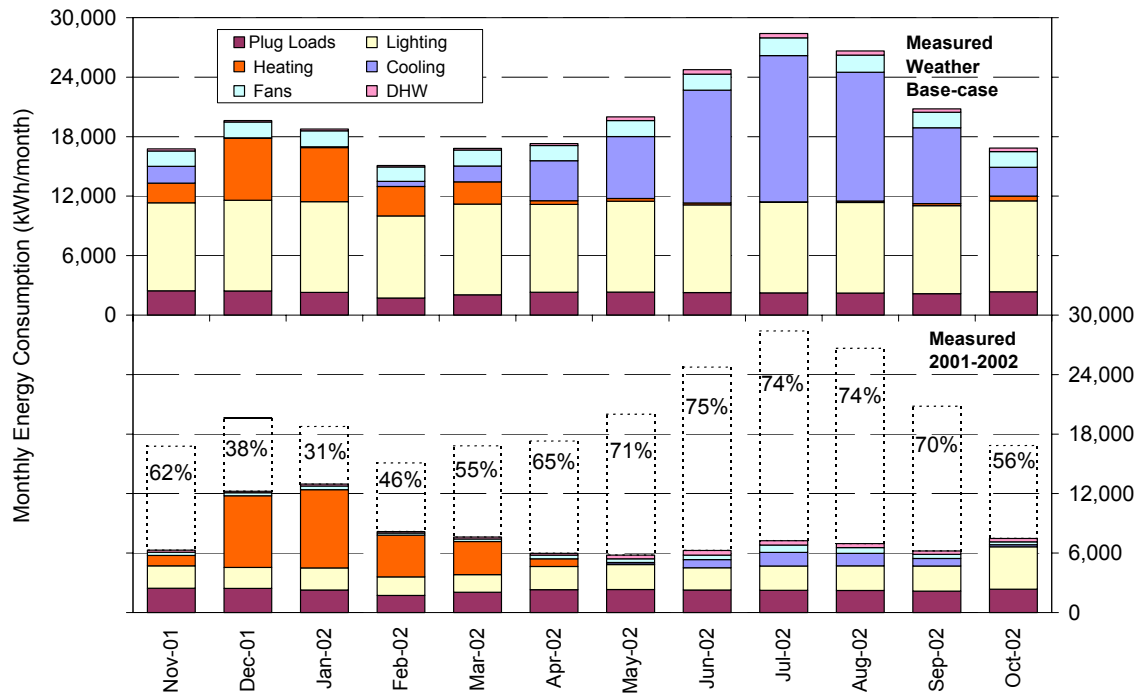
Figure 5-14 Base-case energy consumption compared to measured consumption

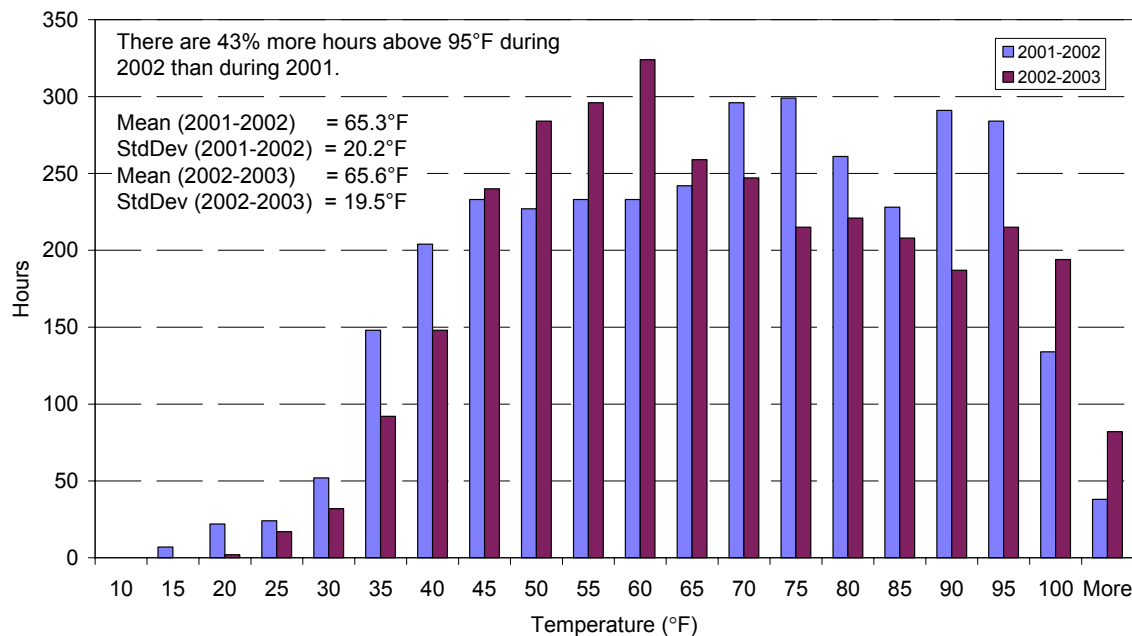
Figure 6-1 Histogram of outdoor dry-bulb temperatures during occupied hours

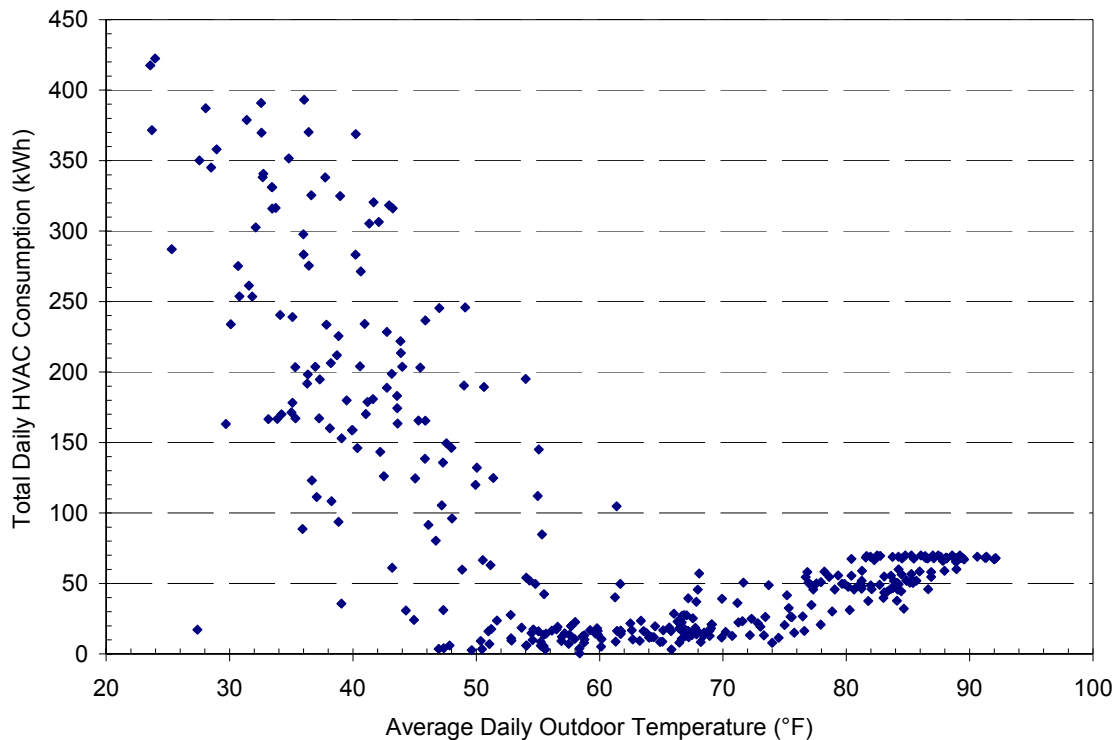
Figure 6-2 HVAC energy consumption as a function of outdoor temperature

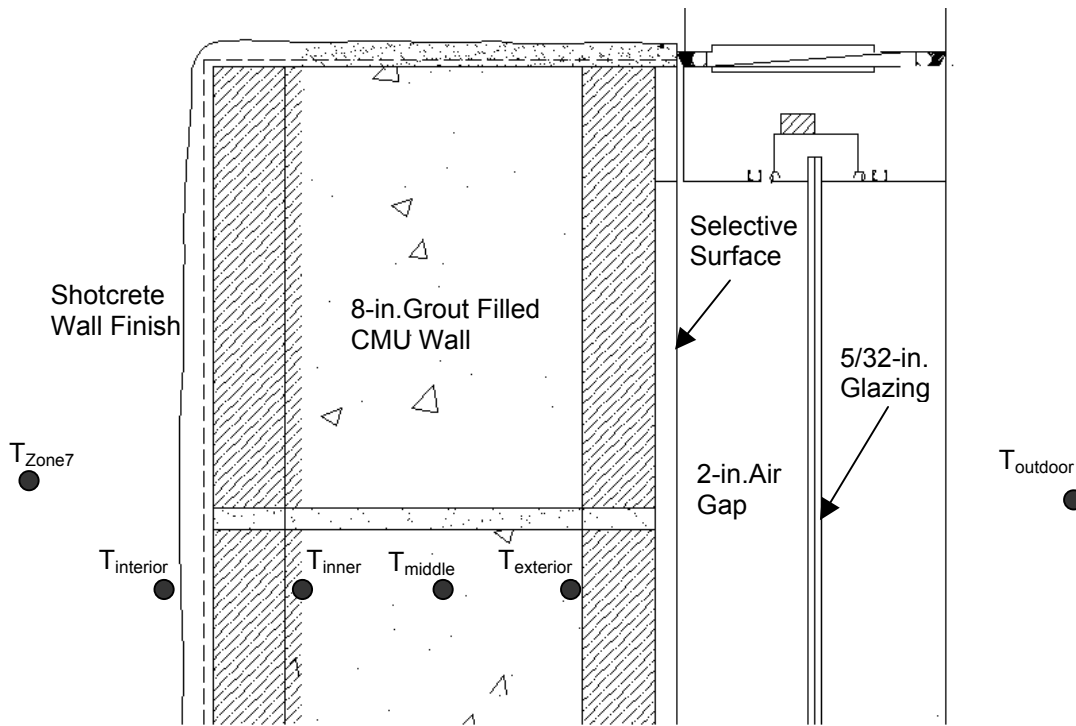
Figure 6-3 Cross section of Trombe wall showing location of temperature sensors

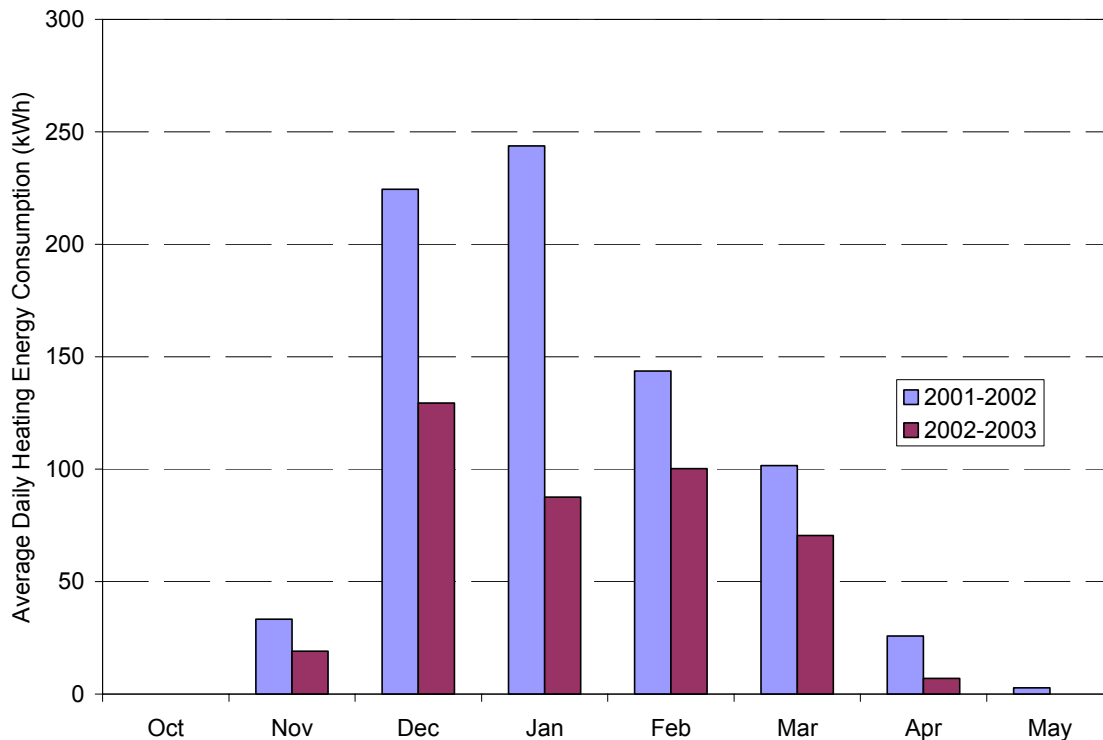
Figure 6-4 Average daily heating energy consumption by month

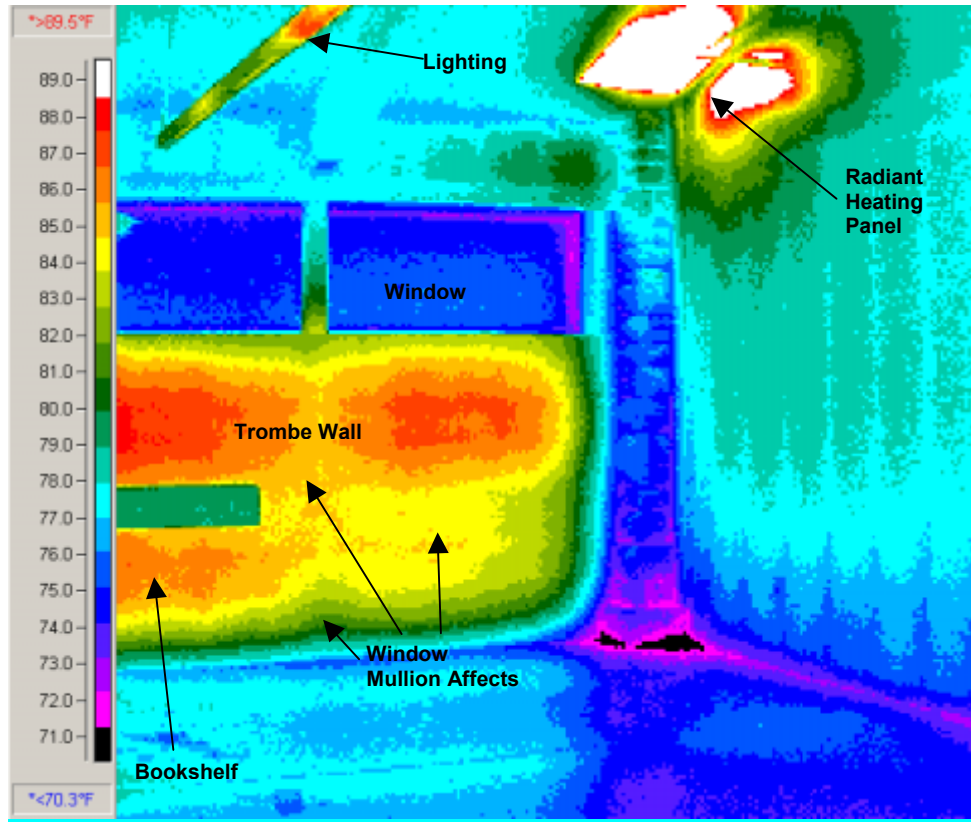
Figure 6-5 Infrared picture of Trombe wall during heating season 2/9/2000 at 6:00 p.m.

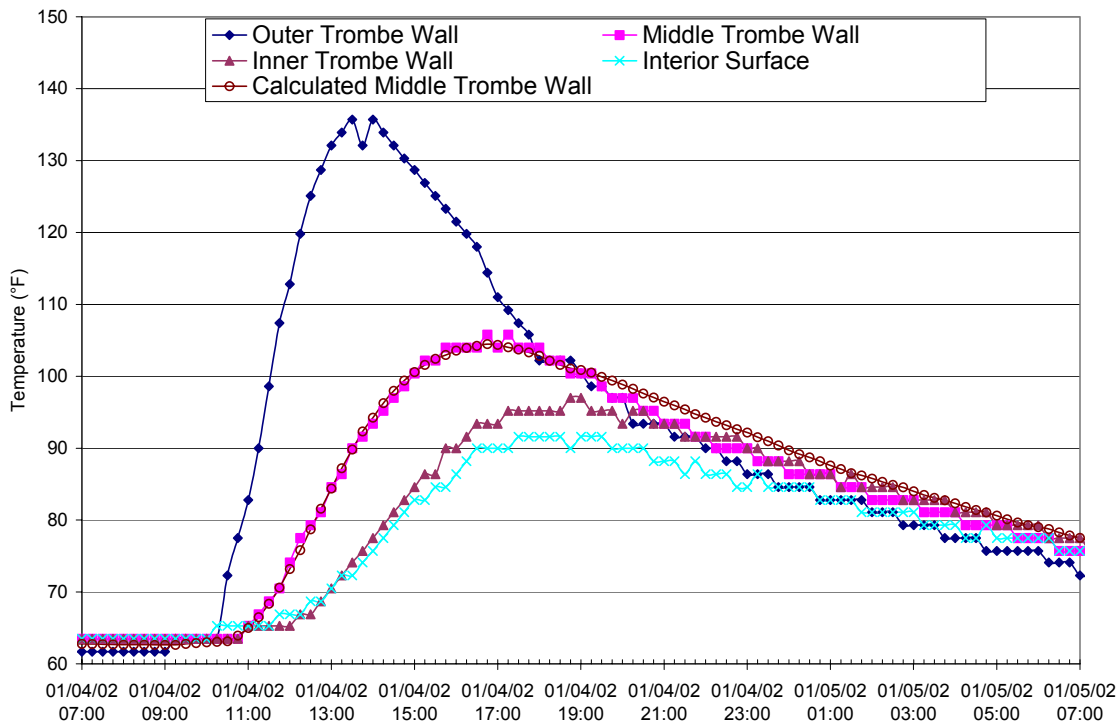
Figure 6-6 Verification of middle Trombe wall temperature after adjusting thermal conductivity

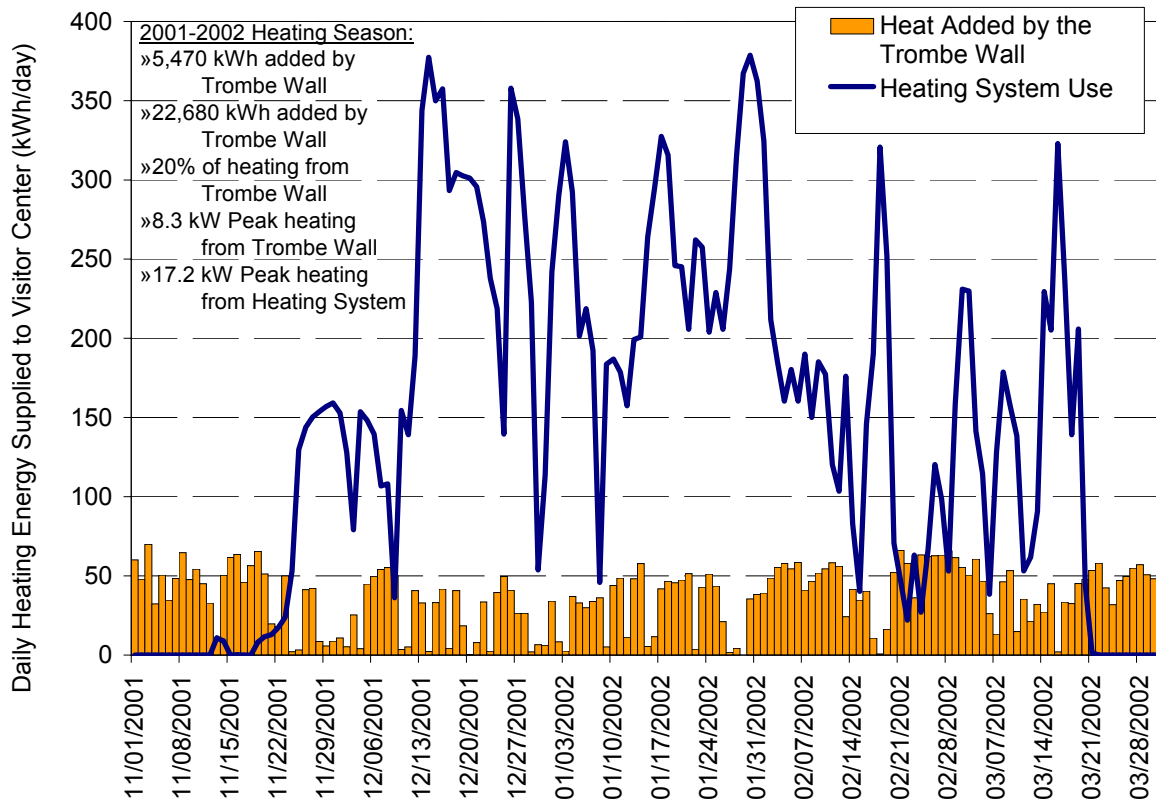
Figure 6-7 Trombe wall and heating system performance, 2001–2002 heating season

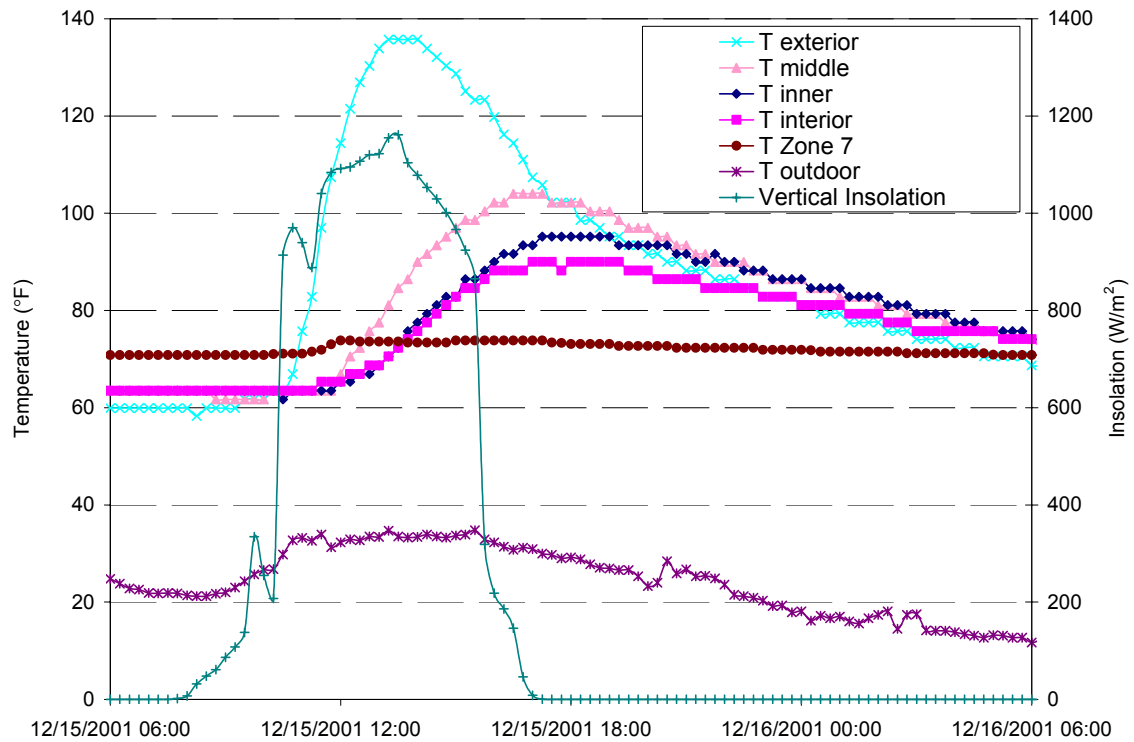
Figure 6-8 Trombe wall temperature transients over a 24-hour period

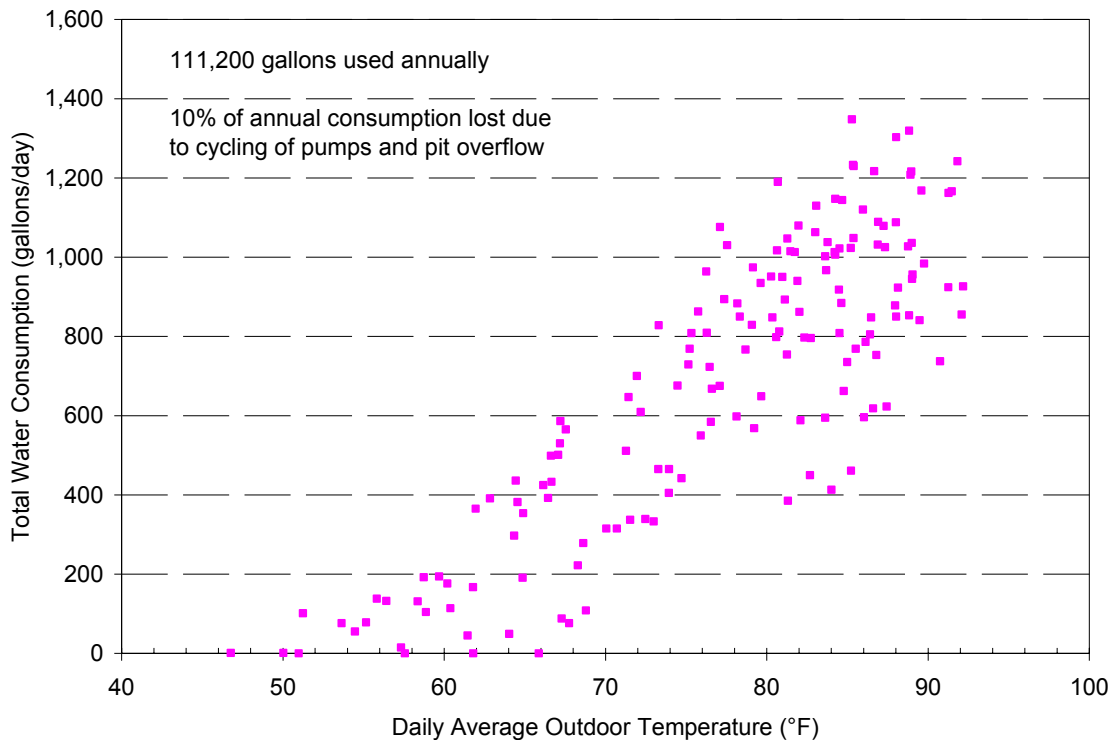
Figure 6-9 Water consumption versus daily average outdoor temperature (Summer 2002)

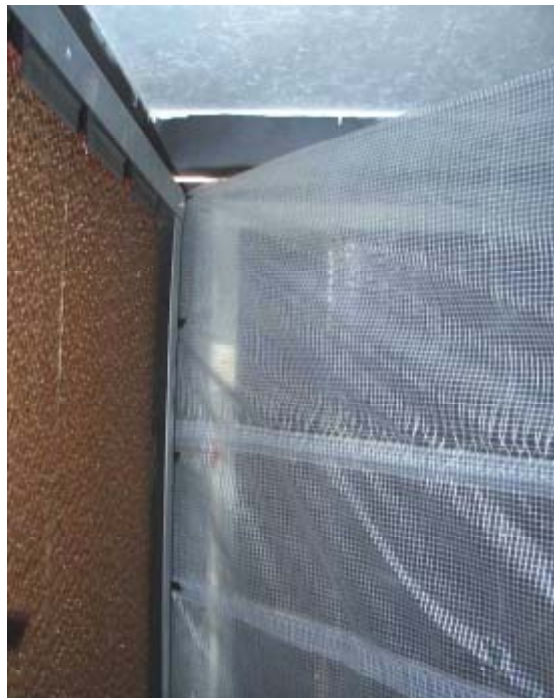
Figure 6-10 Plastic blocking device for cooltowers

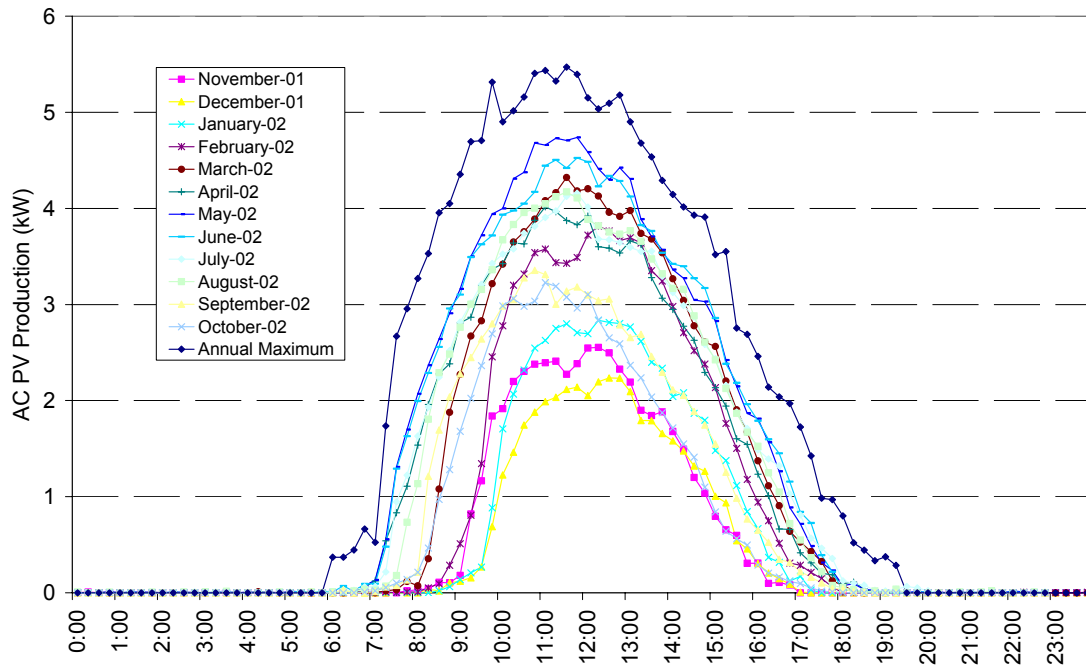
Figure 6-11 Average hourly AC power profile by month for PV production, November 2001 through October 2002

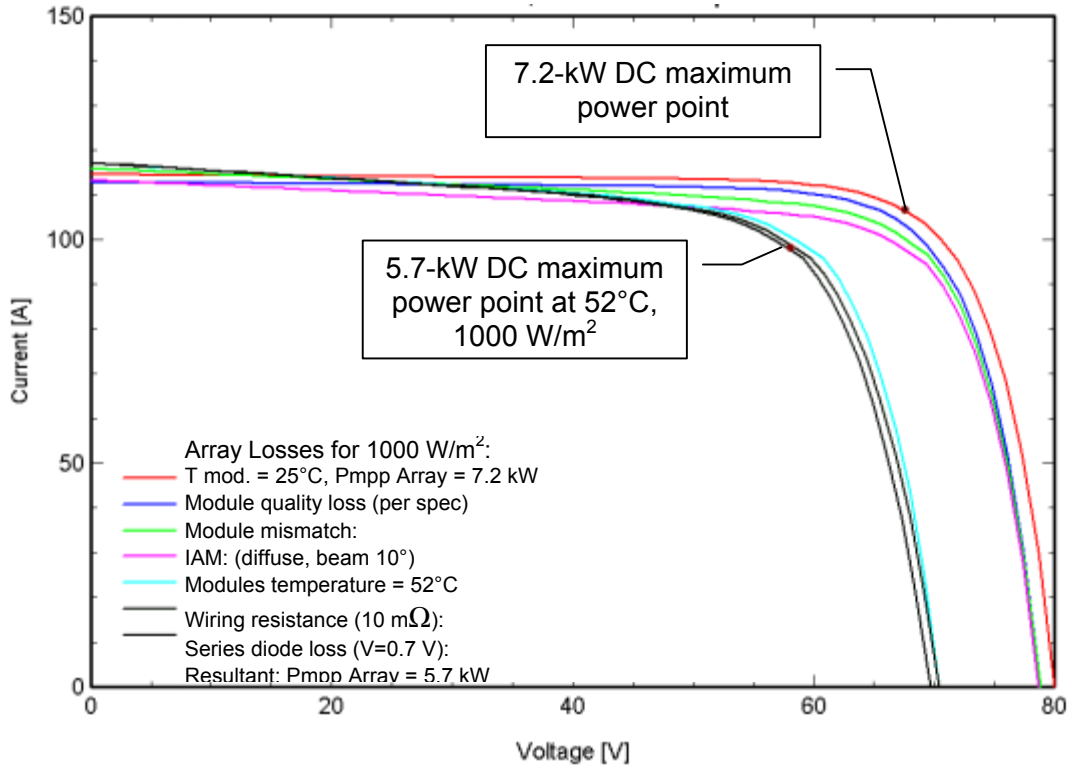
Figure 6-12 Modeled array losses

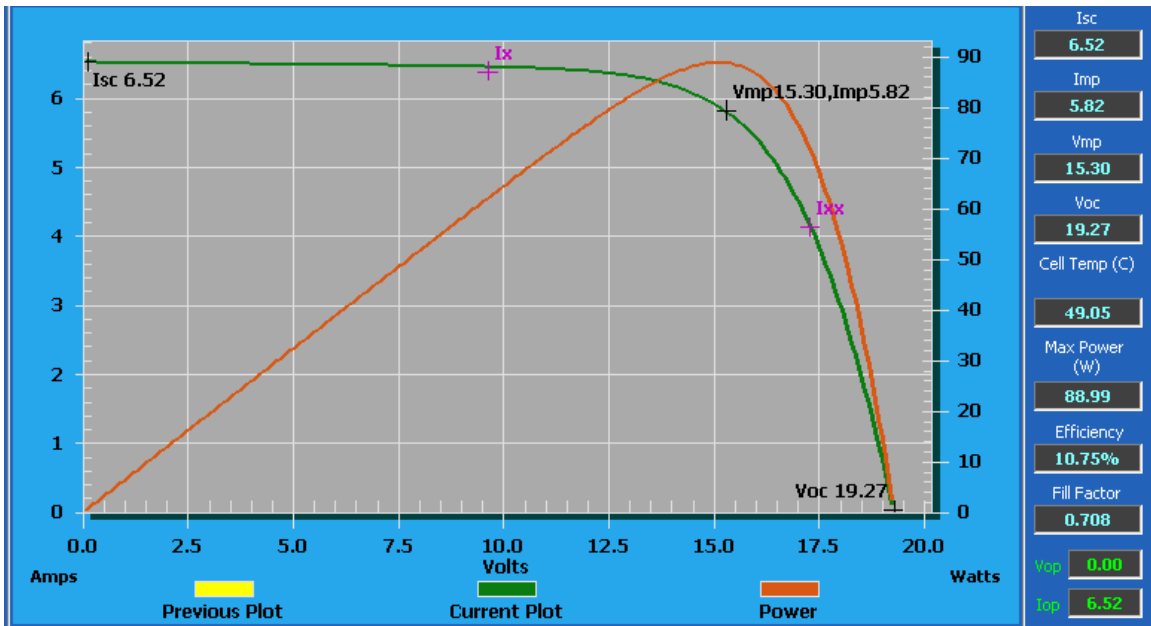
Figure 6-13 Sandia PV performance model I-V curve tracer model for the Zion PV system

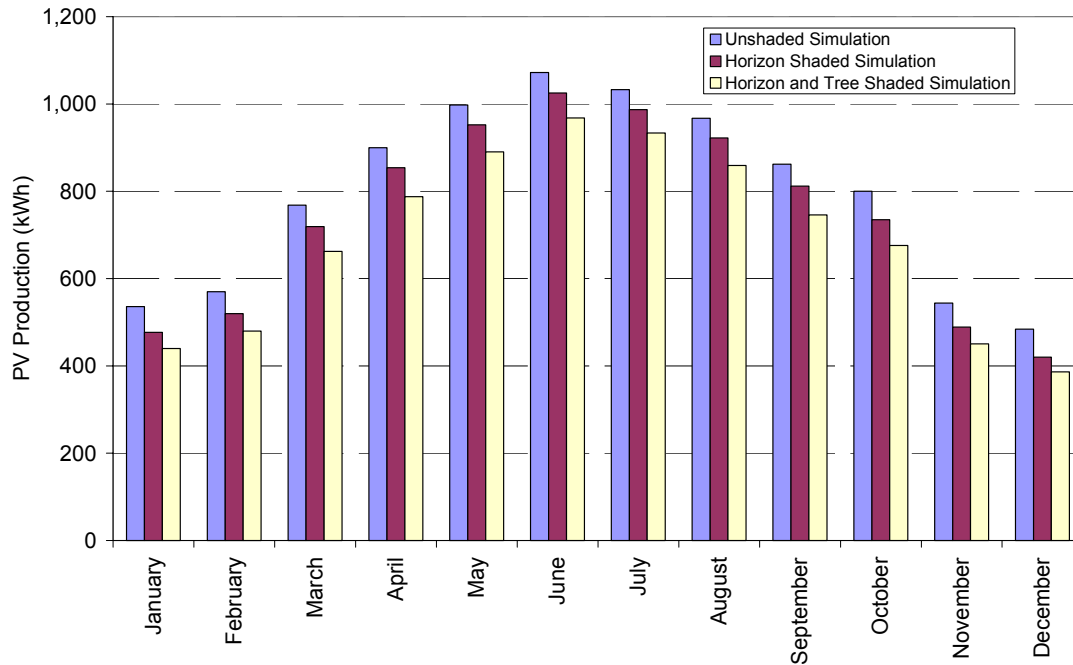
Figure 6-14 PV production for unshaded, horizon shaded, and horizon and tree shaded simulations

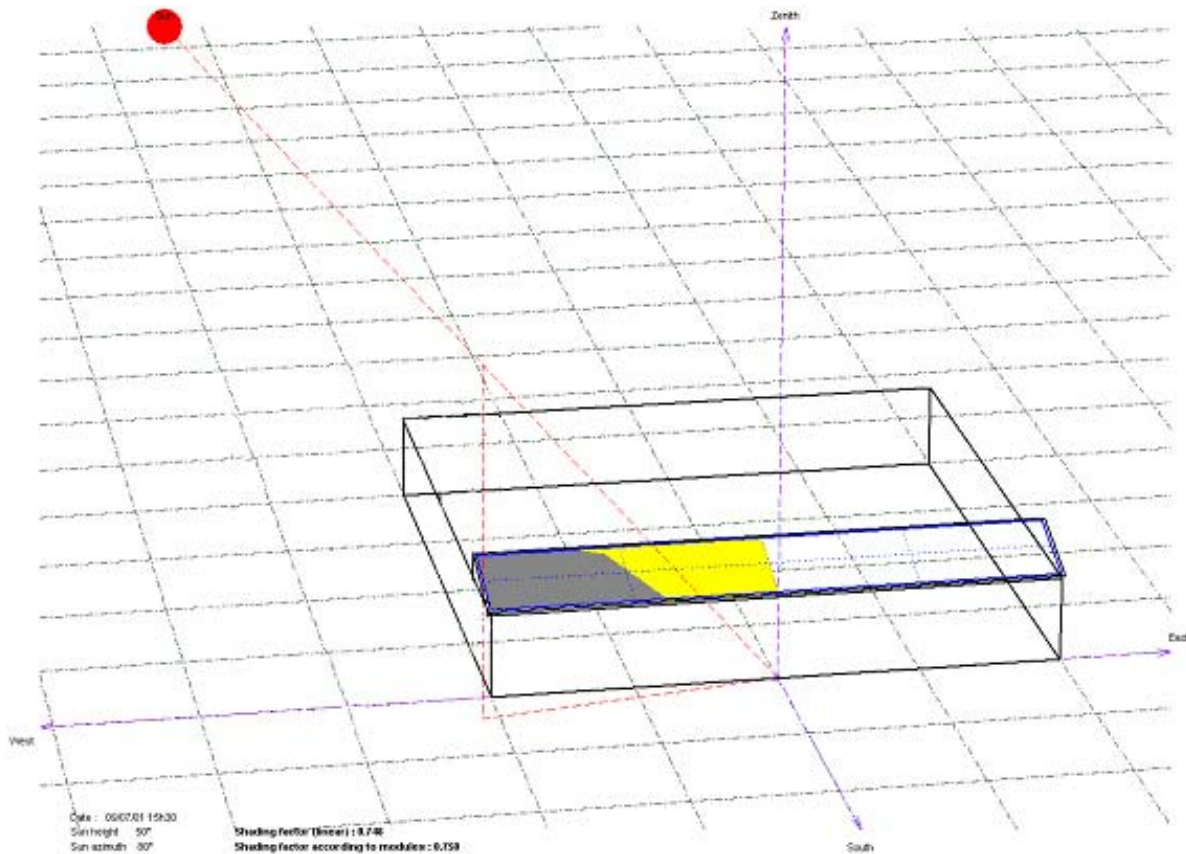
Figure 6-16 Model of tree shading of PV array, 3:30 p.m. July 9, 2000

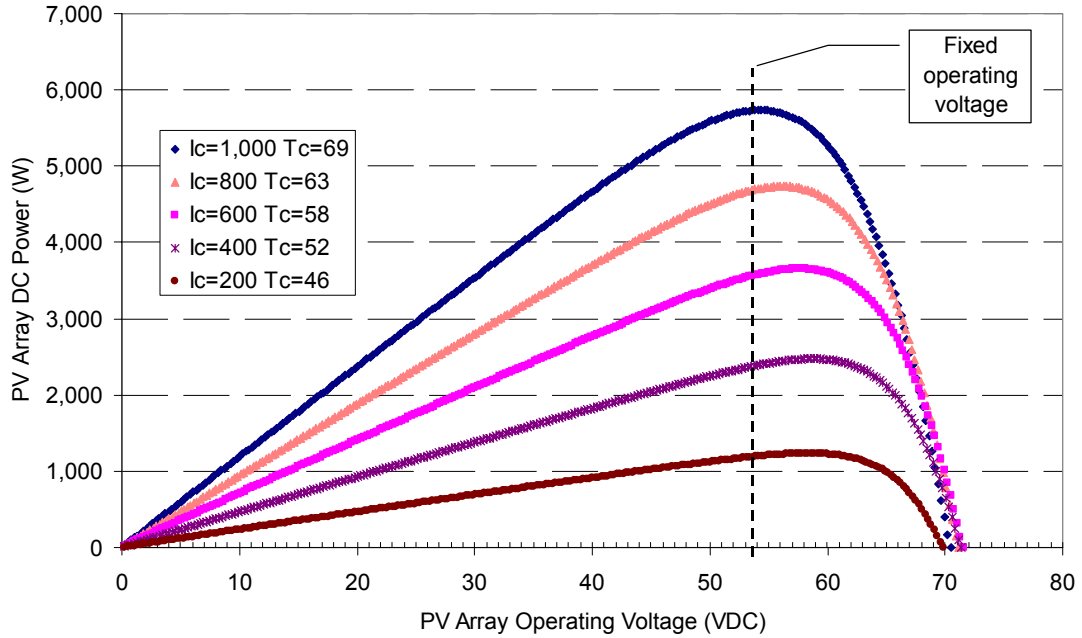
Figure 6-17 Simulated power-voltage curve traces for summer weather conditions

For summer weather conditions of 104°F (40°C) and a wind speed of 3.28 ft/s (1 m/s), the Sandia Curve Tracer predicts a maximum power point of 54 VDC to 59 VDC, depending on insolation (I_c) and cell

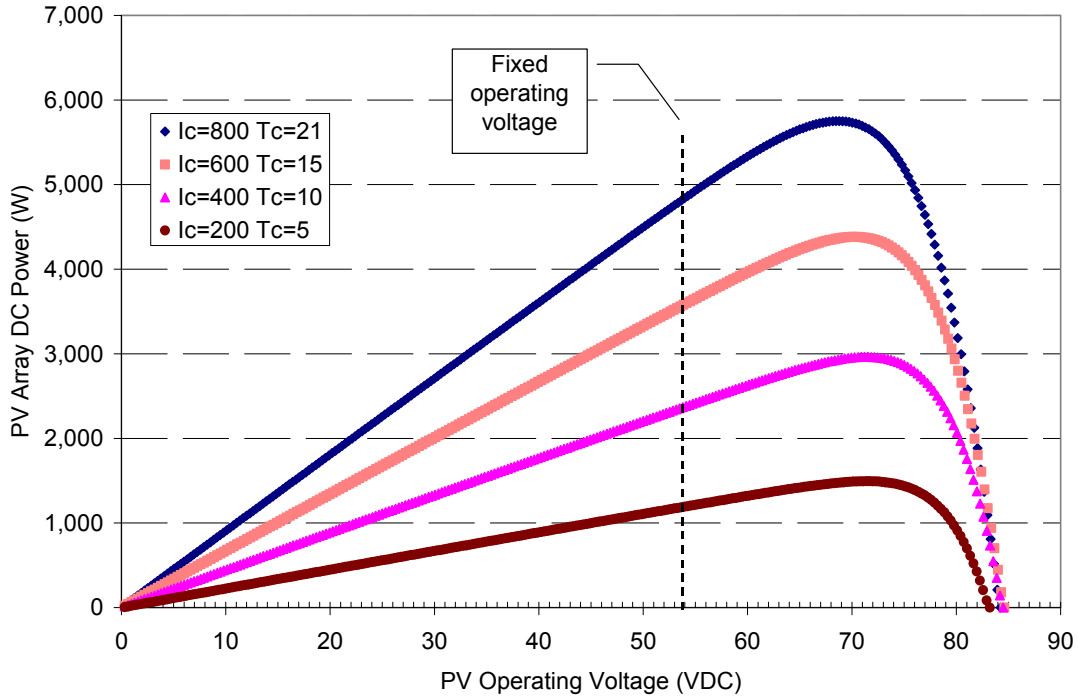
Figure 6-18 Simulated power-voltage curve traces for winter weather conditions

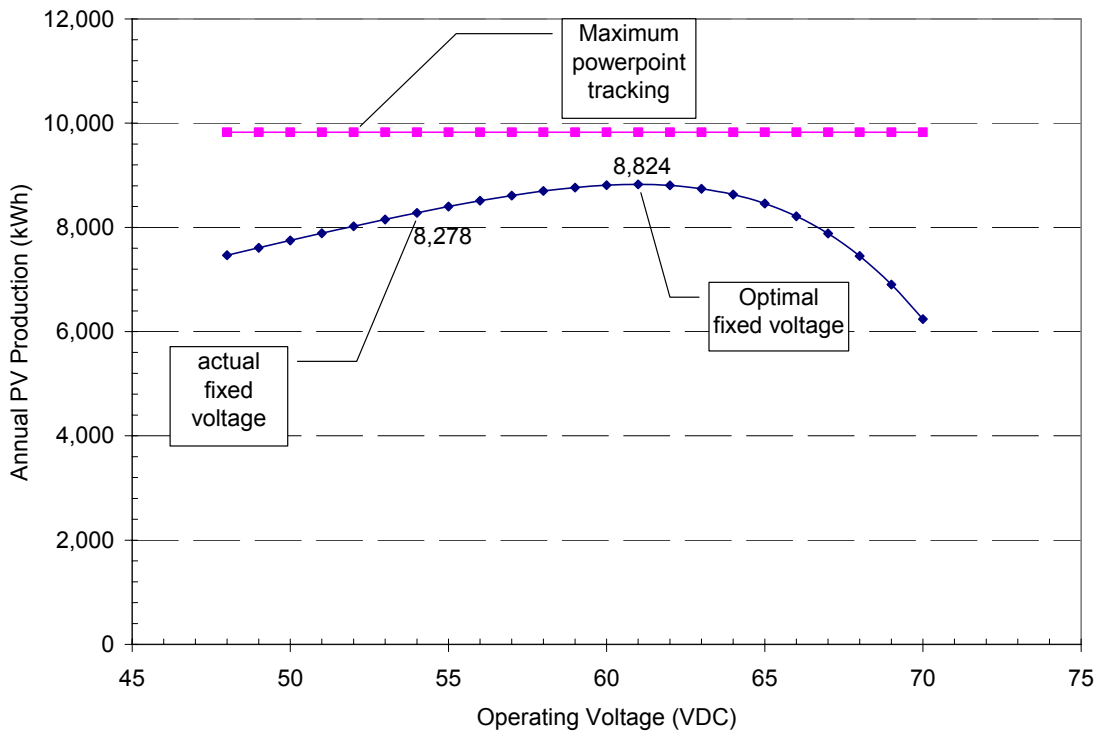
Figure 6-19 Simulated annual PV production: Best fixed voltage, actual fixed voltage, and maximum power-point tracking

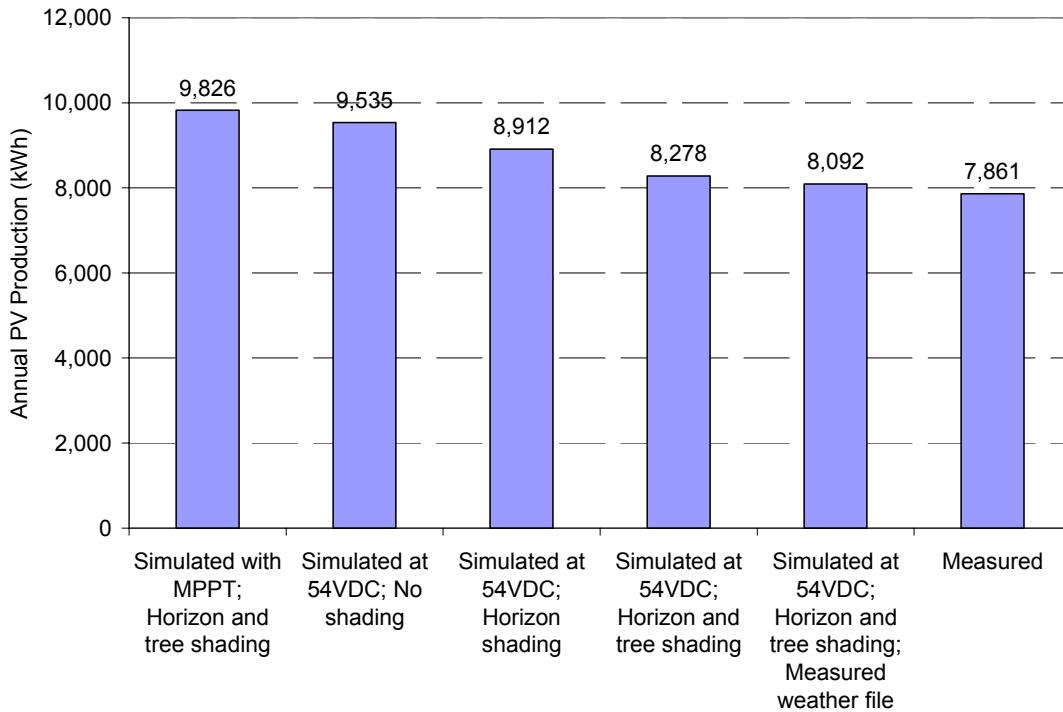
Figure 6-20 Simulated annual PV production comparisons to measured PV production

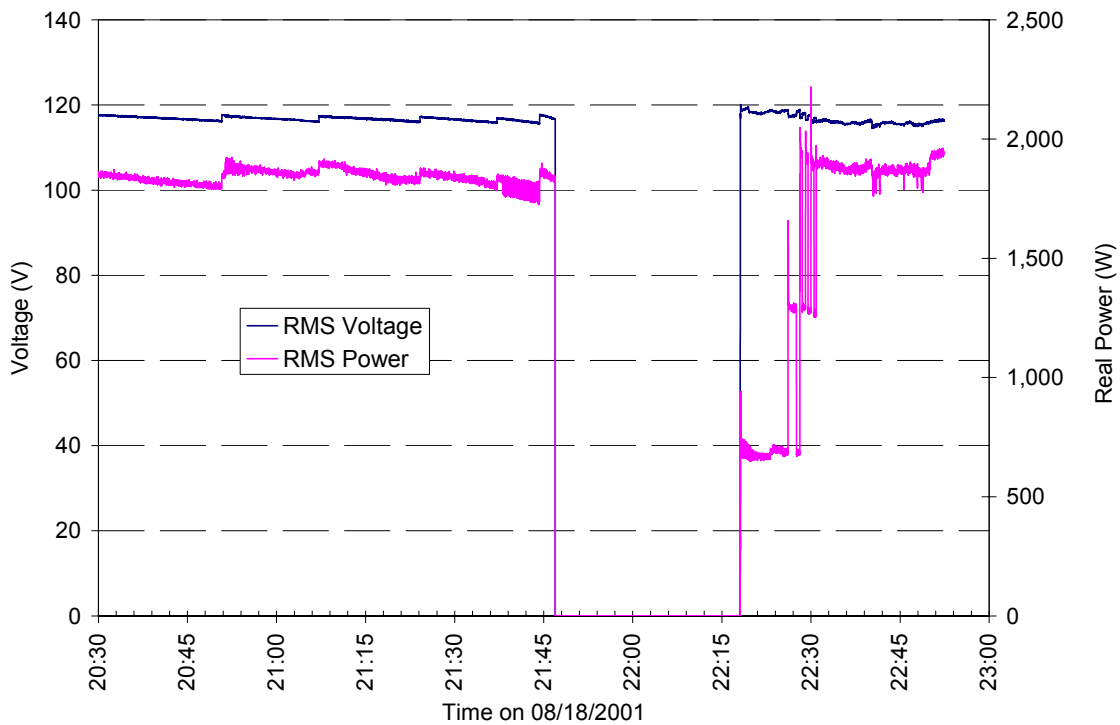
Figure 6-21 Voltage and real power of emergency panel versus time for a utility grid power outage

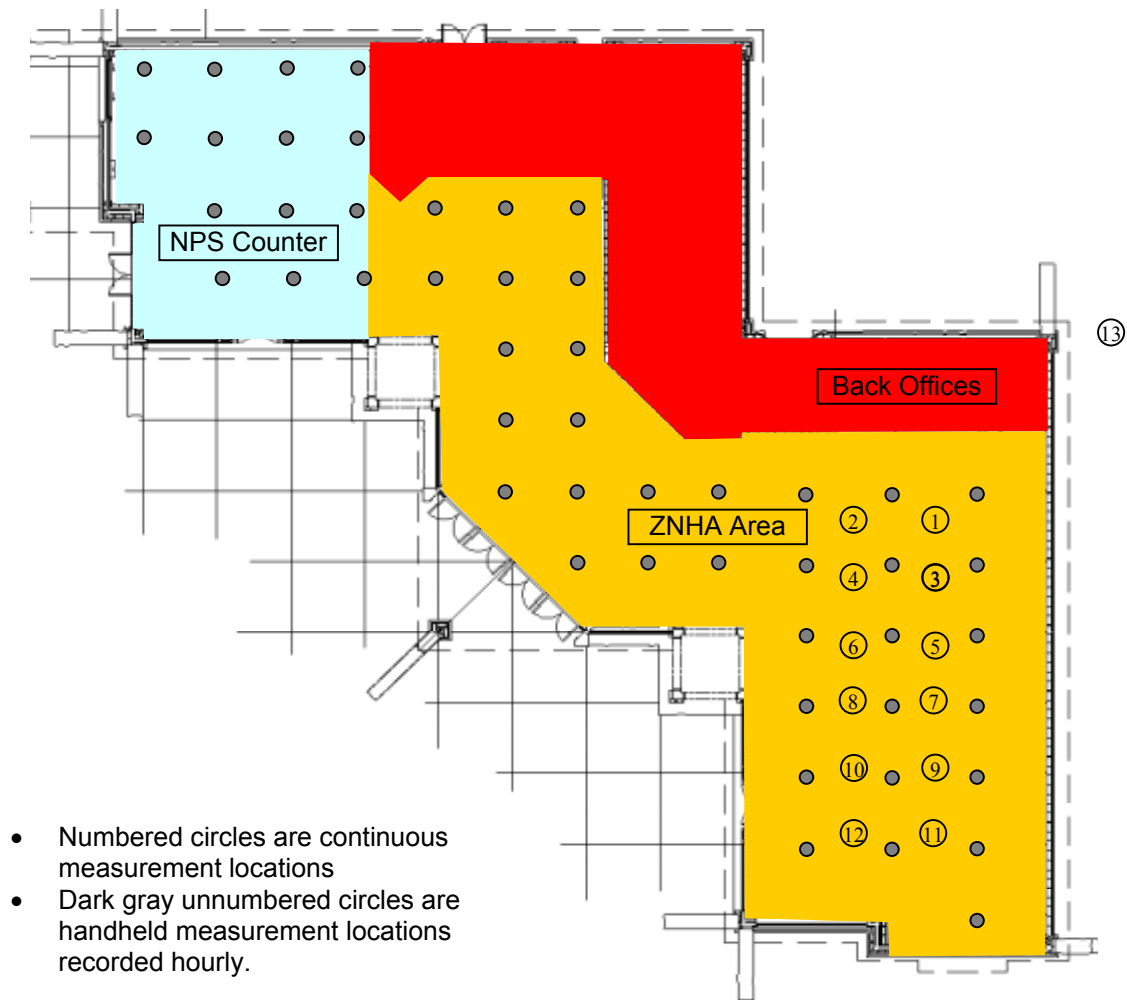
Figure 6-22 Continuous and handheld illuminance measurement locations
