Evaluation of the Low-Energy Design and Energy Performance of the Zion National Park Visitors Center

P. Torcellini, N. Long, S. Pless, and R. Judkoff

NREL

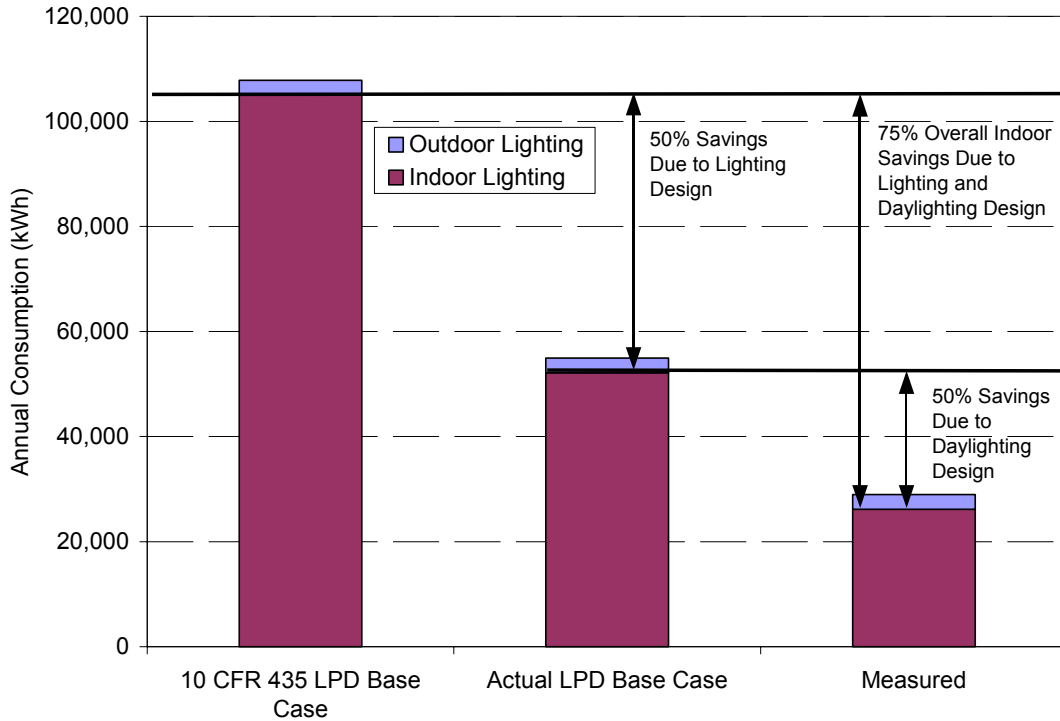
Figure 6-23 Lighting and daylighting design savings for indoor lighting

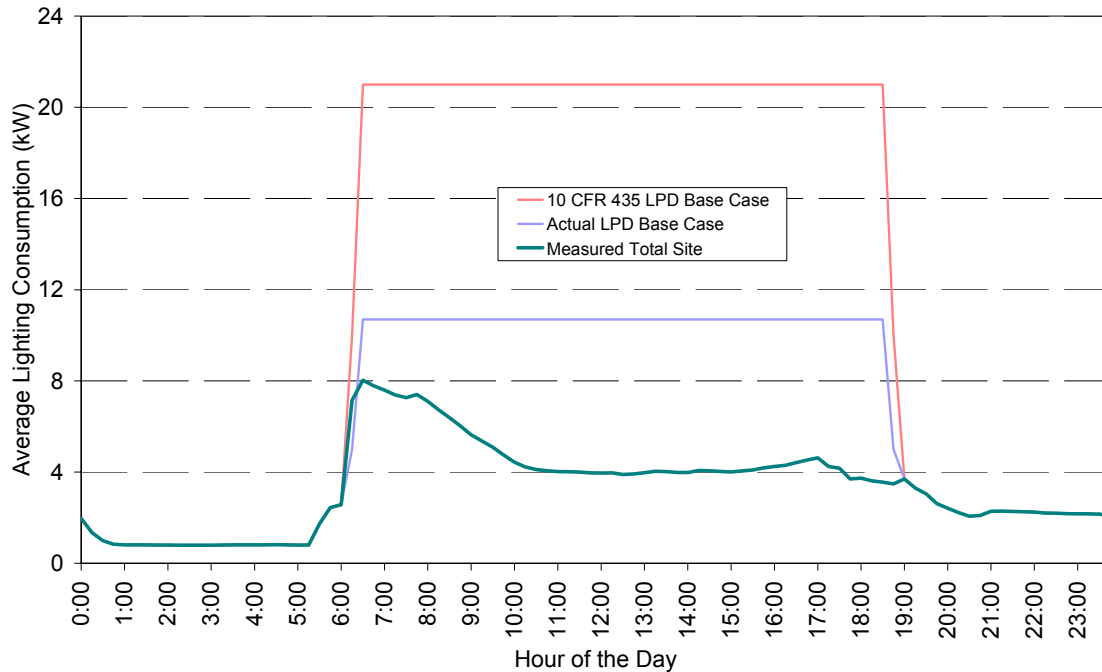
Figure 6-24 Measured, base case, and actual LPD annual lighting consumption profiles and savings (October 2001 to November 2002)

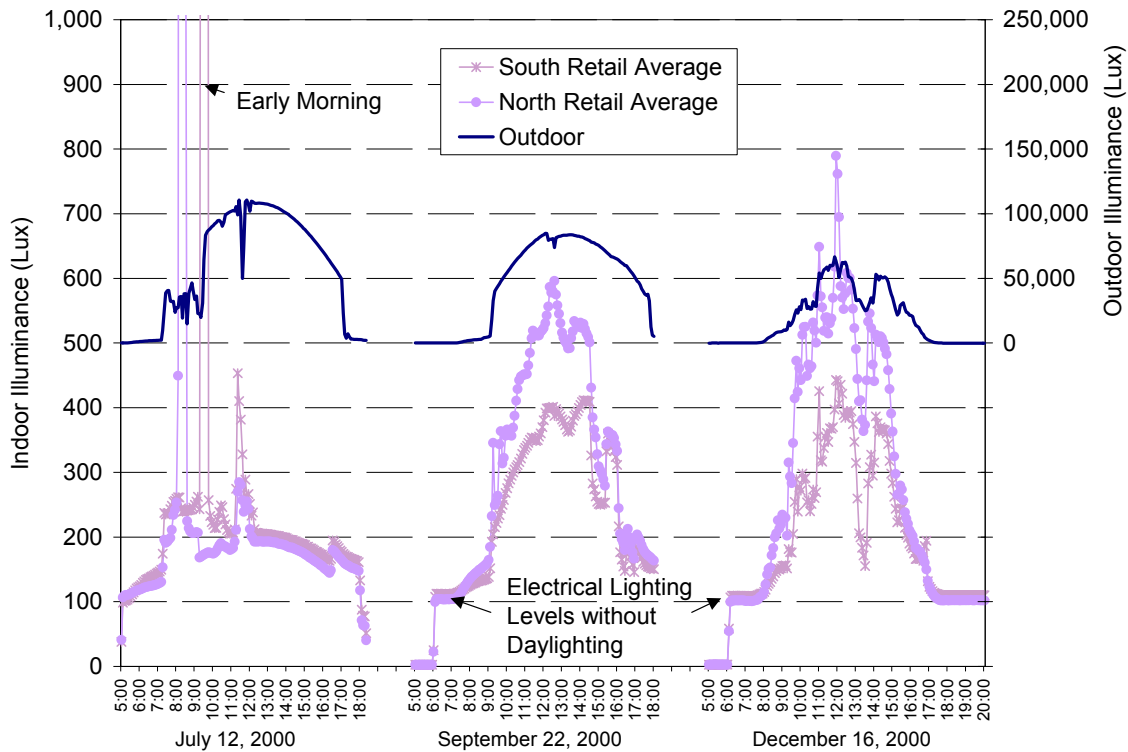
Figure 6-25 Measured bookstore and outdoor illuminance levels, July 12, 2000; September 22, 2000; and December 16, 2000

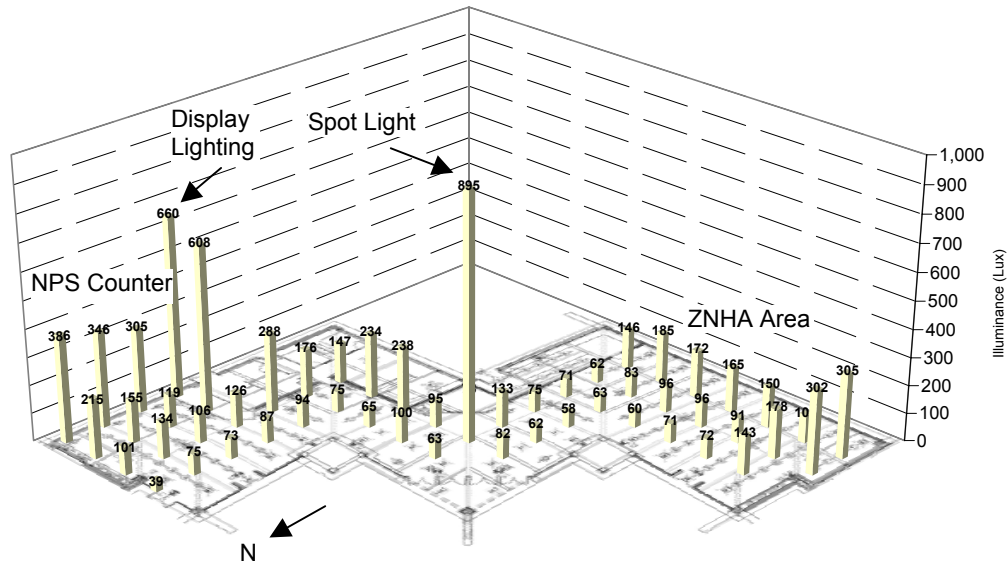
Figure 6-28 Illuminance points over the floor plan from electrical lights without daylighting on July 10, 2000, 10:00 p.m.

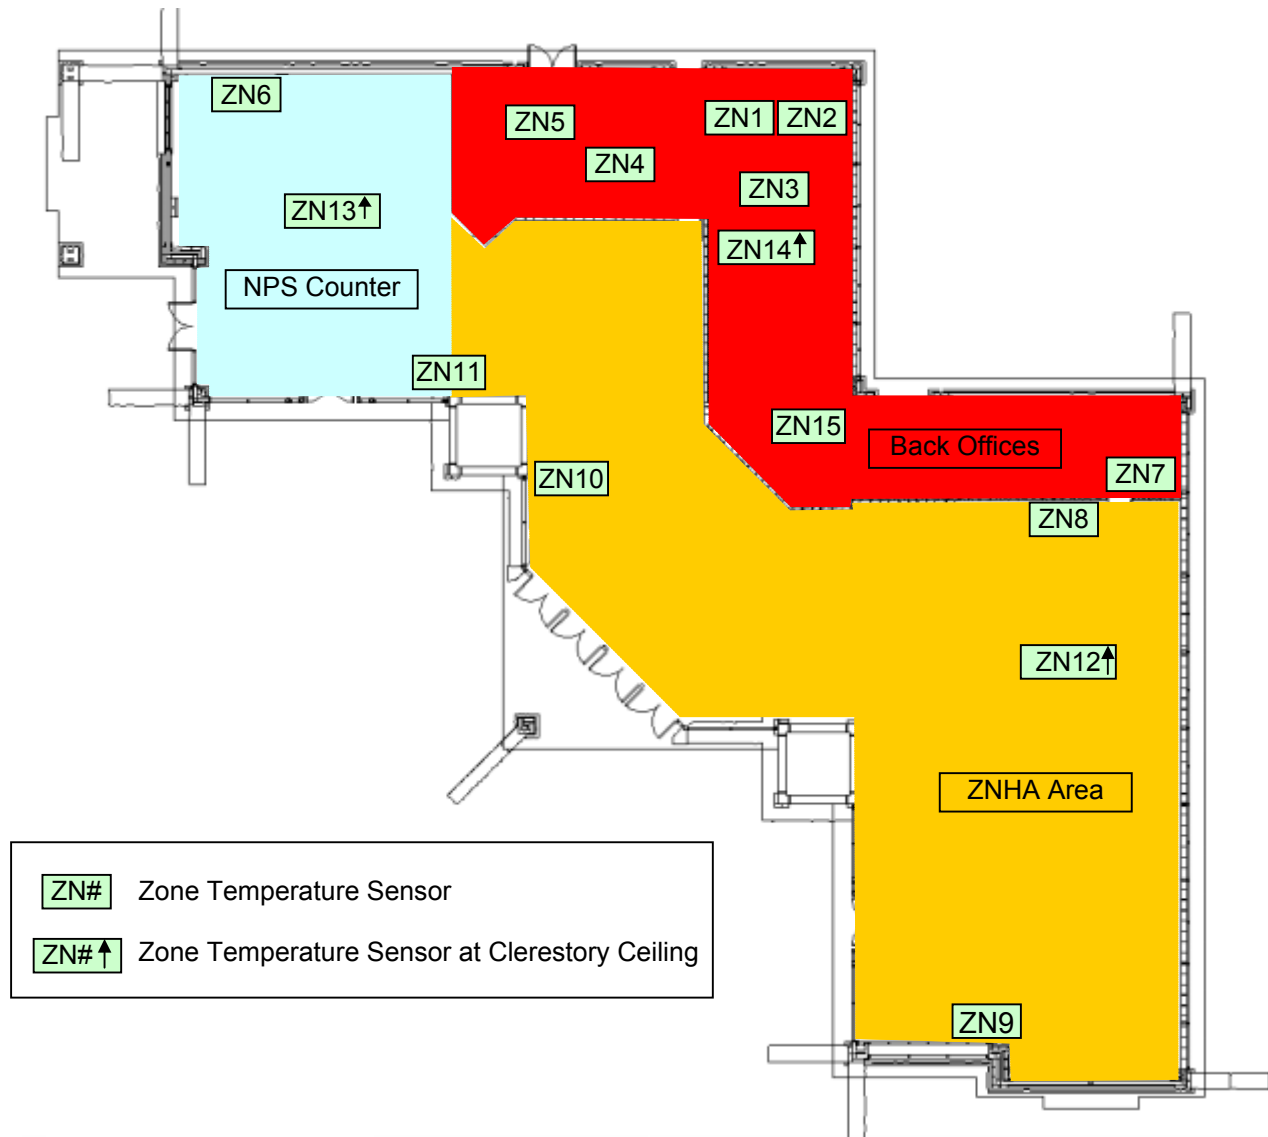
Figure 6-31 Layout of temperature sensors for Visitor Center

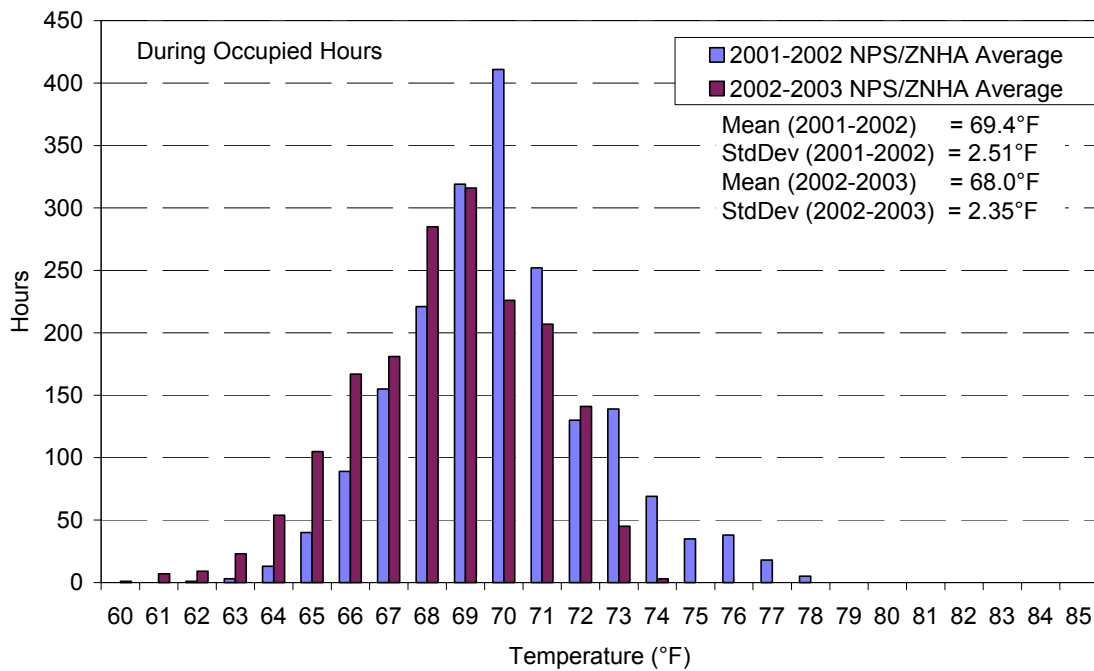
Figure 6-32 Histogram of winter average temperature in the Visitor Center

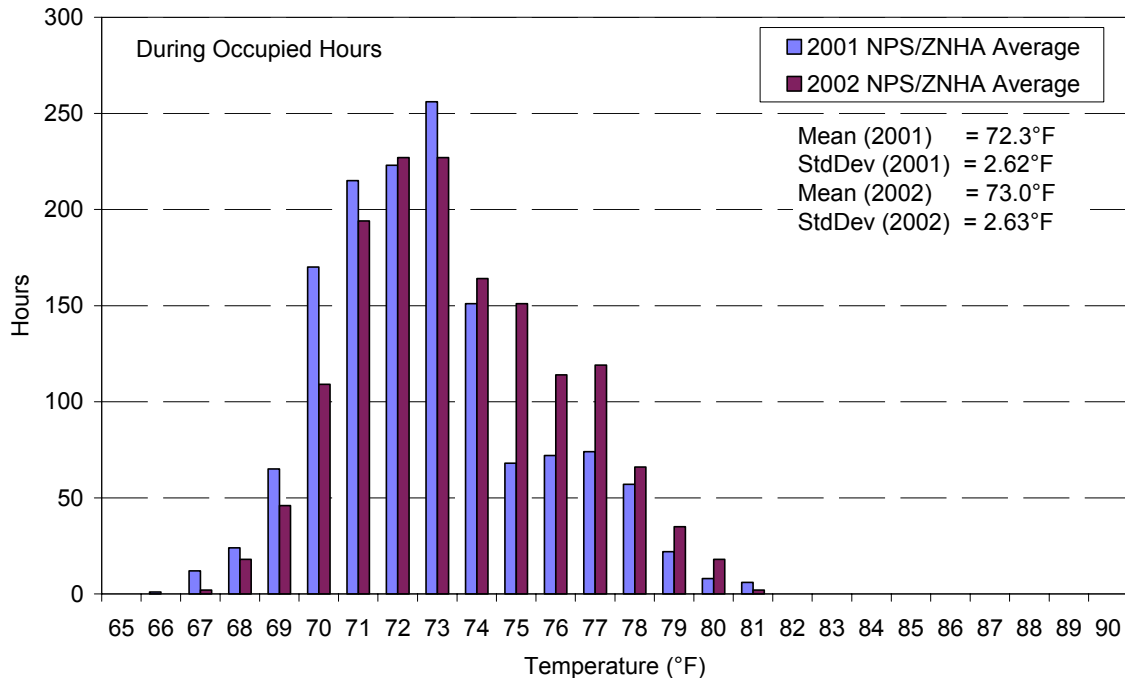
Figure 6-33 Histogram of hours at average temperature in the Visitor Center during summer

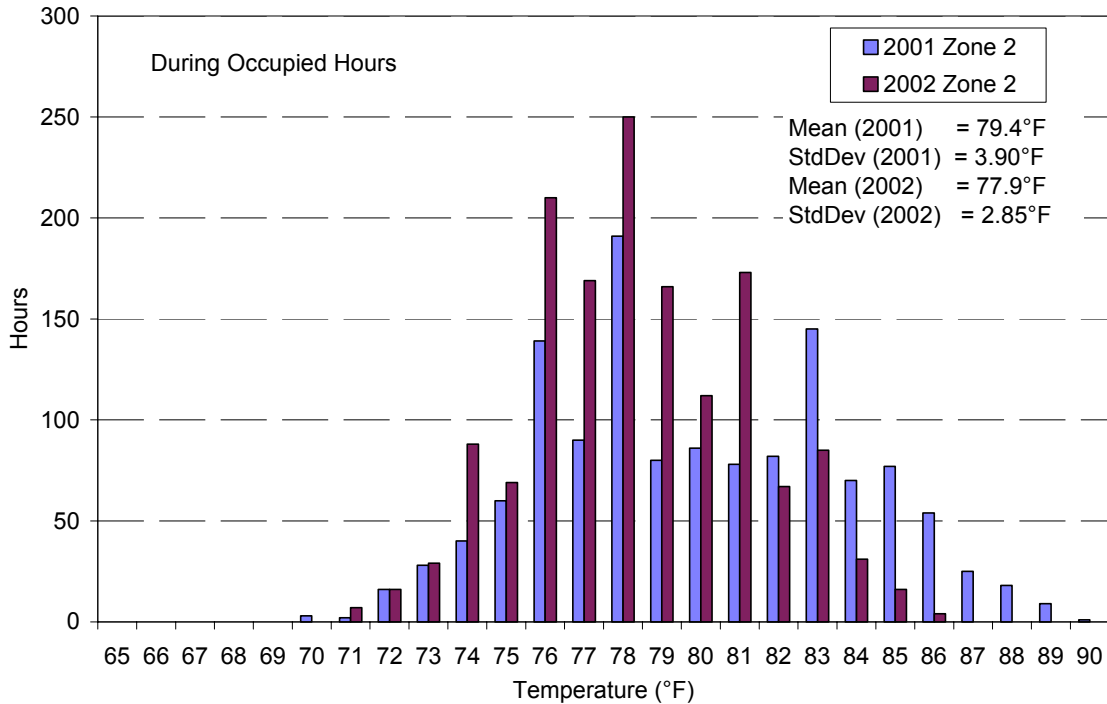
Figure 6-34 Visitor Center Zone 2 comfort histogram during summer

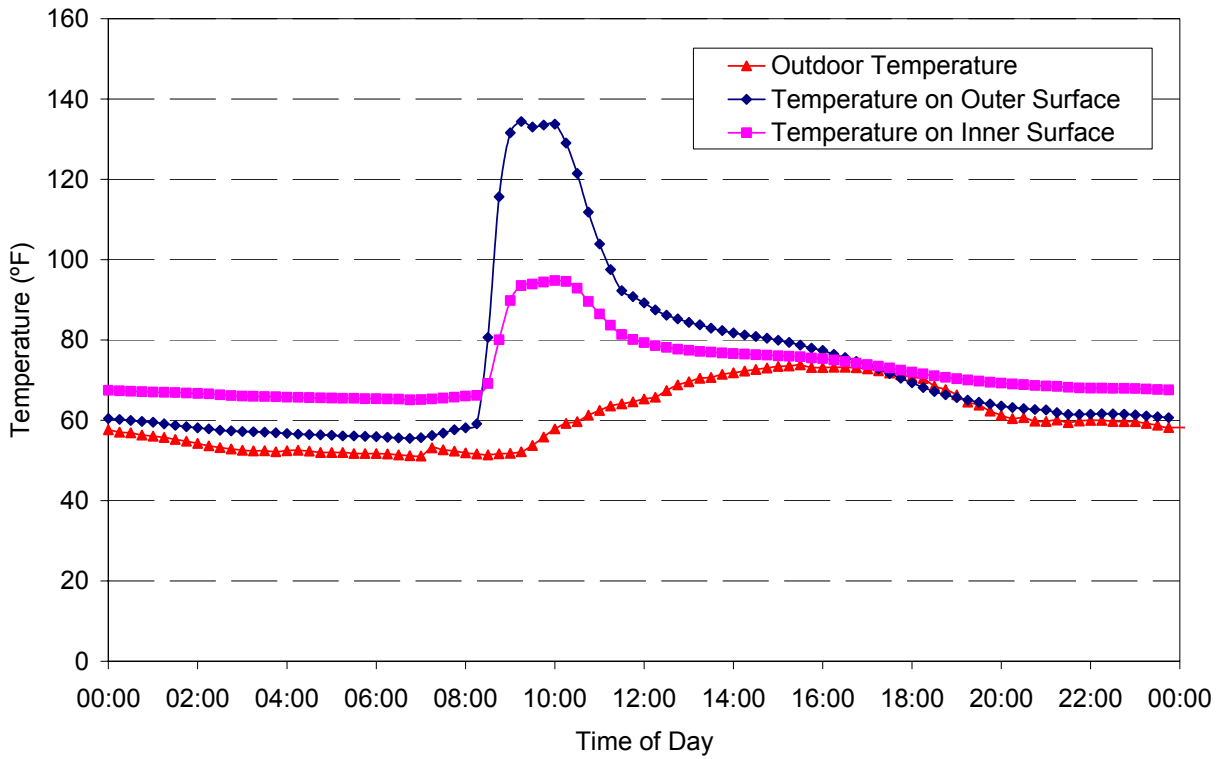
Figure 6-35 Zone 7 exterior door temperatures averaged over October 8, through October 19, 2001

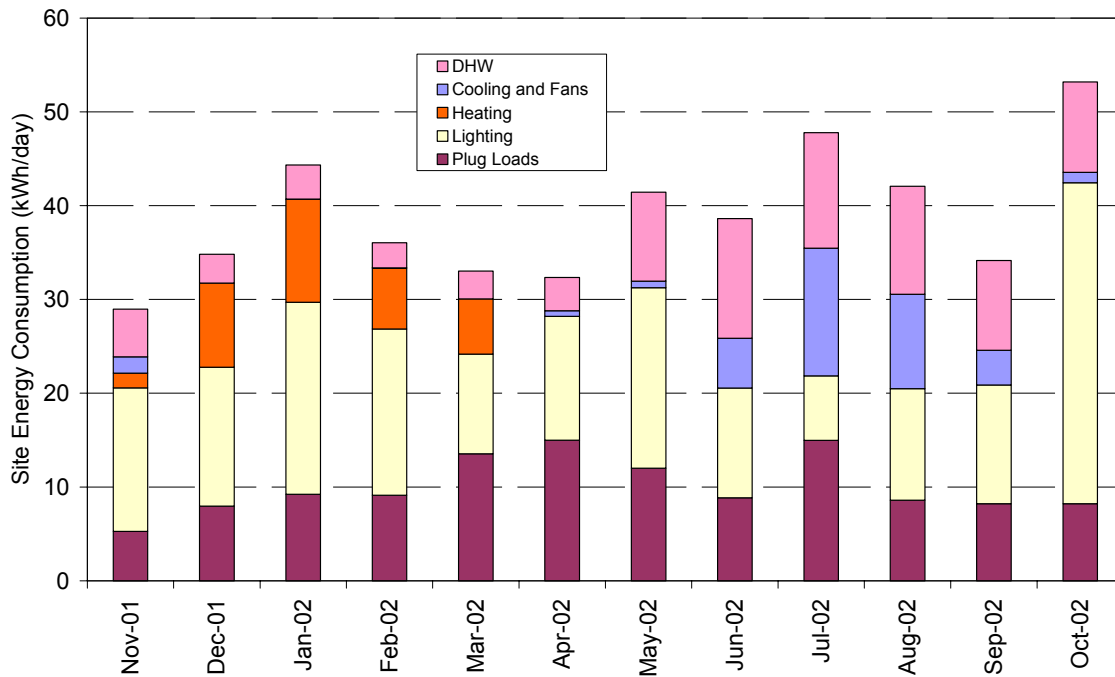
Figure 6-37 Comfort Station end use monthly consumption per day, November 2001 through October 2002

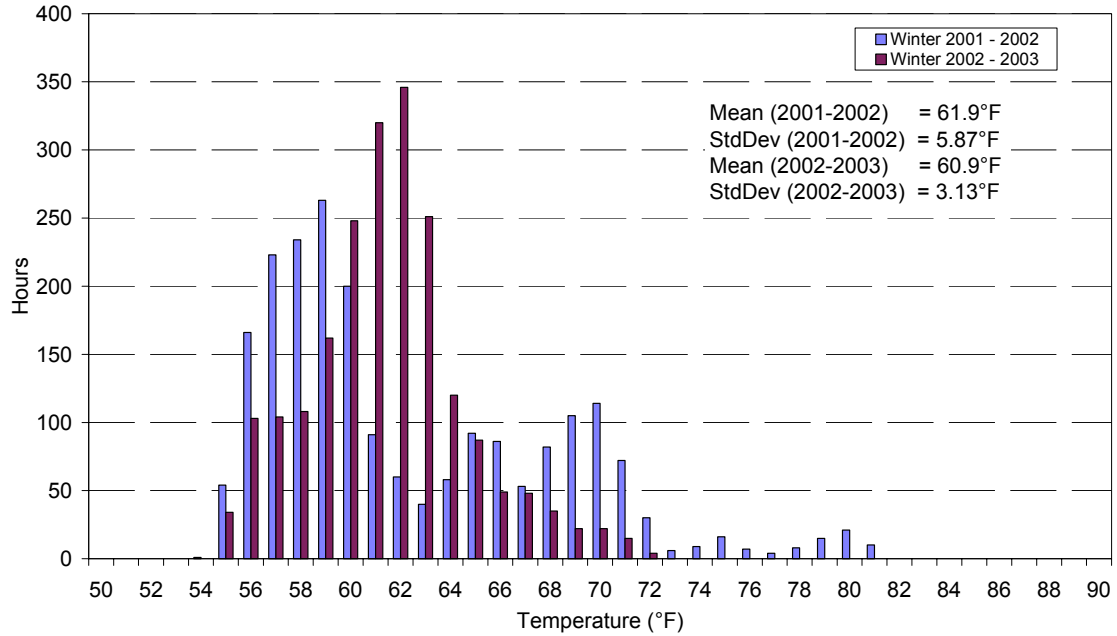
Figure 6-38 Histogram of hours at average temperature in the Comfort Station during winter

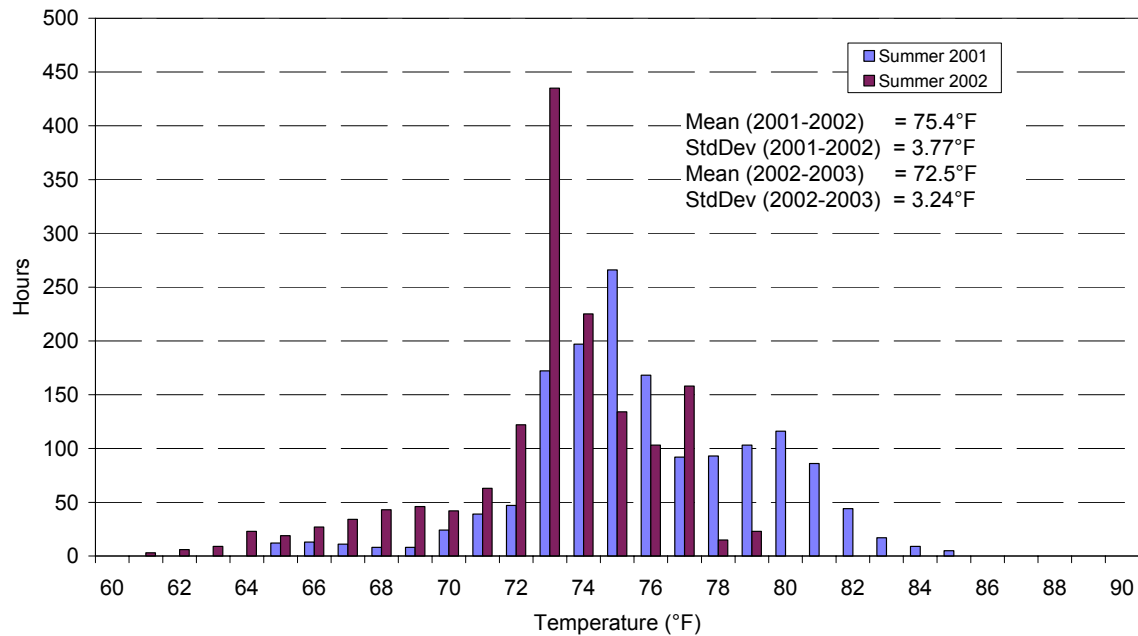
Figure 6-39 Histogram of hours at average temperatures in the Comfort Station during summer

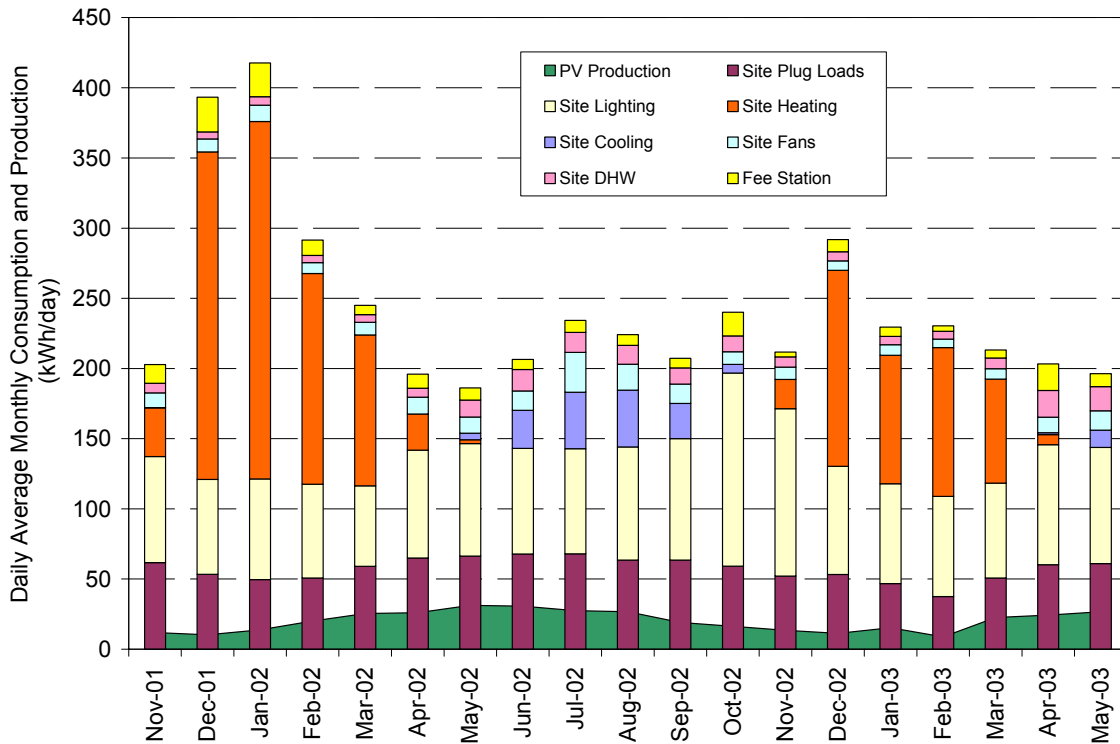
Figure 8-1 End use daily average monthly consumption, November 2001 through May 2003

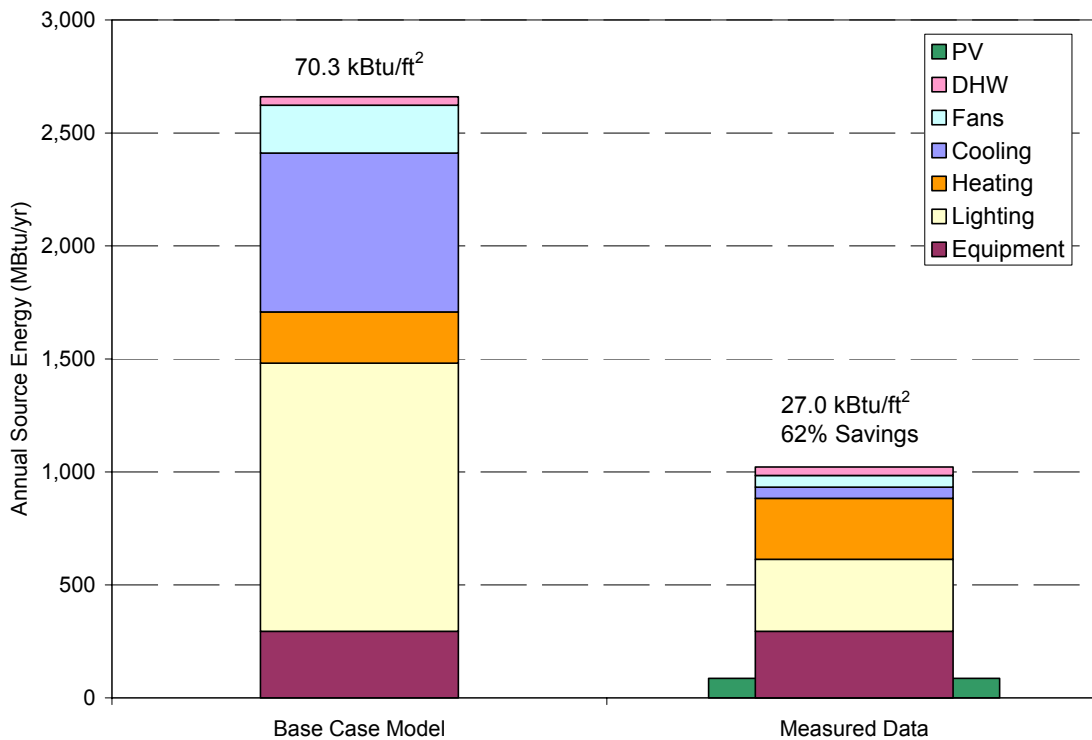
Figure 8-2 Annual performance comparison

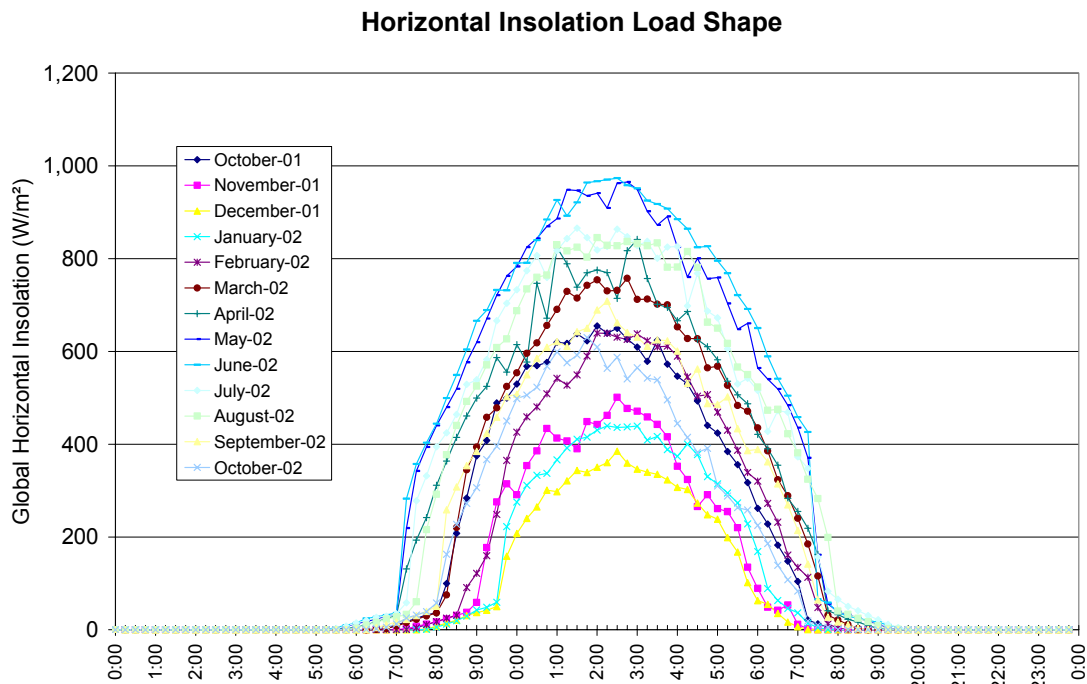
Figure D-2 Horizontal insolation monthly profile, October 2001 through October 2002

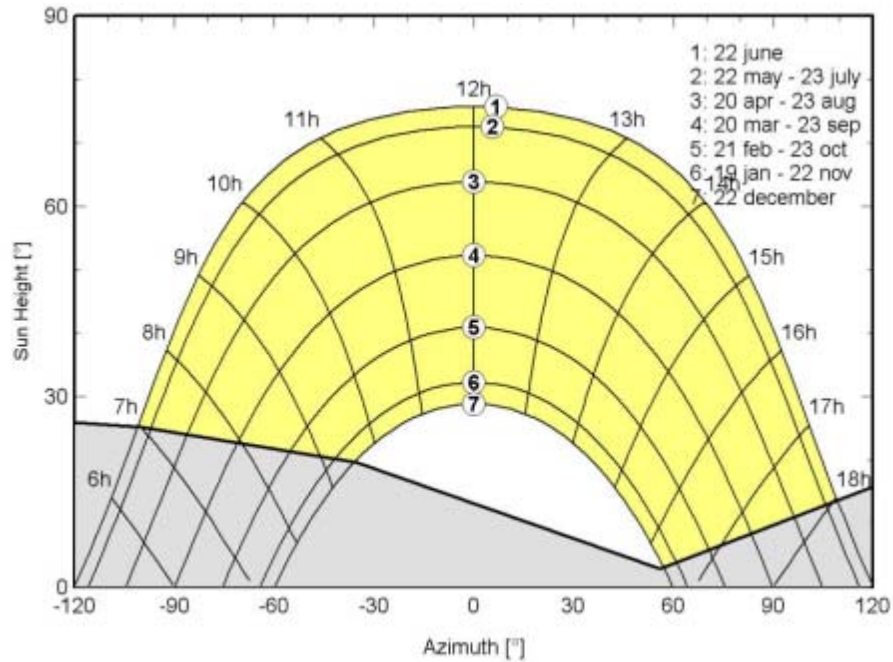
Figure D-3 Southern horizon model

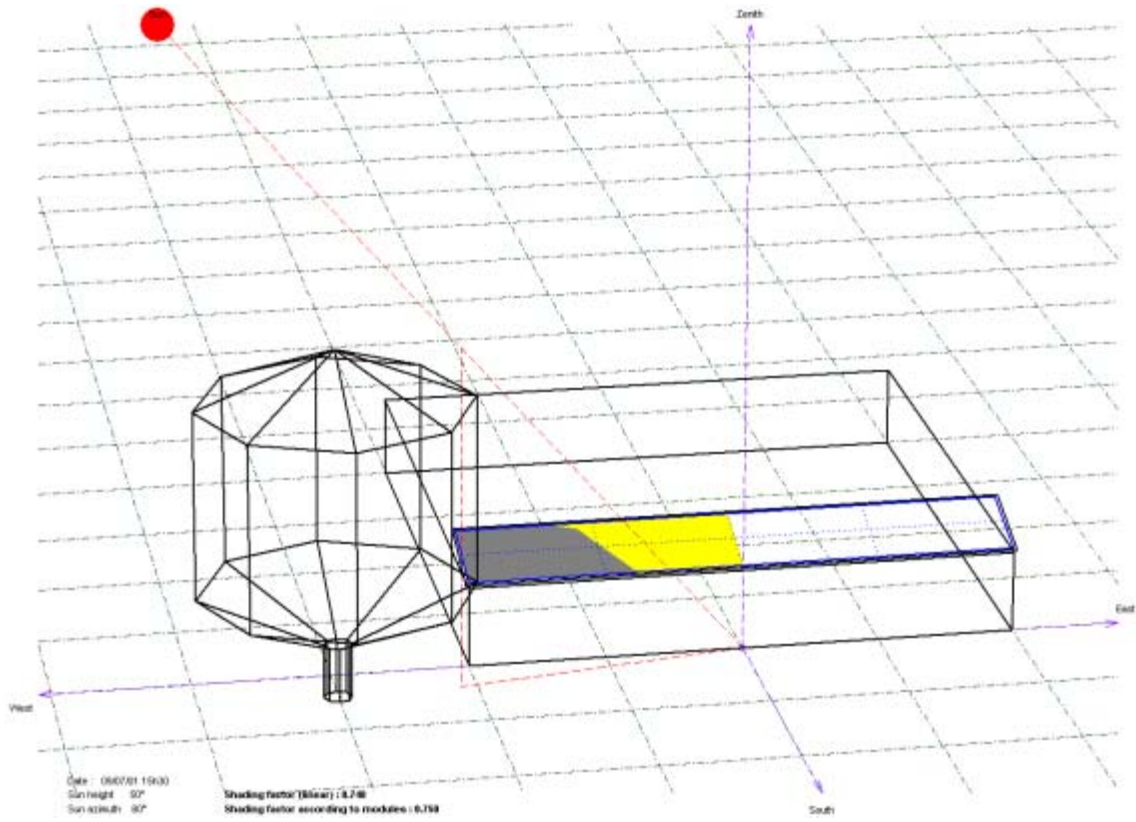
Figure D-5 Model of tree shading of PV array, 3:30 p.m. July 9, 2000

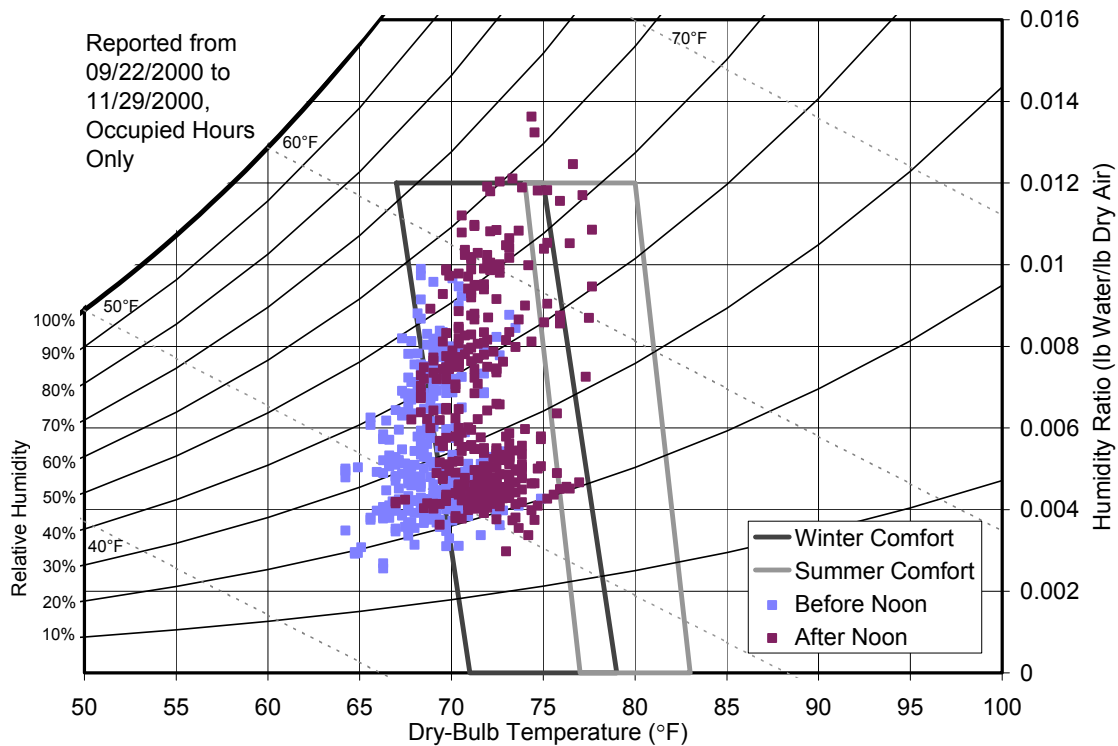
Figure E-1 Comfort chart of cash register area during occupied hours

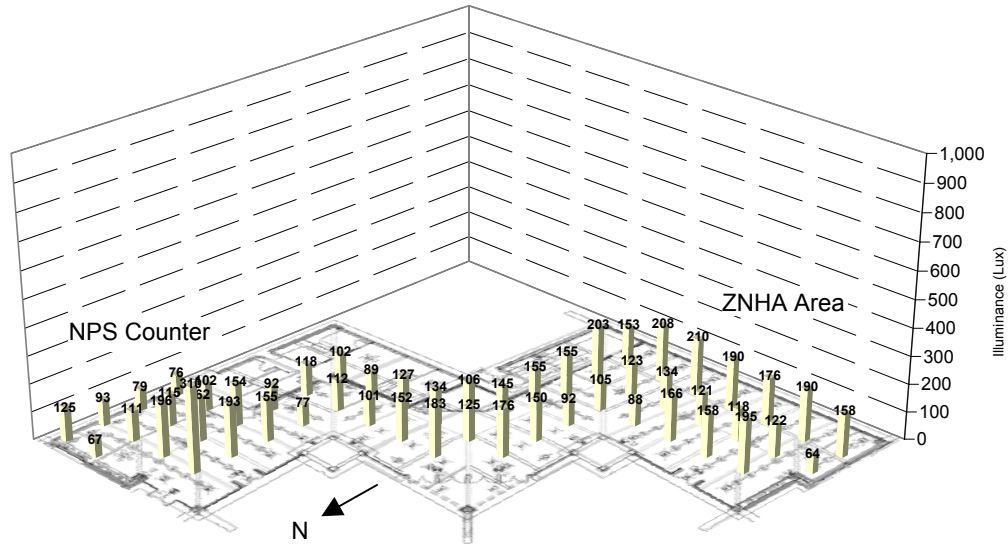
Figure F-1 Illuminance for clear sky with lights OFF; July 11, 2000 at 12:05 p.m.
