BEARING INSPECTION REPORT **FORTH ROAD BRIDGE**

Client: Atkins

Date: 21 April 2008

Client: Atkins
Structure: Forth Road Bridge
Location: South Queensferry, West Lothian
Inspector: Paul Latham
Dates: 18 & 19 February 2008

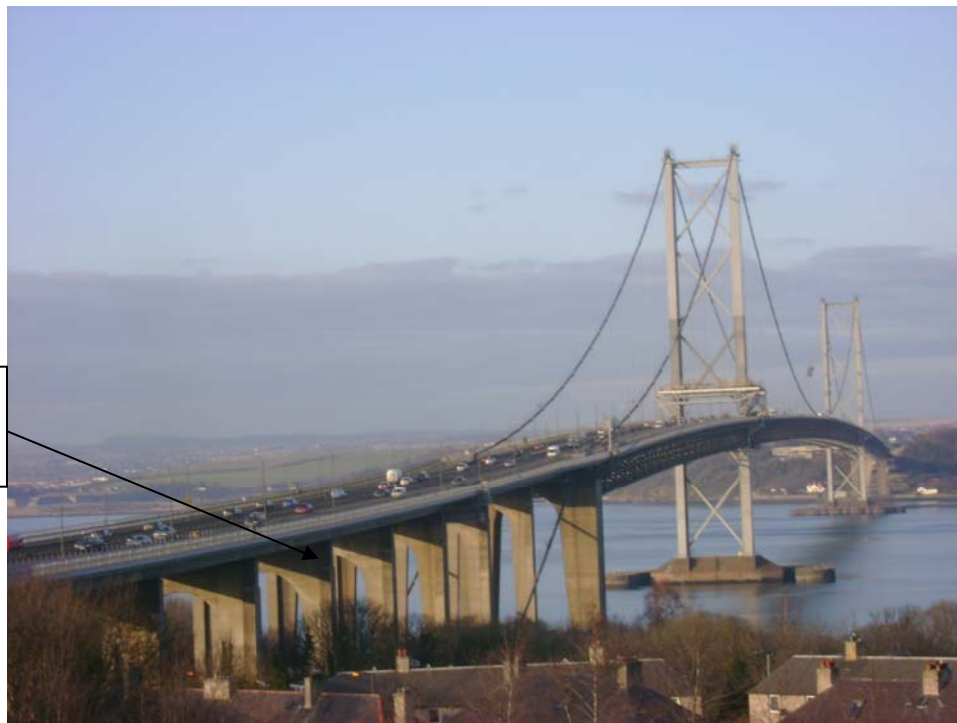
South side viaduct
concrete support
piers

Approach viaduct &
bridge viewed from
south end.

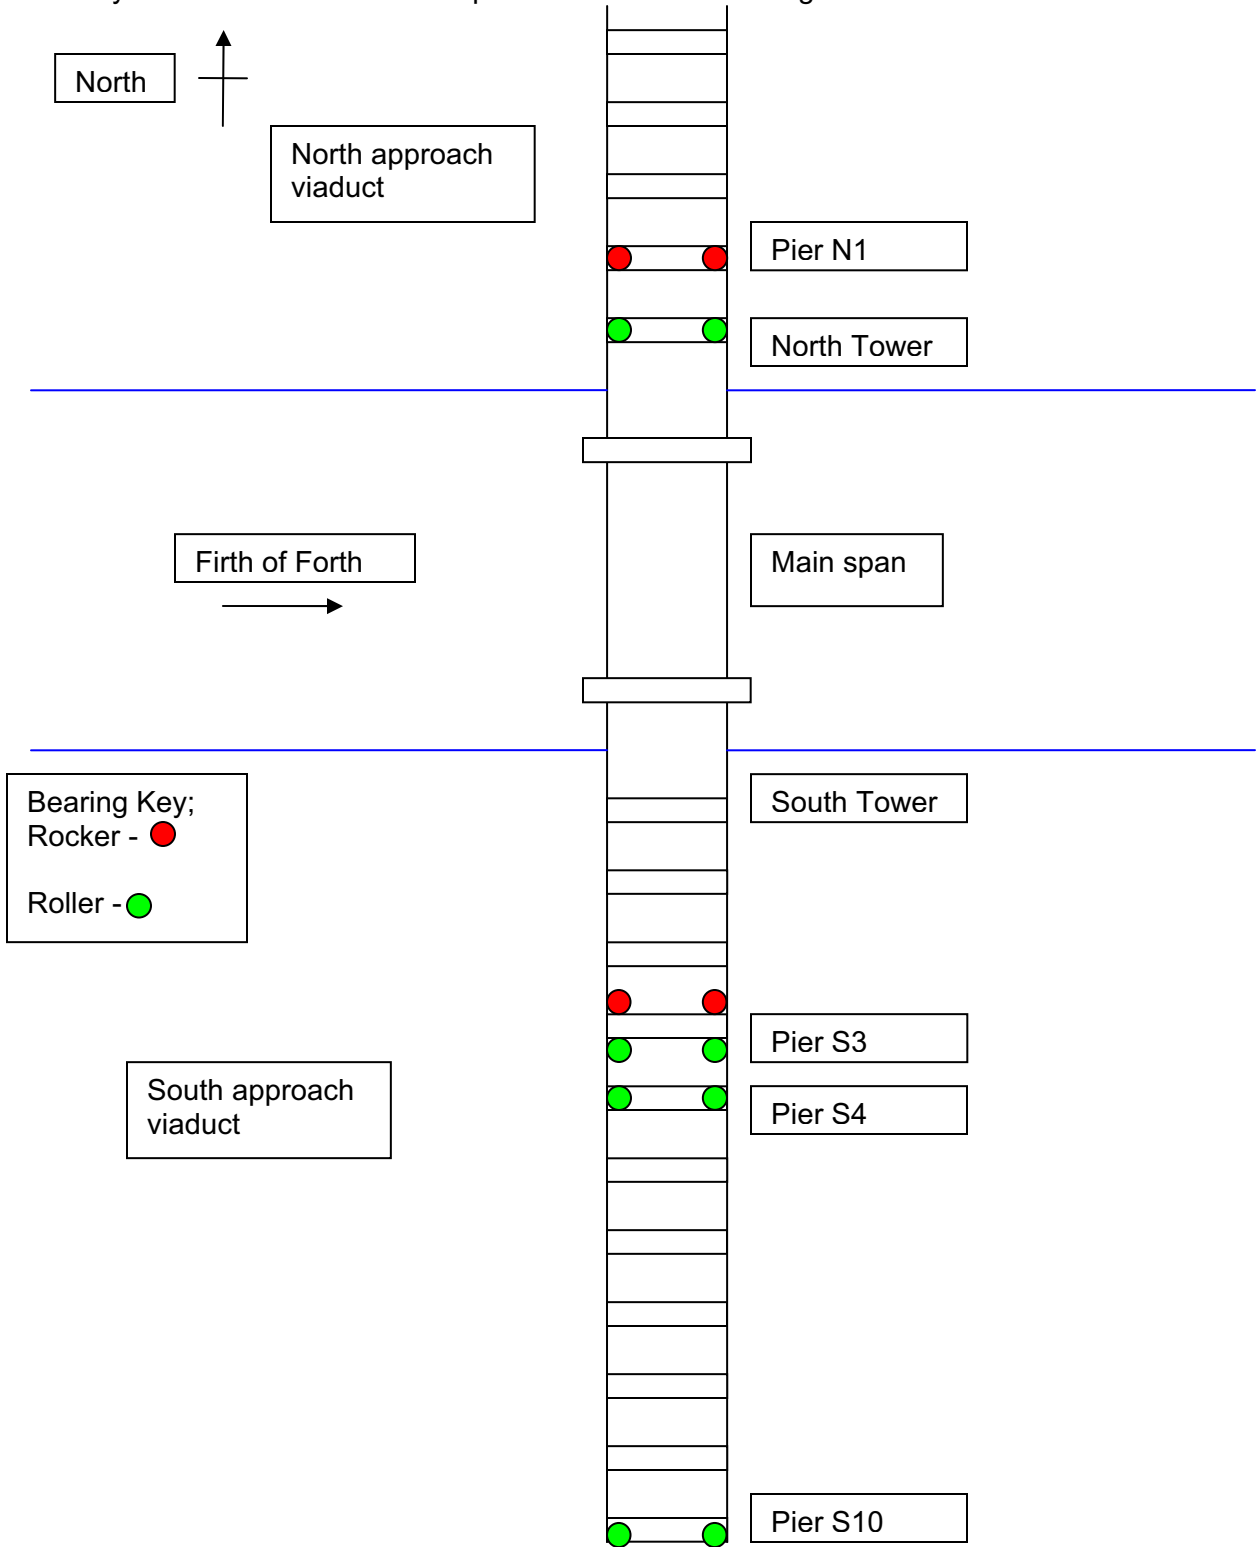
The bearings inspected are identified in the bridge plan below. The bearings were inspected individually and the results collated & presented on the following sheets.
